2015 - 2017 Corvette: Service Bulletin: #16-NA-364: Delayed Engagement After Sitting With Engine Off - Clutch Slow to Fill

#16-NA-364: Delayed Engagement After Sitting With Engine Off - Clutch Slow to Fill - (Jun 29, 2017)

Subject:	Delayed Engagement After Sitting With Engine Off - Clutch Slow to Fill
-----------------	---

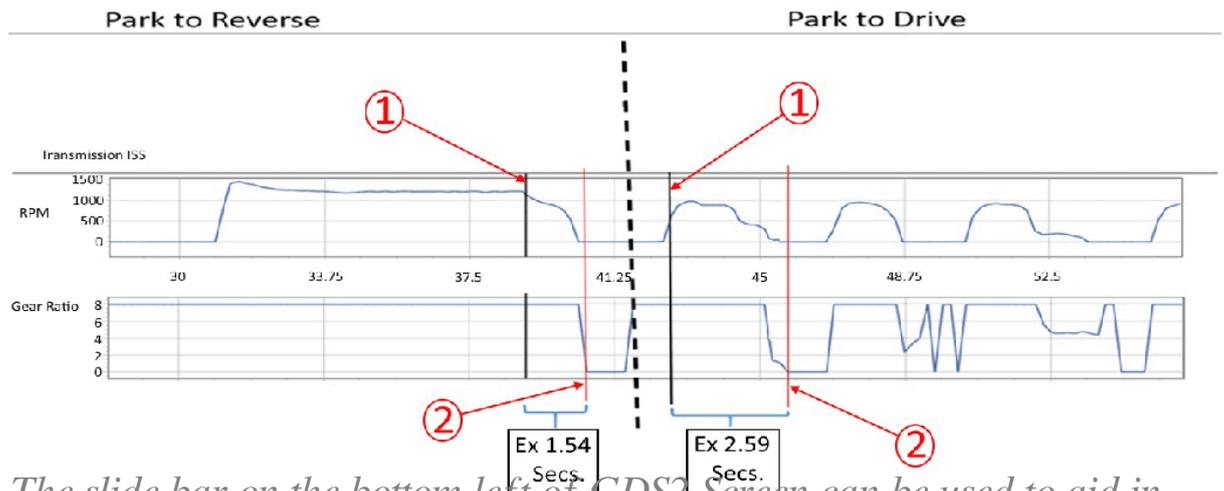
Delayed Harsh Engagement - Clutch Slow to Fill

Note: *Vehicle should only be evaluated if sitting for a minimum of 8 hours but less than 24 hours. To be measured at 50° F (10° C) and above.*

Delayed Engagement Park to Reverse or Drive is present if the time difference between Gear Selected (Pt. 1) and Transmission Input Shaft Speed reaching 0 RPMs (Pt. 2) exceeds 3 seconds. Foot is HELD on Brake during maneuver.

The slide bar on the bottom left of GDS2 Screen can be used to aid in discerning time (Pt. 2 – Pt. 1) = Delayed Engagement Time.
