2015 - 2017 Corvette: Service Bulletin: #16-NA-364: Delayed Engagement After Sitting With Engine Off - Clutch Slow to Fill

#16-NA-364: Delayed Engagement After Sitting With Engine Off - Clutch Slow to Fill - (Jun 29, 2017)

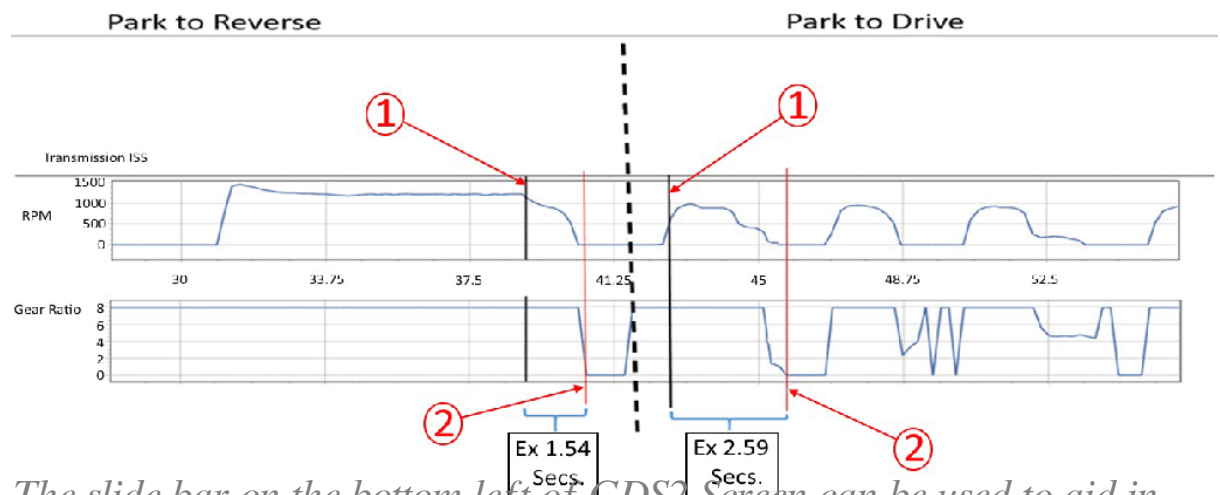
Delayed Engagement Park to Reverse or Drive is present if the time difference between Gear Selected (Pt. 1) and Transmission Input Shaft Speed reaching 0 RPMs (Pt. 2) exceeds 3 seconds. Foot is HELD on Brake during maneuver.

The slide bar on the bottom left of GDS2 Screen can be used to aid in discerning time (Pt. 2 – Pt. 1) = Delayed Engagement Time.
