2015 - 2017 Corvette: Service Bulletin: #16-NA-364: Delayed Engagement After Sitting With Engine Off - Clutch Slow to Fill

#16-NA-364: Delayed Engagement After Sitting With Engine Off - Clutch Slow to Fill - (Jun 29, 2017)

Subject:	Delayed Engagement After Sitting With Engine Off - Clutch Slow to Fill
-----------------	---

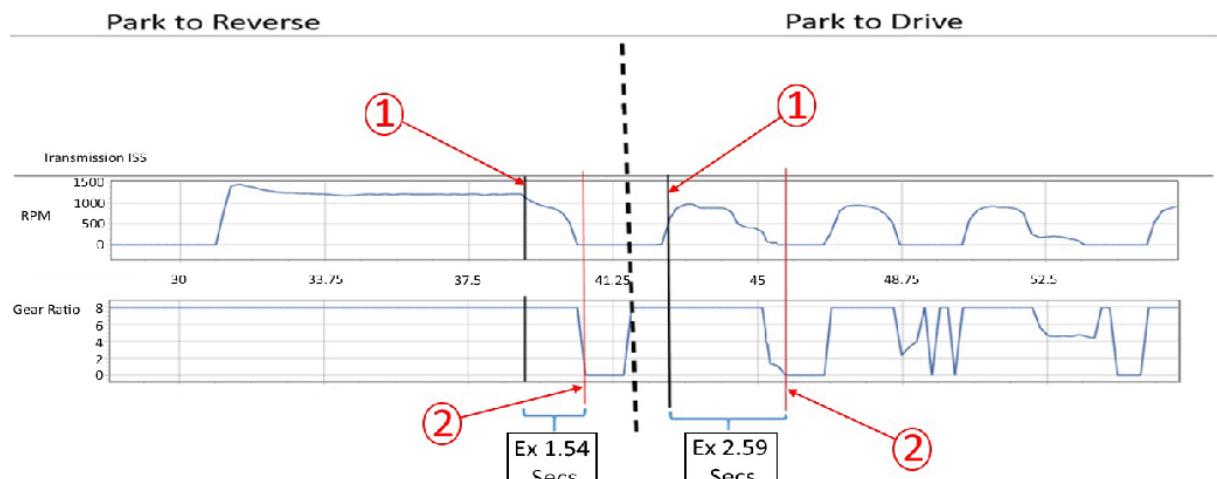
Delayed Harsh Engagement - Clutch Slow to Fill

Delayed Engagement Park to Reverse or Drive is present if the time difference between Gear Selected (Pt. 1) and Transmission Input Shaft Speed reaching 0 RPMs (Pt. 2) exceeds 3 seconds. Foot is HELD on Brake during maneuver.

The slide bar on the bottom left of GDS2 Screen can be used to aid in discerning time (Pt. 2 – Pt. 1) = Delayed Engagement Time.

For 2016-2017 MY vehicles, attempt to learn the C5 - Reverse and C3 - Drive Clutch using the following procedure:

1. Allow the transmission sump temperature to rise between 20° and 30°C (68° and 86°F).

2. Perform 20 Park to Reverse shifts or 20 Park to Drive shifts releasing the brake pedal with each shift allowing the vehicle to roll 5-10 feet per engagement into gear.

If the learn procedure does not correct the condition, disassemble the transmission and inspect the 1-3-5-6-7 Clutch (C3) for a delay into Drive and inspect the 4-5-6-7-8 Reverse Clutch (C5) for a delay into Reverse. The respective clutch plates and seals should be inspected for
