# 2015 - 2017 Corvette: Service Bulletin: #16-NA-364: Delayed Engagement After Sitting With Engine Off - Clutch Slow to Fill

## #16-NA-364: Delayed Engagement After Sitting With Engine Off - Clutch Slow to Fill - (Jun 29, 2017)

<b>Subject:</b>	Delayed Engagement After Sitting With Engine Off - Clutch Slow to Fill
-----------------	---

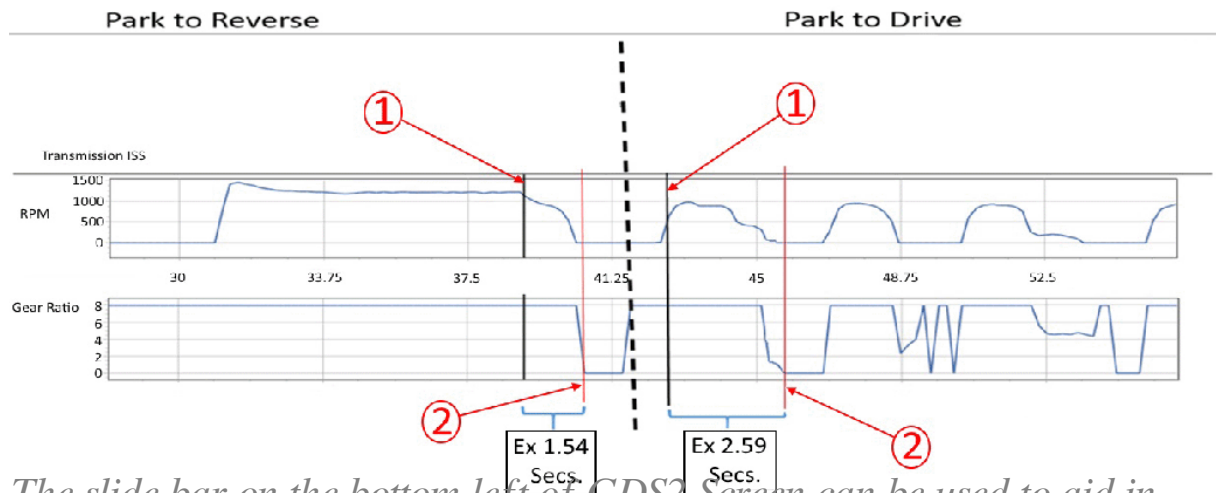
Delayed Engagement Park to Reverse or Drive is present if the time difference between Gear Selected (Pt. 1) and Transmission Input Shaft Speed reaching 0 RPMs (Pt. 2) exceeds 3 seconds. Foot is HELD on Brake during maneuver.

*The slide bar on the bottom left of GDS2 Screen can be used to aid in discerning time (Pt. 2 – Pt. 1) = Delayed Engagement Time.*
