# 2015 - 2017 Corvette: Service Bulletin: #15-NA-002: Information on Fuel Odor and/or Fuel Leaks from Underhood SIDI Pipes Between High Pressure Pump and Fuel Rails

## #15-NA-002: Information on Fuel Odor and/or Fuel Leaks from Underhood SIDI Pipes Between High Pressure Pump and Fuel Rails - (Jul 11, 2017)

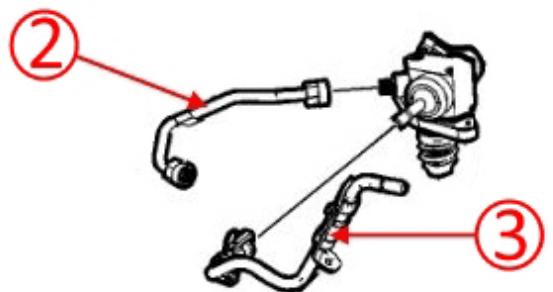
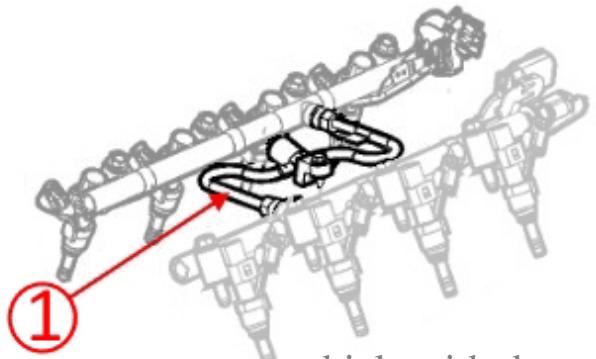
<b><i>Cause</i></b>	This condition may be caused by the result of a fuel leak at one of the high pressure fuel rail pipe connections that was installed incorrectly during service of another engine component, that required the fuel system to be opened. (i.e. fuel rail, lifter, head gasket, High pressure pump, injector, etc.)
---------------------	---

1. If a leak is found at any nut location, change as denoted below.

- If a leak in pipe 2 is found, change *only* pipe 2 (Int pipe 2), ensuring the interfaces for this tube are clean and free of debris.
- If a leak in pipe 1 is found, change pipe 1 *and* pipe 2 (Int pipe 1 and 2), ensuring the interfaces for this tube are clean and free of debris.
- If a leak in pipe 3 is found, change pipe 3 only (Fuel feed). Ensure the interfaces for this tube are clean and free of debris.

After installing the new pipes, start the engine, let idle for 3 minutes and confirm no leak is evident.
