2015 - 2017 Corvette: Service Bulletin: #15-NA-002: Information on Fuel Odor and/or Fuel Leaks from Underhood SIDI Pipes Between High Pressure Pump and Fuel Rails

#15-NA-002: Information on Fuel Odor and/or Fuel Leaks from Underhood SIDI Pipes Between High Pressure Pump and Fuel Rails - (Jul 11, 2017)

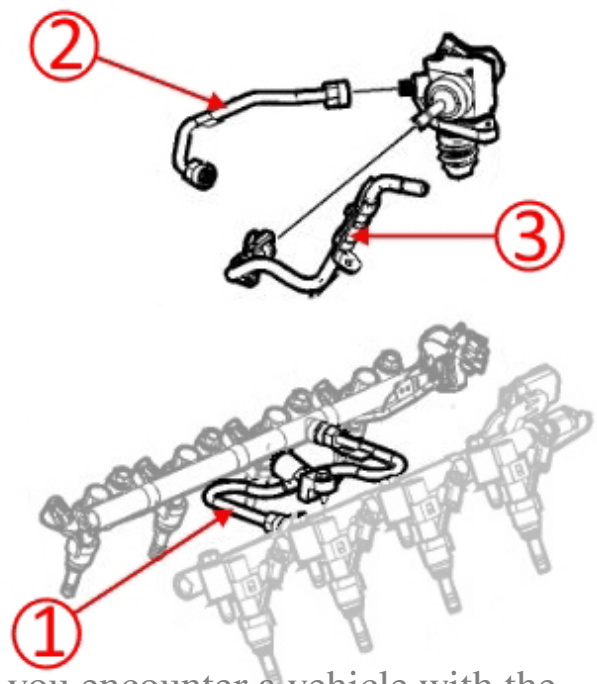
<i>Involved Region or Country</i>	North America and N. A. Export Regions
<i>Condition</i>	<p>Some customers may comment on one or more of the following conditions:</p> <ul style="list-style-type: none"> • Fuel odor smelled • Fuel leak in front of vehicle • Low/poor fuel economy • Vehicle hard start or engine stumble • Vehicle no start • Wet foam insulator on engine <p>The technician may find fuel leaking around the bellhousing or VL0M.</p>

<p>Note: The conditions listed may occur with or without the Malfunction Indicator Lamp (MIL) illuminating.</p>
<p>Important: It is required to replace the engine fuel feed intermediate pipes during any service repairs that required one or more of the pipes to be loosened or removed.</p>	
<p><i>Cause</i></p>	<p>This condition may be caused by the result of a fuel leak at one of the high pressure fuel rail pipe connections that was installed incorrectly during service of another engine component, that required the fuel system to be opened. (i.e. fuel rail, lifter, head gasket, High pressure pump, injector, etc.)</p>
<p><i>Correction</i></p>	<p>Important: If any damage occurred due to leaking fuel, be sure to replace as necessary. (i.e. Fuel Pump Insulator)</p>

1. If a leak is found at any nut location, change as denoted below.

- If a leak in pipe 2 is found, change *only* pipe 2 (Int pipe 2), ensuring the interfaces for this tube are clean and free of debris.
- If a leak in pipe 1 is found, change pipe 1 *and* pipe 2 (Int pipe 1 and 2), ensuring the interfaces for this tube are clean and free of debris.
- If a leak in pipe 3 is found, change pipe 3 only (Fuel feed). Ensure the interfaces for this tube are clean and free of debris.
