2015 - 2017 Corvette: Service Bulletin: #15-NA-002: Information on Fuel Odor and/or Fuel Leaks from Underhood SIDI Pipes Between High Pressure Pump and Fuel Rails

#15-NA-002: Information on Fuel Odor and/or Fuel Leaks from Underhood SIDI Pipes Between High Pressure Pump and Fuel Rails - (Jul 11, 2017)

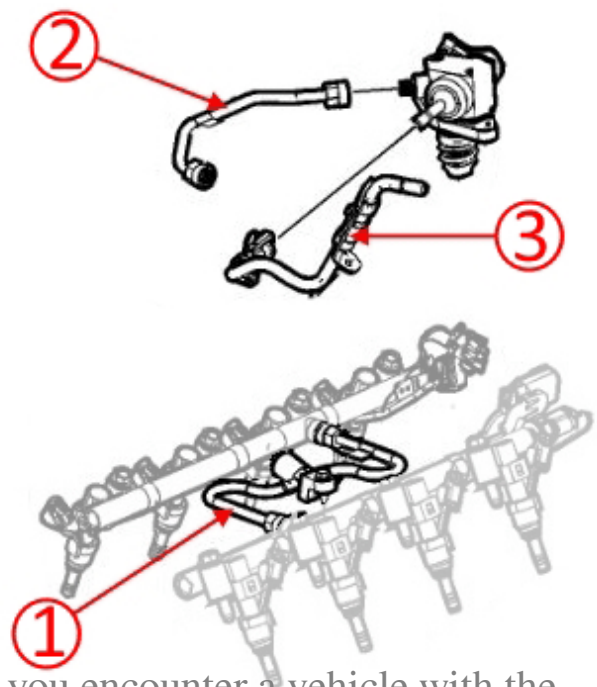
<i>Involved Region or Country</i>	North America and N. A. Export Regions
<i>Condition</i>	<p>Some customers may comment on one or more of the following conditions:</p> <ul style="list-style-type: none"> • Fuel odor smelled • Fuel leak in front of vehicle • Low/poor fuel economy • Vehicle hard start or engine stumble • Vehicle no start • Wet foam insulator on engine <p>The technician may find fuel leaking around the bellhousing or VL0M.</p>

<p>Note: The conditions listed may occur with or without the Malfunction Indicator Lamp (MIL) illuminating.</p>
<p>Important: It is required to replace the engine fuel feed intermediate pipes during any service repairs that required one or more of the pipes to be loosened or removed.</p>	
<p><i>Cause</i></p>	<p>This condition may be caused by the result of a fuel leak at one of the high pressure fuel rail pipe connections that was installed incorrectly during service of another engine component, that required the fuel system to be opened. (i.e. fuel rail, lifter, head gasket, High pressure pump, injector, etc.)</p>
<p><i>Correction</i></p>	<p>Important: If any damage occurred due to leaking fuel, be sure to replace as necessary. (i.e. Fuel Pump Insulator)</p>

1. If a leak is found at any nut location, change as denoted below.

- If a leak in pipe 2 is found, change *only* pipe 2 (Int pipe 2), ensuring the interfaces for this tube are clean and free of debris.
- If a leak in pipe 1 is found, change pipe 1 *and* pipe 2 (Int pipe 1 and 2), ensuring the interfaces for this tube are clean and free of debris.
- If a leak in pipe 3 is found, change pipe 3 only (Fuel feed). Ensure the interfaces for this tube are clean and free of debris.

After installing the new pipes, start the engine, let idle for 3 minutes and confirm no leak is evident.

If required, replace the engine insulator if absorbed with fuel or emits a fuel odor.
