2014 - 2017 Corvette: Product Safety Recall: Frontal Airbag and Pretensioner Non Deploy - (Jul 10, 2017)

#17287: Product Safety Recall - Frontal Airbag and Pretensioner Non Deploy - (Jul 10, 2017)

| <i>Reference Number:</i> N172105680 | <i>Release Date:</i> July 2017 |

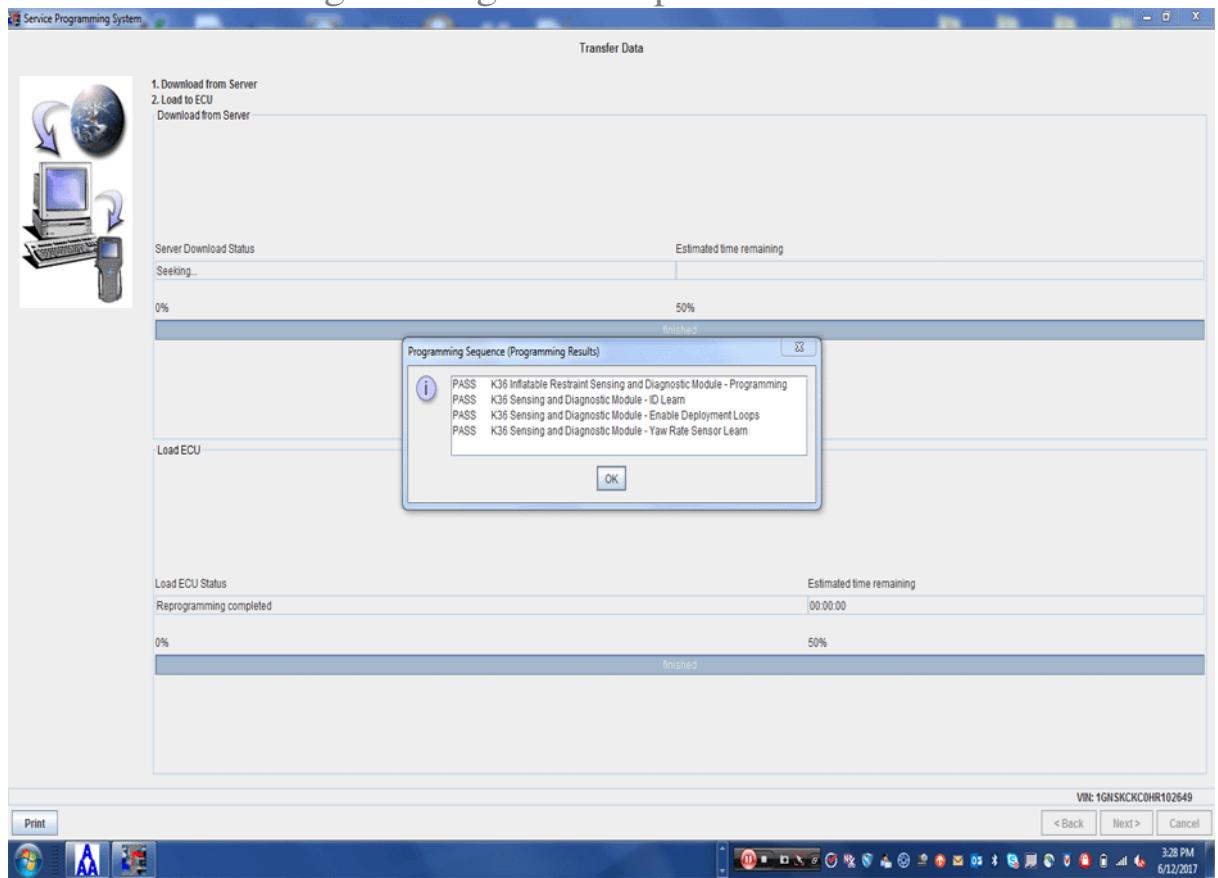
Important: The screen above should show all “PASS” or “SKIPPED” and/or PASS” if the programming event is successful. If ANY of the results show “FAILED”, proceed to “Unable to Program SDM” section.

Submit a screenshot of the “Programming Sequence (Programming Results)” including the VIN (lower right corner) in the screenshot as shown above along with the SPS Warranty Claim Code when submitting this transaction.
