2014 - 2017 Corvette: Product Safety Recall: Frontal Airbag and Pretensioner Non Deploy - (Jul 10, 2017)

#17287: Product Safety Recall - Frontal Airbag and Pretensioner Non Deploy - (Jul 10, 2017)

<i>Reference Number:</i> N172105680	<i>Release Date:</i> July 2017
<i>Revision:</i> 00

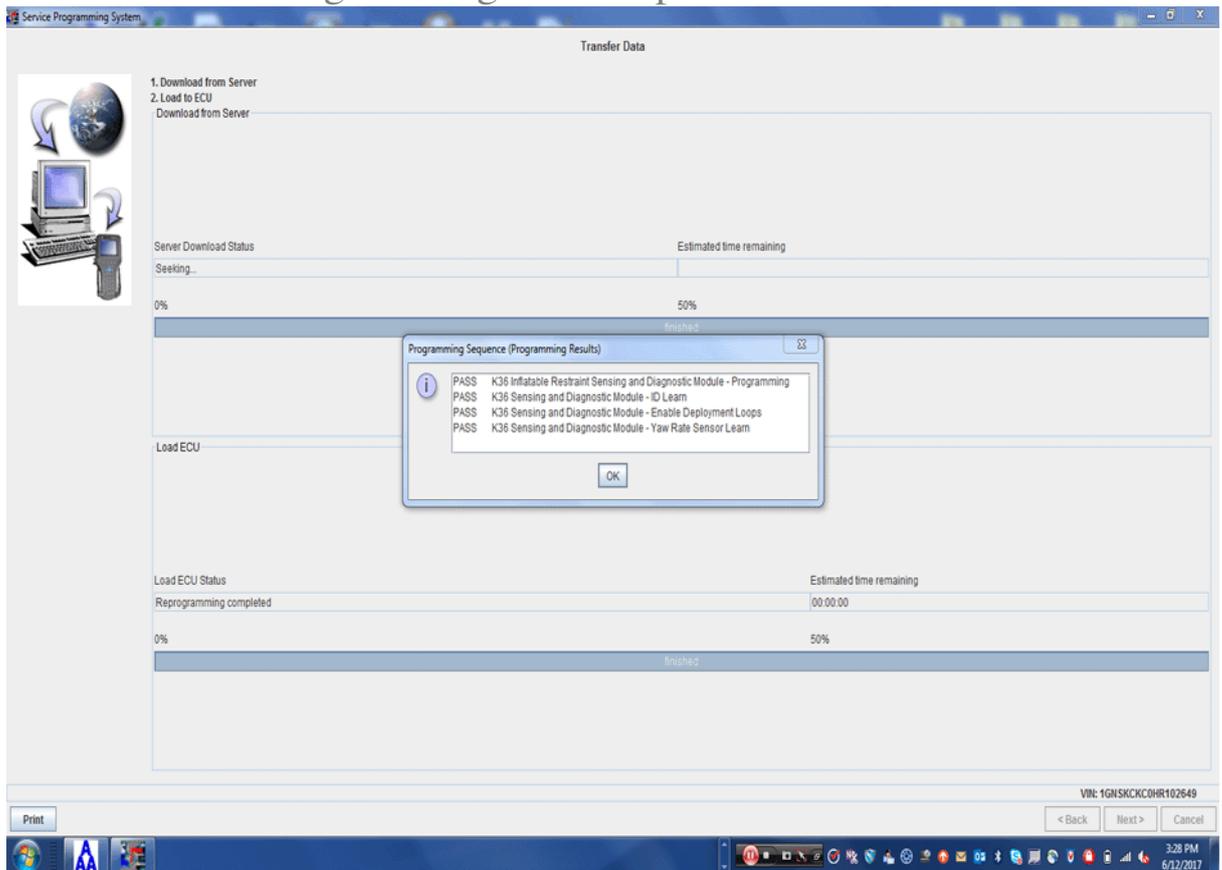
Important: The screen above should show all “PASS” or “SKIPPED” and/or PASS” if the programming event is successful. If ANY of the results show “FAILED”, proceed to “Unable to Program SDM” section.

Submit a screenshot of the “Programming Sequence (Programming Results)” including the VIN (lower right corner) in the screenshot as shown above along with the SPS Warranty Claim Code when submitting this transaction.
