2014 - 2018 Corvette: Service Bulletin: #PIP5248D: Stalling Shudder And/or Hard shifting Into 1st Gear Or Reverse Vibration On launch

#PIP5248D: Stalling Shudder And/or Hard shifting Into 1st Gear Or Reverse Vibration On launch (With Excessive Crankshaft End Play) - (Aug 10, 2017)

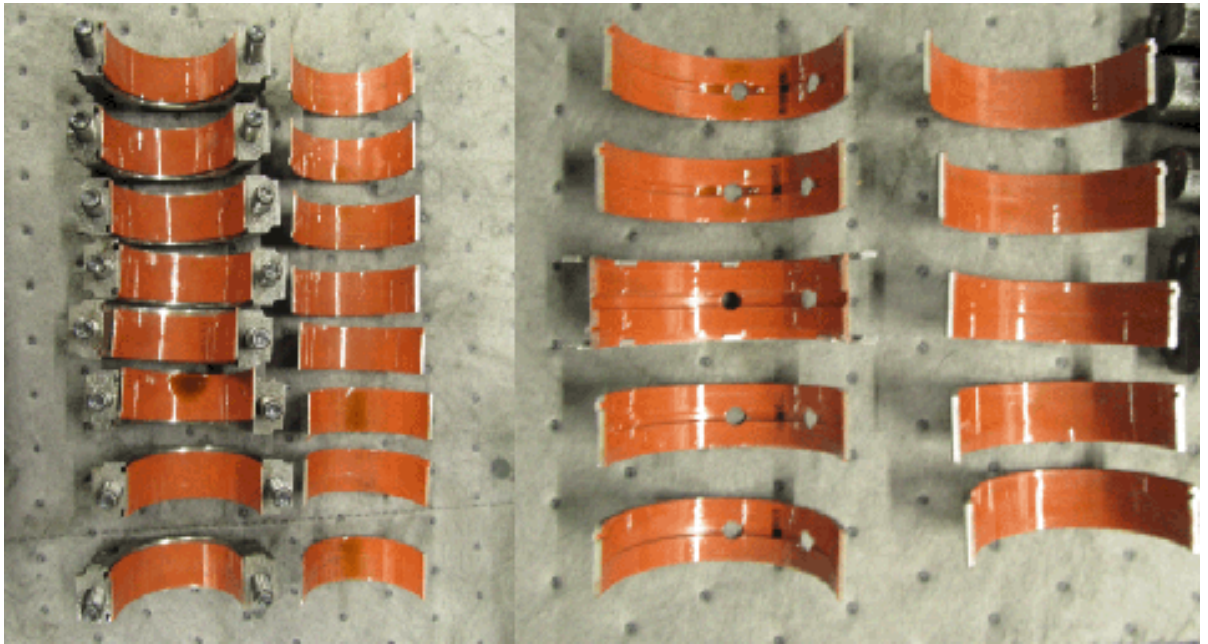
Note: If bearings and crankshaft look like components in attached picture, damage has not occurred.

Inspect thrust bearing for wear on one side and crankshaft on that “mating” surface.

If wear is evident (3 vertical channels worn off) replace connecting rod bearings, main bearings, thrust bearing and crankshaft.
