# 2014 - 2018 Corvette: Service Bulletin: #PIP5248D: Stalling Shudder And/or Hard shifting Into 1st Gear Or Reverse Vibration On launch

## #PIP5248D: Stalling Shudder And/or Hard shifting Into 1st Gear Or Reverse Vibration On launch (With Excessive Crankshaft End Play) - (Aug 10, 2017)

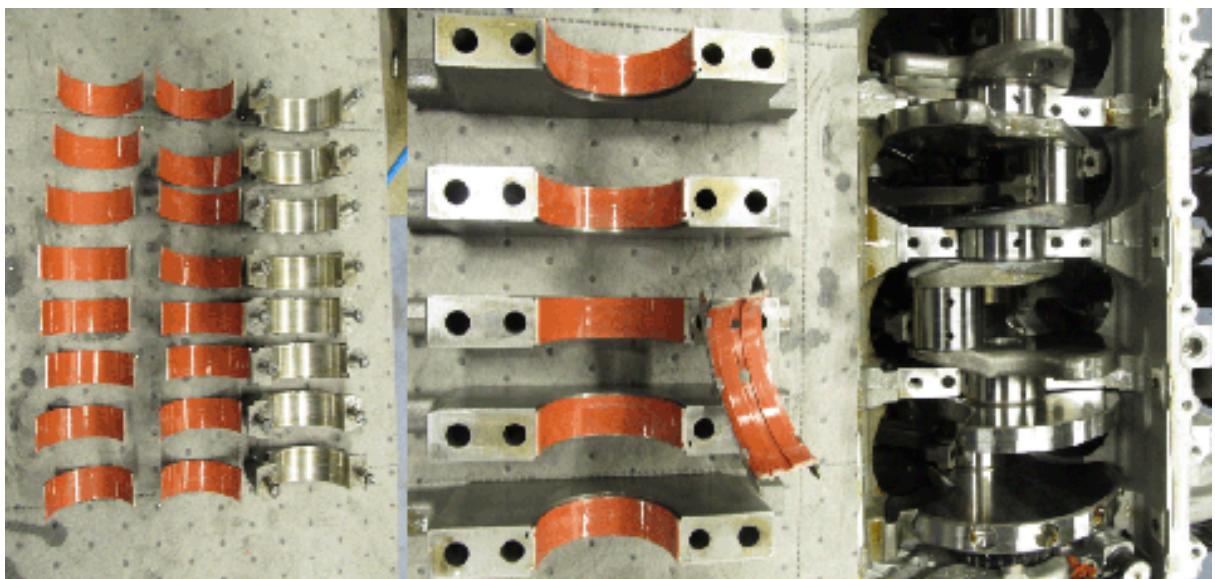
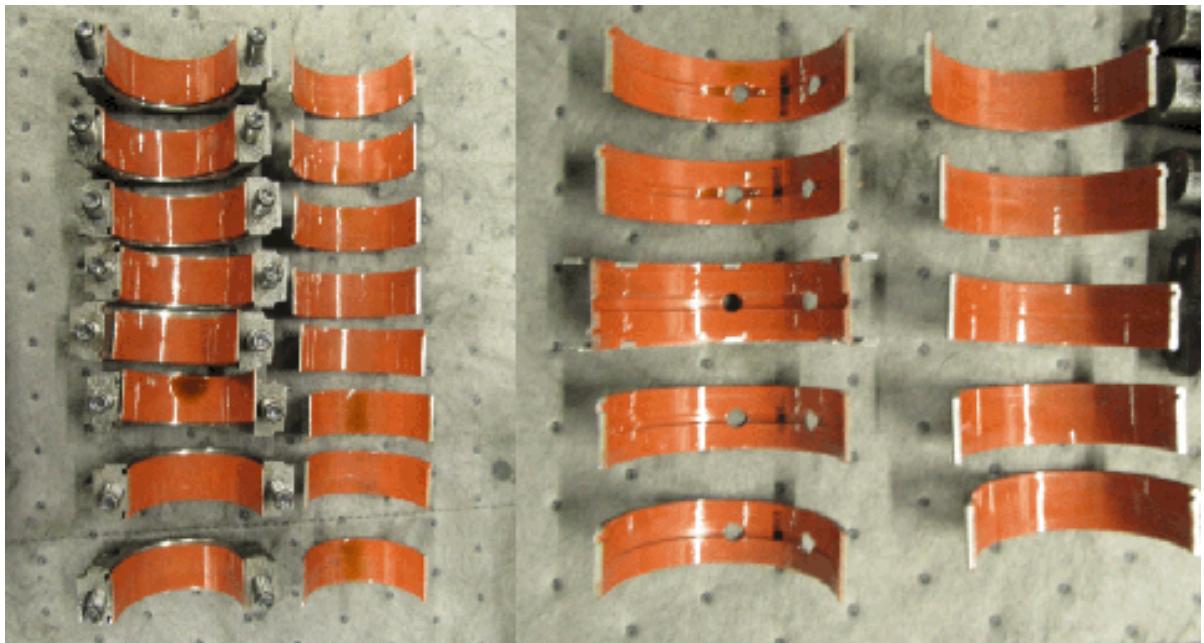
This concern could be caused by excessive crankshaft end play.

**Note:** If bearings and crankshaft look like components in attached picture, damage has not occurred.

Inspect thrust bearing for wear on one side and crankshaft on that “mating” surface.

If wear is evident (3 vertical channels worn off) replace connecting rod bearings, main bearings, thrust bearing and crankshaft.
