# 2016 - 2017 Corvette: Service Bulletin: #PIP5498B: SES Lamp P050D P0300 Setting On A Cold Start And/Or a Run Rough Warm with No codes

## #PIP5498B: SES Lamp P050D P0300 Setting On A Cold Start And/Or a Run Rough Warm with No codes - (Aug 8, 2017)

**Subject:** SES Lamp P050D P0300 Setting On  
A Cold Start And/Or a Run Rough  
Warm with No codes

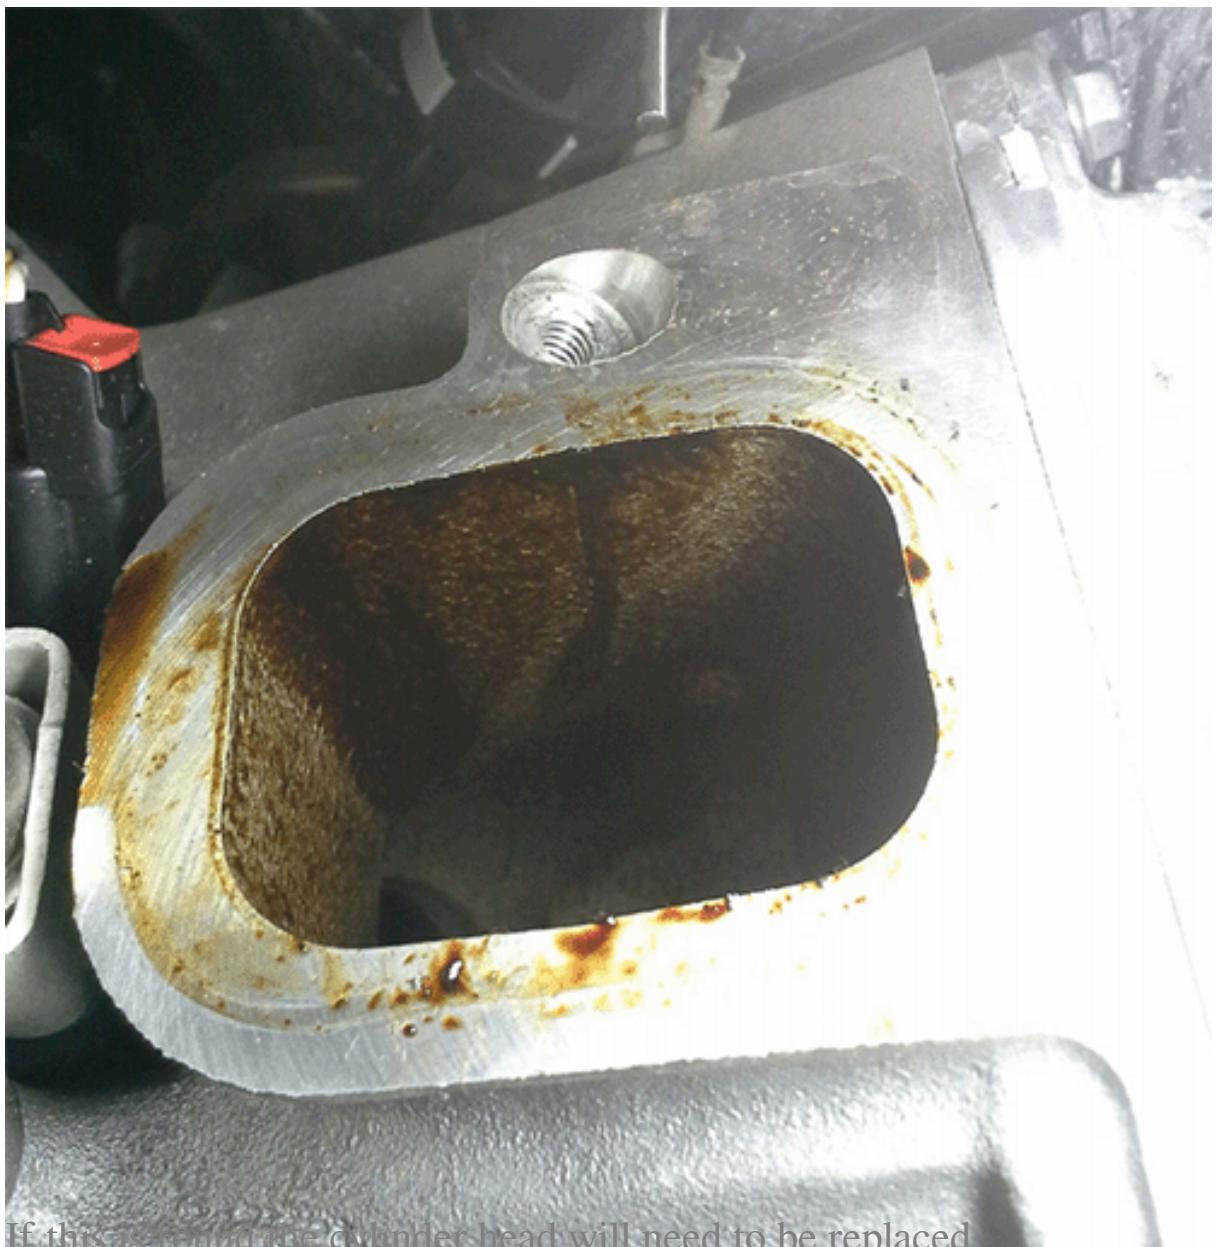
If the head casting line is the concern the intake port will be wet with a coolant oil mix.

This could be the cause of a running rough warn concern with or without codes.

The location of where the coolant is running down in the port will also look washed down.

If this is found the cylinder head will need to be replaced
