# 2016 - 2017 Corvette: Service Bulletin: #PIP5498B: SES Lamp P050D P0300 Setting On A Cold Start And/Or a Run Rough Warm with No codes

## #PIP5498B: SES Lamp P050D P0300 Setting On A Cold Start And/Or a Run Rough Warm with No codes - (Aug 8, 2017)

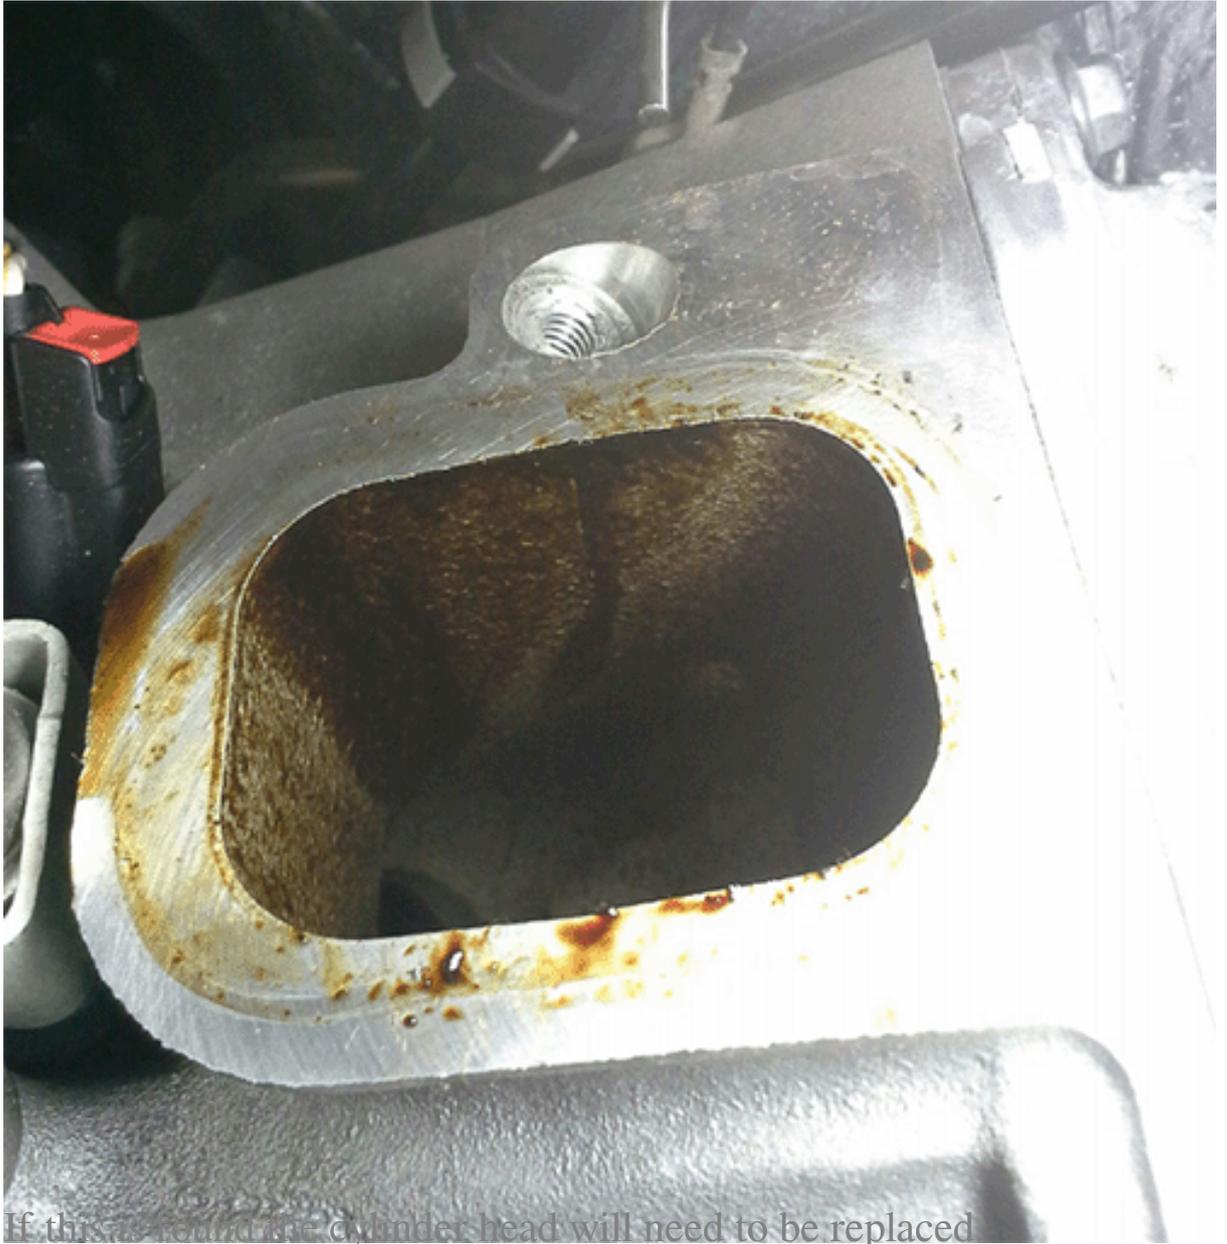
If the head casting line is the concern the intake port will be wet with a coolant oil mix.

This could be the cause of a running rough warn concern with or without codes.

The location of where the coolant is running down in the port will also look washed down.

If this is found the cylinder head will need to be replaced
