2015 - 2018 Corvette Z06: GM TechLink: Hard Shifting into 1st Gear or Reverse

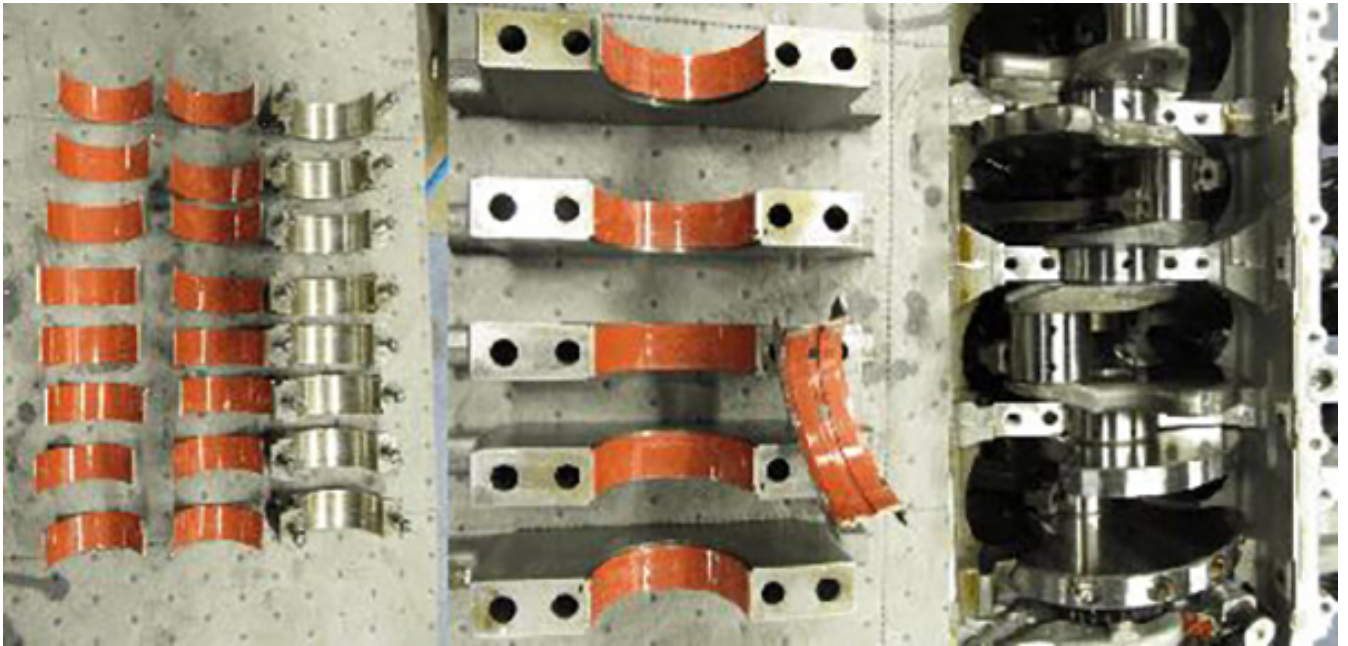
Fig. 10

The hard shifting conditions may require replacement of the crankshaft or thrust bearing. Before replacing any components, check for excessive crankshaft end play. Crankshaft end play clearance should be within a specification of 0.0015–0.0086 in. (0.040–0.220 mm).

If end play is found to be out of specification, remove the engine and check for possible crankshaft thrust bearing or crankshaft wear. The crankshaft and bearings should not show signs of excessive wear. (Fig. 10) Inspect the thrust bearing for wear on one side and the crankshaft on the mating surface.

If wear is evident — the three vertical channels may be worn off — replace the connecting rods, main bearings, thrust bearing and crankshaft.
