# 2015 - 2018 Corvette Z06: GM TechLink: Hard Shifting into 1st Gear or Reverse

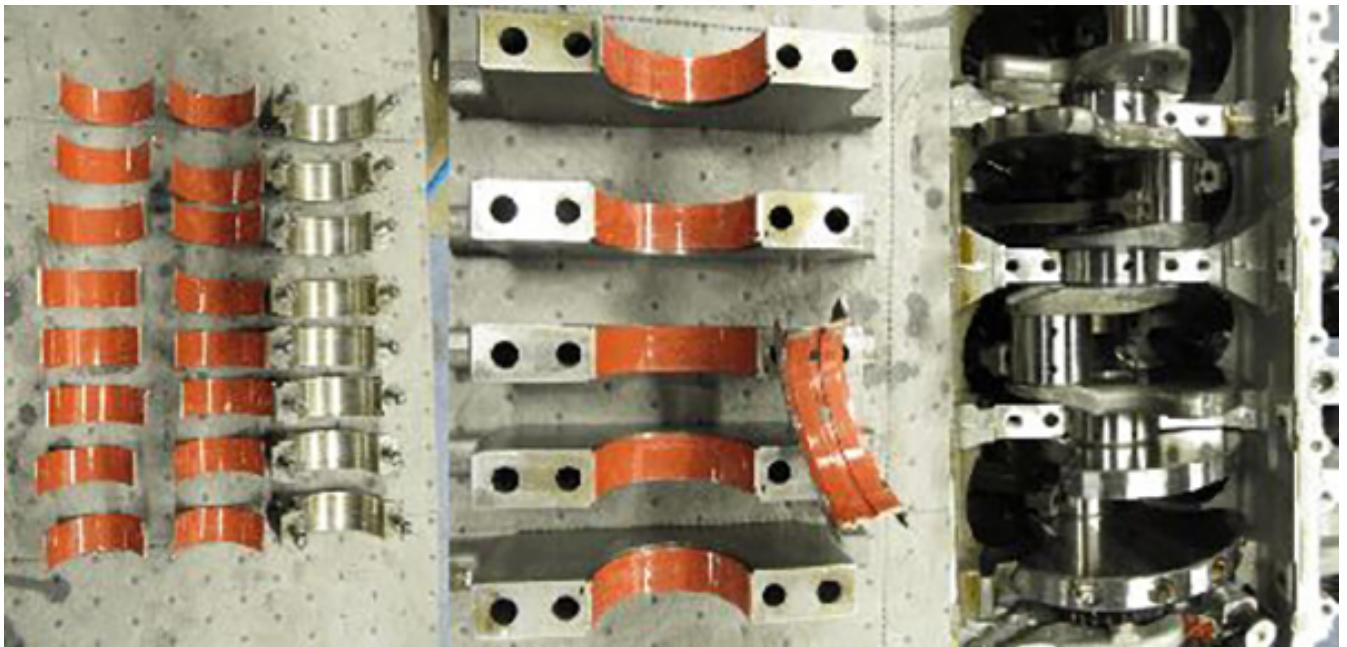
**Fig. 10**

The hard shifting conditions may require replacement of the crankshaft or thrust bearing. Before replacing any components, check for excessive crankshaft end play. Crankshaft end play clearance should be within a specification of 0.0015–0.0086 in. (0.040–0.220 mm).

If end play is found to be out of specification, remove the engine and check for possible crankshaft thrust bearing or crankshaft wear. The crankshaft and bearings should not show signs of excessive wear. (Fig. 10) Inspect the thrust bearing for wear on one side and the crankshaft on the mating surface.

If wear is evident — the three vertical channels may be worn off — replace the connecting rods, main bearings, thrust bearing and crankshaft.
