2015 - 2018 Corvette Z06: GM TechLink: Hard Shifting into 1st Gear or Reverse

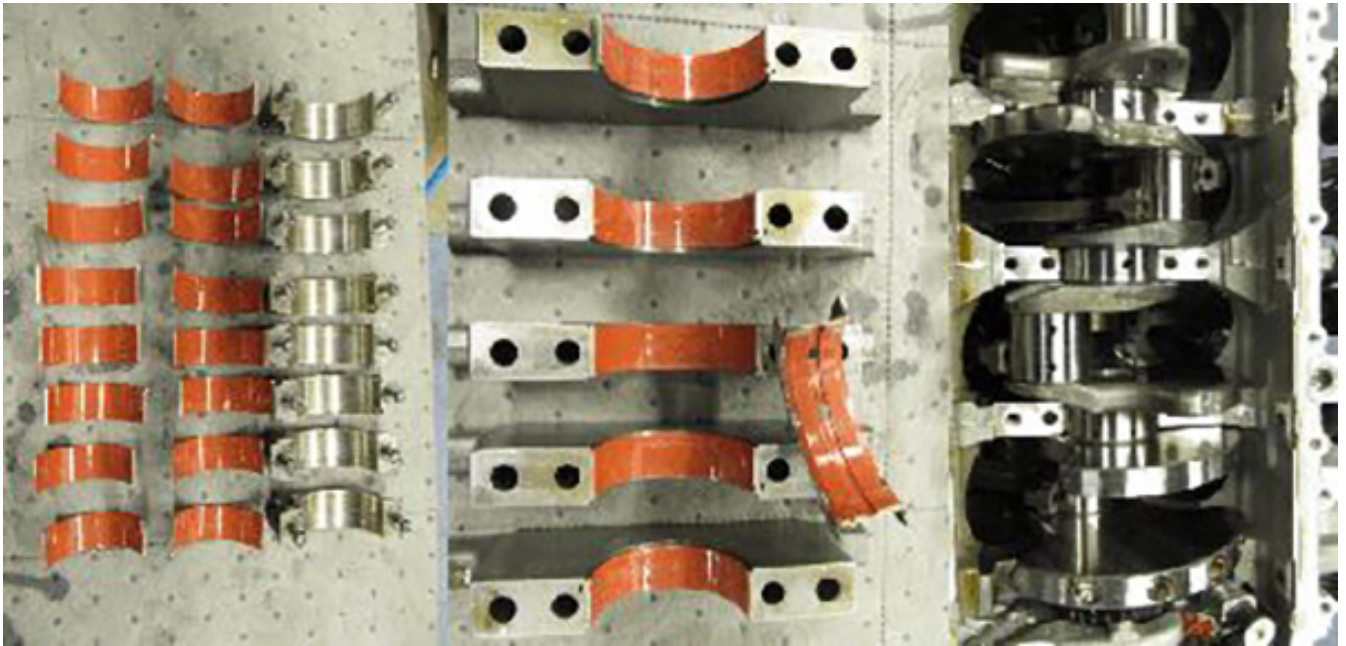
Fig. 10

If end play is found to be out of specification, remove the engine and check for possible crankshaft thrust bearing or crankshaft wear. The crankshaft and bearings should not show signs of excessive wear. (Fig. 10) Inspect the thrust bearing for wear on one side and the crankshaft on the mating surface.

If wear is evident — the three vertical channels may be worn off — replace the connecting rods, main bearings, thrust bearing and crankshaft.
