# **2015 - 2017 Corvette: GM TechLink: Diagnostic Tips for Harsh Shifting Transmission Conditions**

## **Diagnostic Tips for Harsh Shifting Transmission Conditions**

June 10, 2017

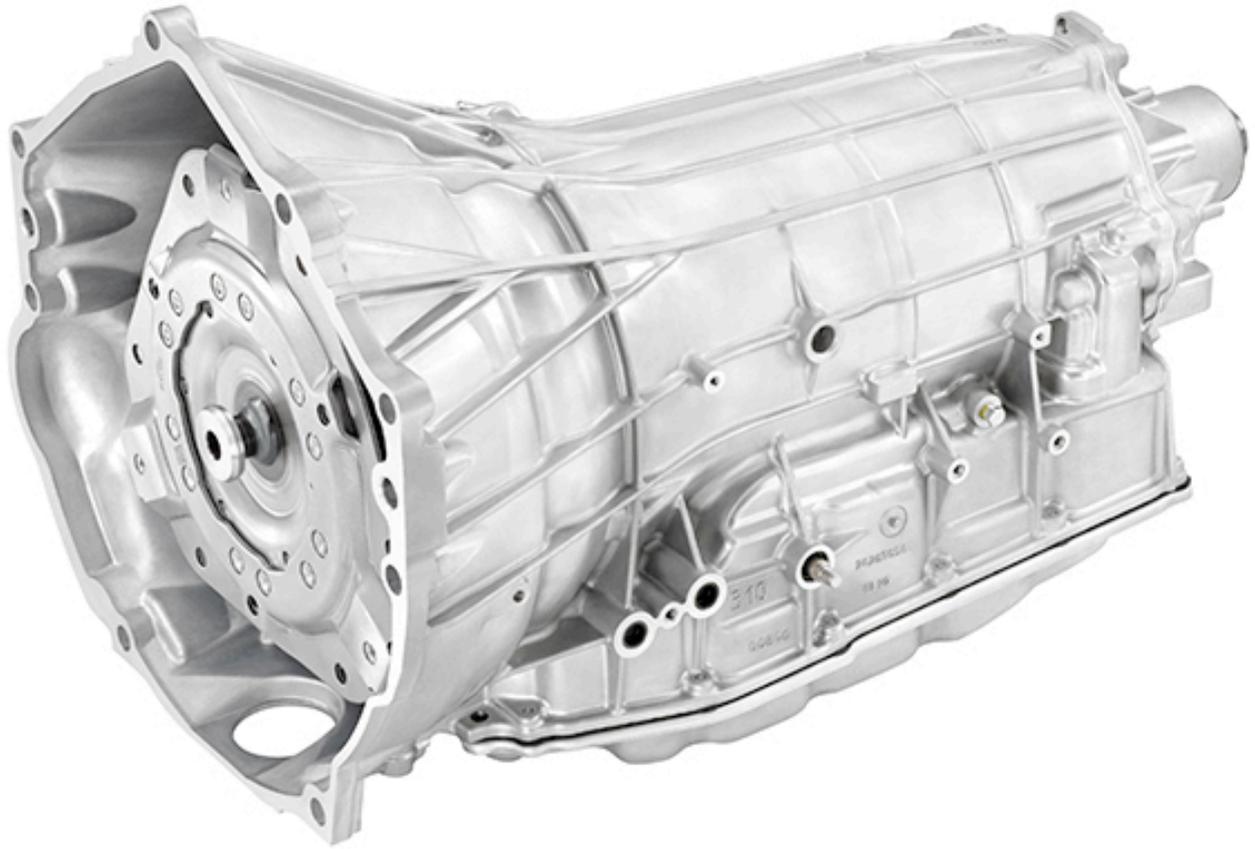
**Fig. 12**

Harsh shifting conditions and delayed garage shift engagements may be noticed on some 2017 Colorado, Canyon, Express, Savana; 2016-2017 ATS, CT6, CTS, Camaro; 2015 - 2017 Escalade, Silverado, Sierra, Yukon Denali, and Corvette models equipped with the 8L45 or 8L90 automatic transmission (RPOs M5N, M5T, M5U, M5X). (Fig. 12) The harsh shift conditions may be caused by one or more clutch fill times not completely learned in the Transmission Control Module (TCM).
