2014 - 2016 Corvette: Service Bulletin: #17-NA-278: Convertible Top Creak or Snap Noise While Driving

#17-NA-278: Convertible Top Creak or Snap Noise While Driving - (Aug 29, 2017)

Subject:				Convertible Top Creak or Snap Noise While Driving			
Brand:	Model:	Model Year:		VIN:		Engine:	Transmission:
		from	to	from	to		
Chevrolet	Corvette Convertible	2014	2016			All	All

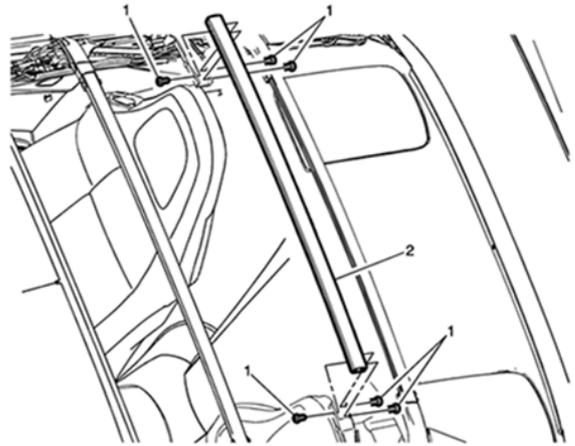
<i>Involved Region or Country</i>	North America, Japan, Europe, Middle East, Russia
<i>Condition</i>	Some customers may comment on hearing a creak or snapping noise from the convertible top while driving their vehicle. The noise may be loudest when the vehicle has sat in the sun for a length of time.
<i>Cause</i>

The cause of the condition may be that the fasteners (1) at the ends of the #3 Bow (2) may have lost torque.
