2014 - 2016 Corvette: Service Bulletin: #17-NA-278: Convertible Top Creak or Snap Noise While Driving

#17-NA-278: Convertible Top Creak or Snap Noise While Driving - (Aug 29, 2017)

Subject:				Convertible Top Creak or Snap Noise While Driving			
Brand:	Model:	Model Year:		VIN:		Engine:	Transmission:
		from	to	from	to		
Chevrolet	Corvette Convertible	2014	2016			All	All

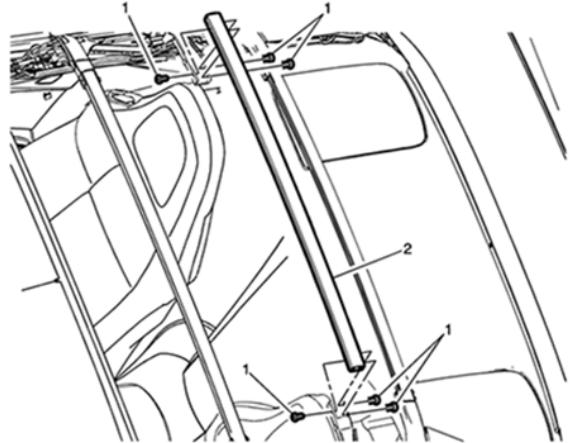
Involved Region or Country	North America, Japan, Europe, Middle East, Russia
Condition	Some customers may comment on hearing a creak or snapping noise from the convertible top while driving their vehicle. The noise may be loudest when the vehicle has sat in the sun for a length of time.
Cause

The cause of the condition may be that the fasteners (1) at the ends of the #3 Bow (2) may have lost torque.

Following the Service Procedure below, remove the original smaller screws and install the new larger M6 screws referenced in the Part Table.
