2016 - 2019 Corvette: GM TechLink: Coolant Entering Engine Cylinders

May 17, 2019 - GM TechLink

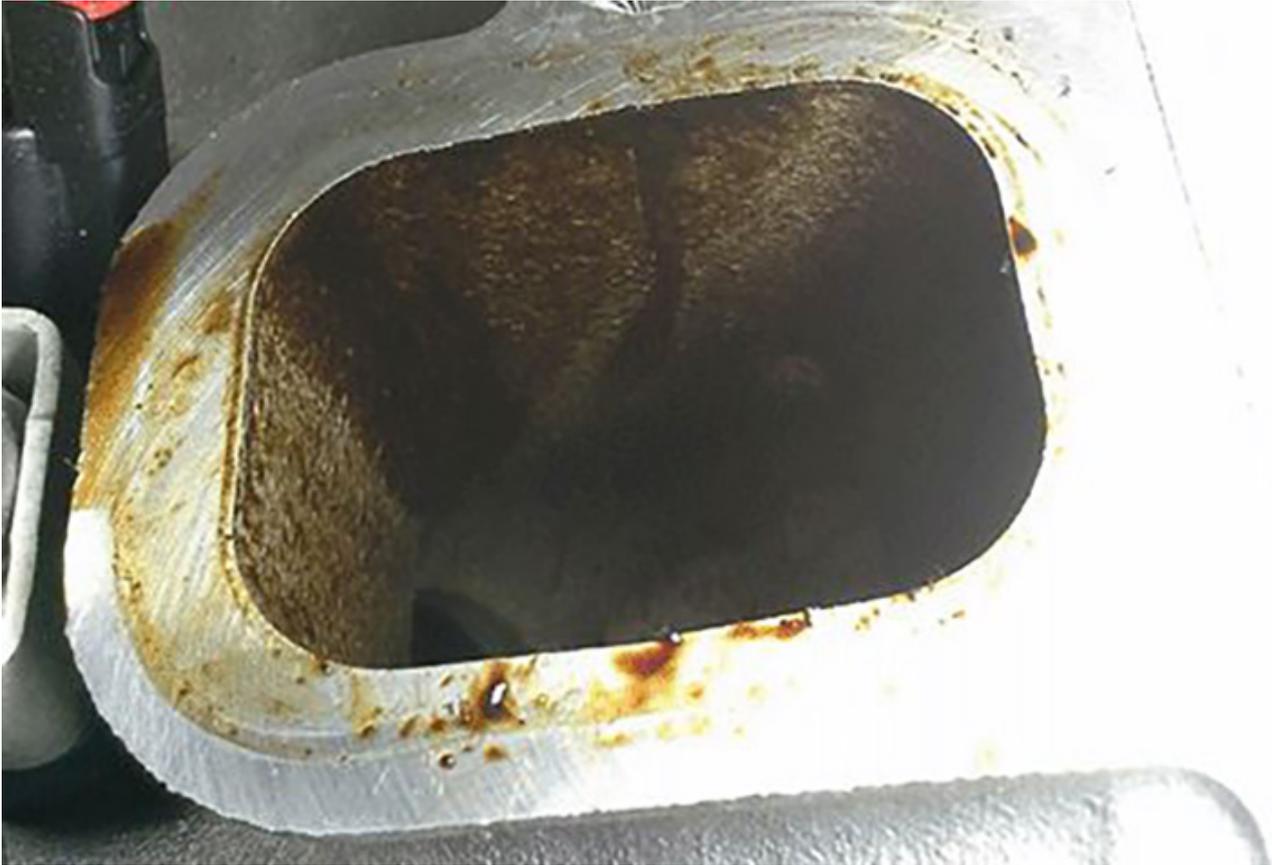
Fig. 13

If the head casting line is the issue, the intake port will be wet with a coolant

and oil mix. This condition may cause the running rough while warm concern with or without DTCs set. The location where the coolant is running down in the port will look washed down. If this condition is found, the cylinder head will need to be replaced. (Fig. 13)
