# 2015 - 2019 Corvette: TechLink: Low Oil Pressure Conditions

September 13, 2019

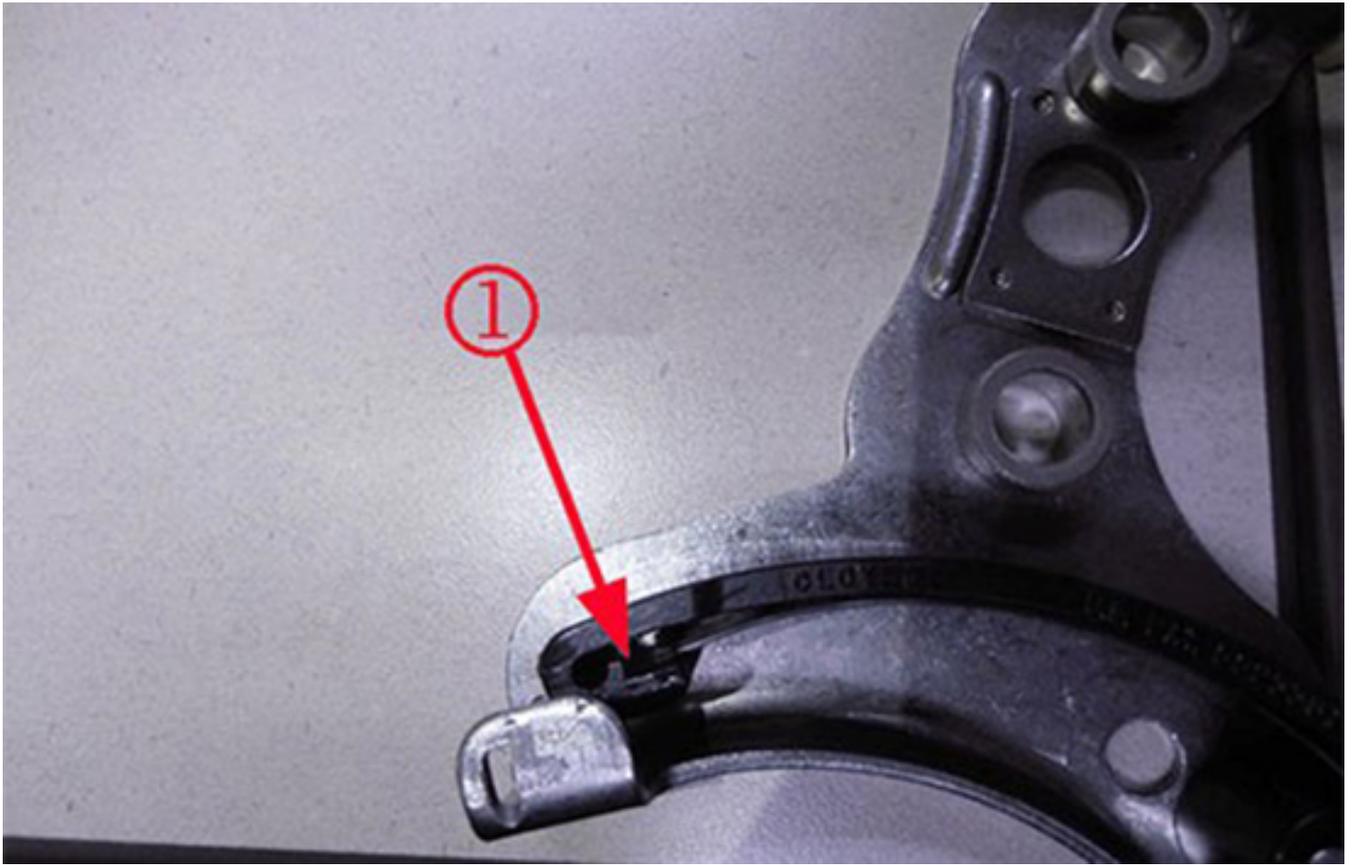
**Fig. 19**

If these conditions are found, the tensioner spring in the timing chain guide may be “short” and not fully seated into the guide pivot end. (Fig. 19) Cycling the oil pump control valve will not cause any changes in the oil pump response. Replace the timing chain tensioner guide.

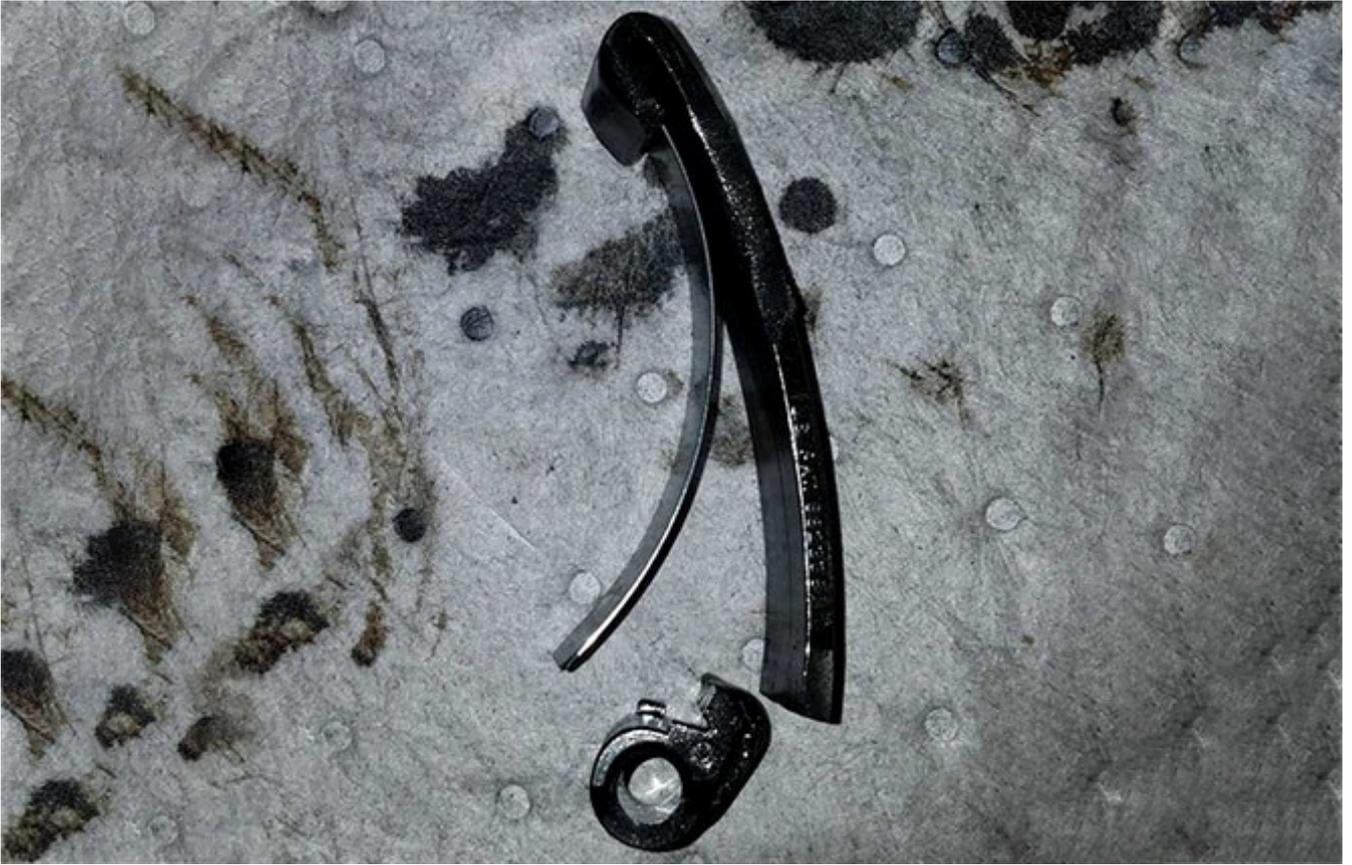
**Fig. 20**

In addition, a broken tensioner shoe (Fig. 20) may allow the spring to rub a hole in the oil pump.
