2015 - 2019 Corvette: TechLink: Low Oil Pressure Conditions

September 13, 2019

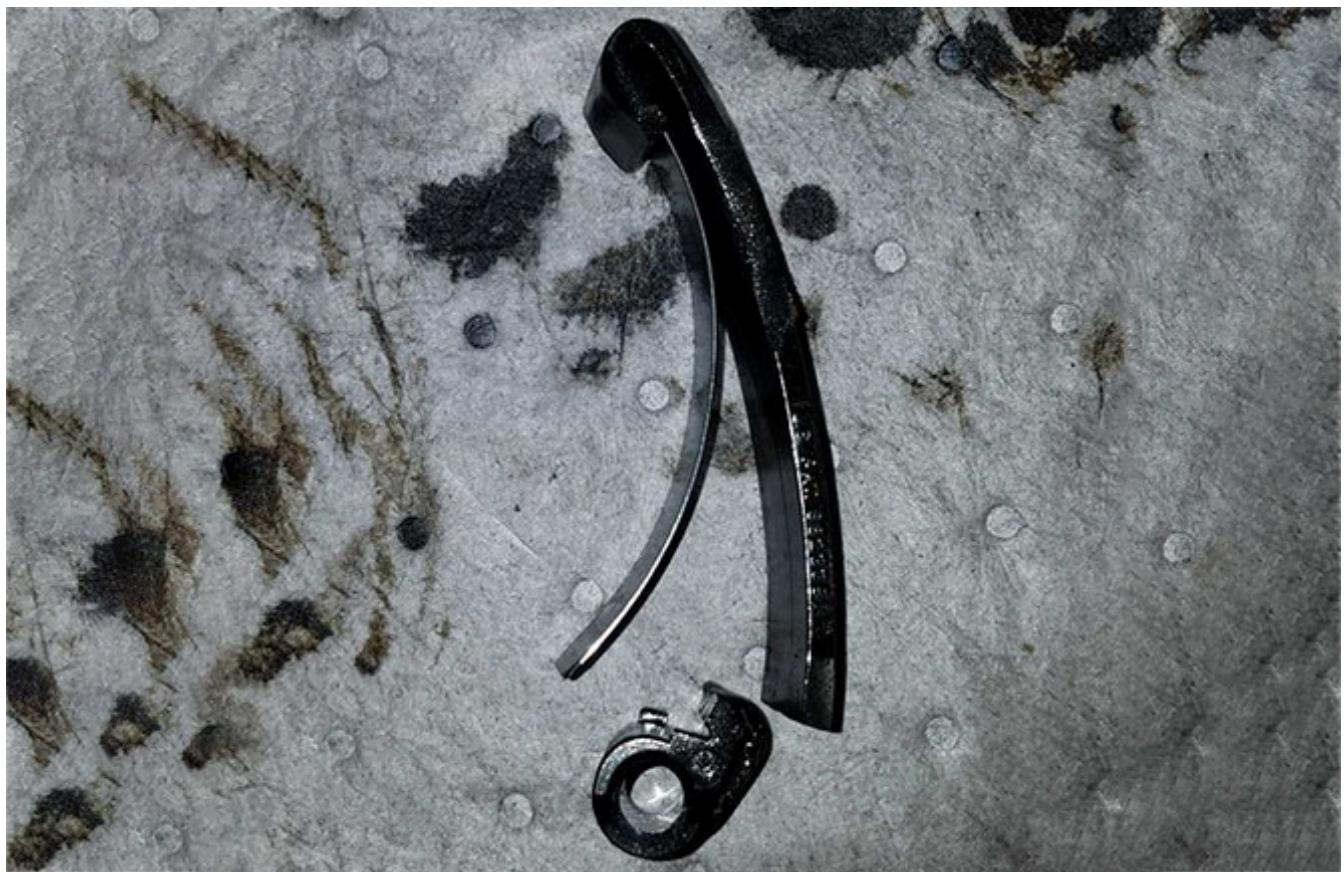
Fig. 20

In addition, a broken tensioner shoe (Fig. 20) may allow the spring to rub a hole in the oil pump.
