2020 Corvette: Service Bulletin: #N202302840: Service Update - Door Paint Chipping

Subject: N202302840 — Door
Paint Chipping
Models: 2020 Chevrolet Corvette

Release Date: April 2020

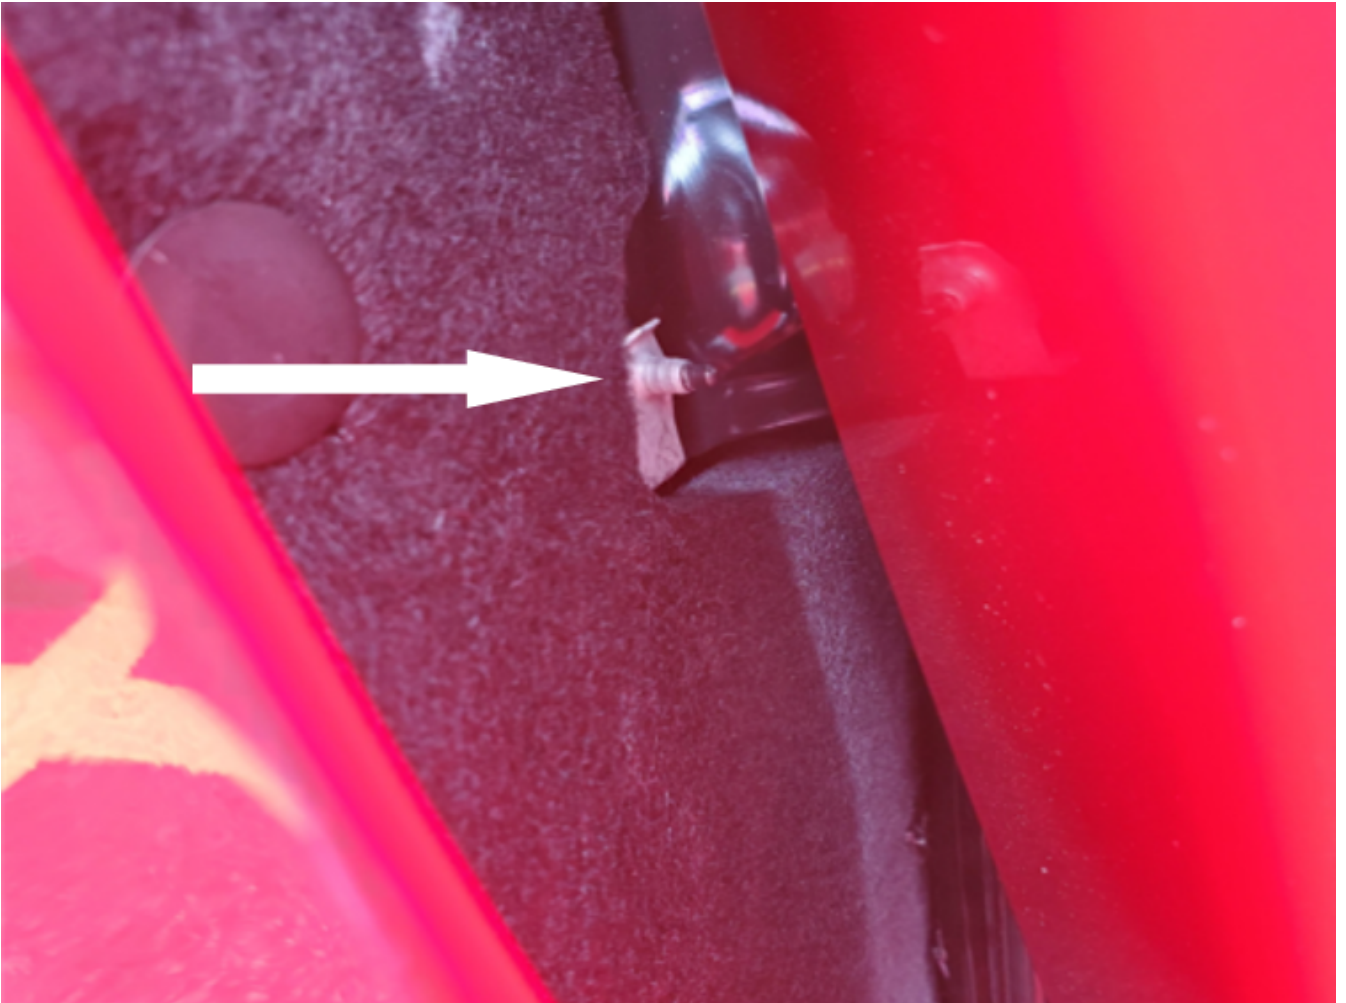
1. Carefully open the left front door inspecting for any contact with the fender fastener. This fastener is located just below the door check strap area.
2. Locate the threaded portion of the fender mounting bolt where

it exits the nut.

3. Count the number of threads showing.

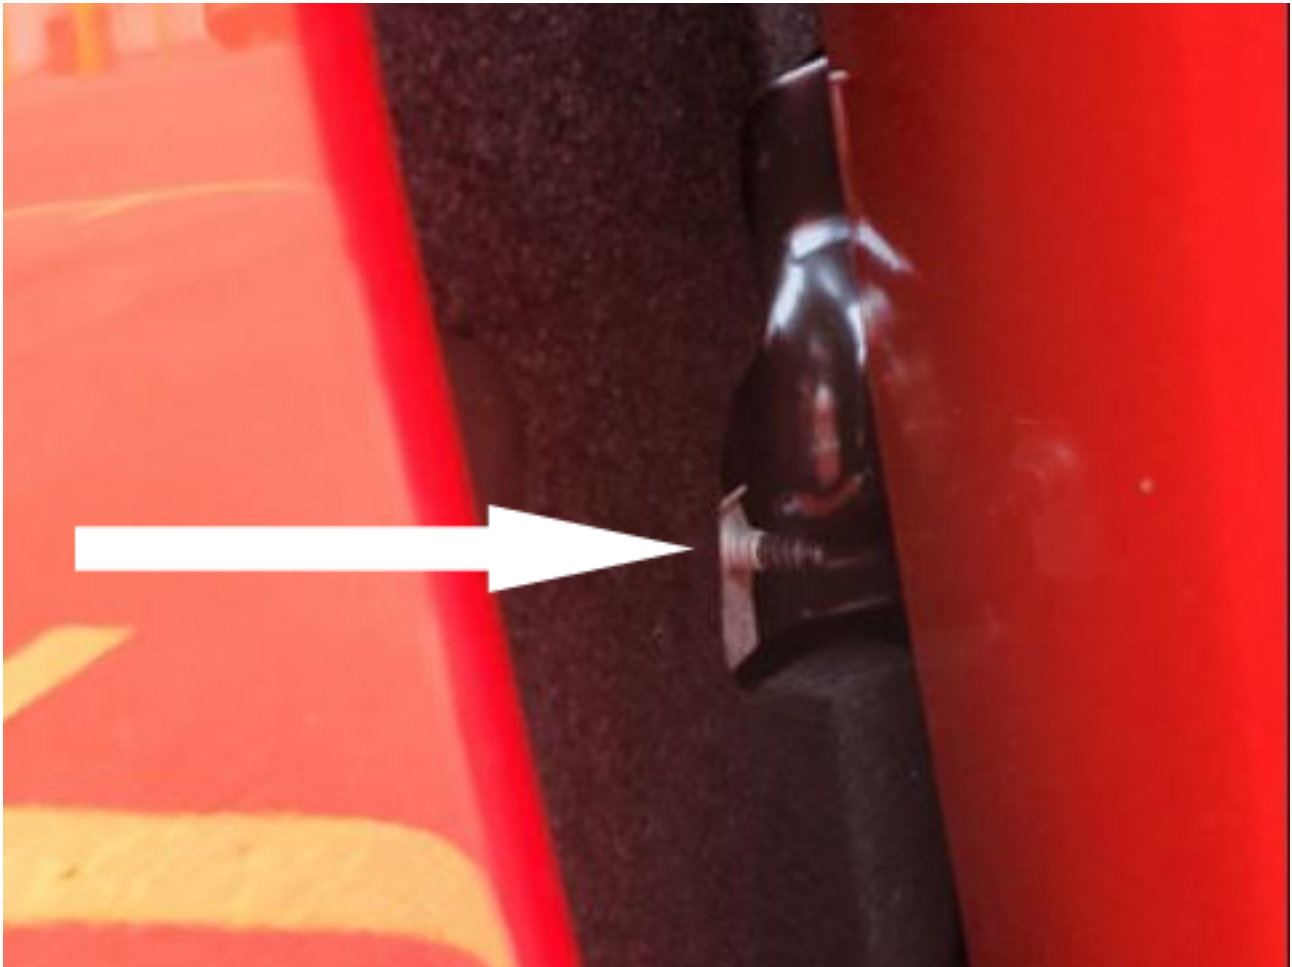
- If less than 1 full thread is showing, no further action is required.
