2020 Corvette: Service Bulletin: #N202302840: Service Update - Door Paint Chipping

Subject: N202302840 — Door

Paint Chipping

Models: 2020 Chevrolet Corvette

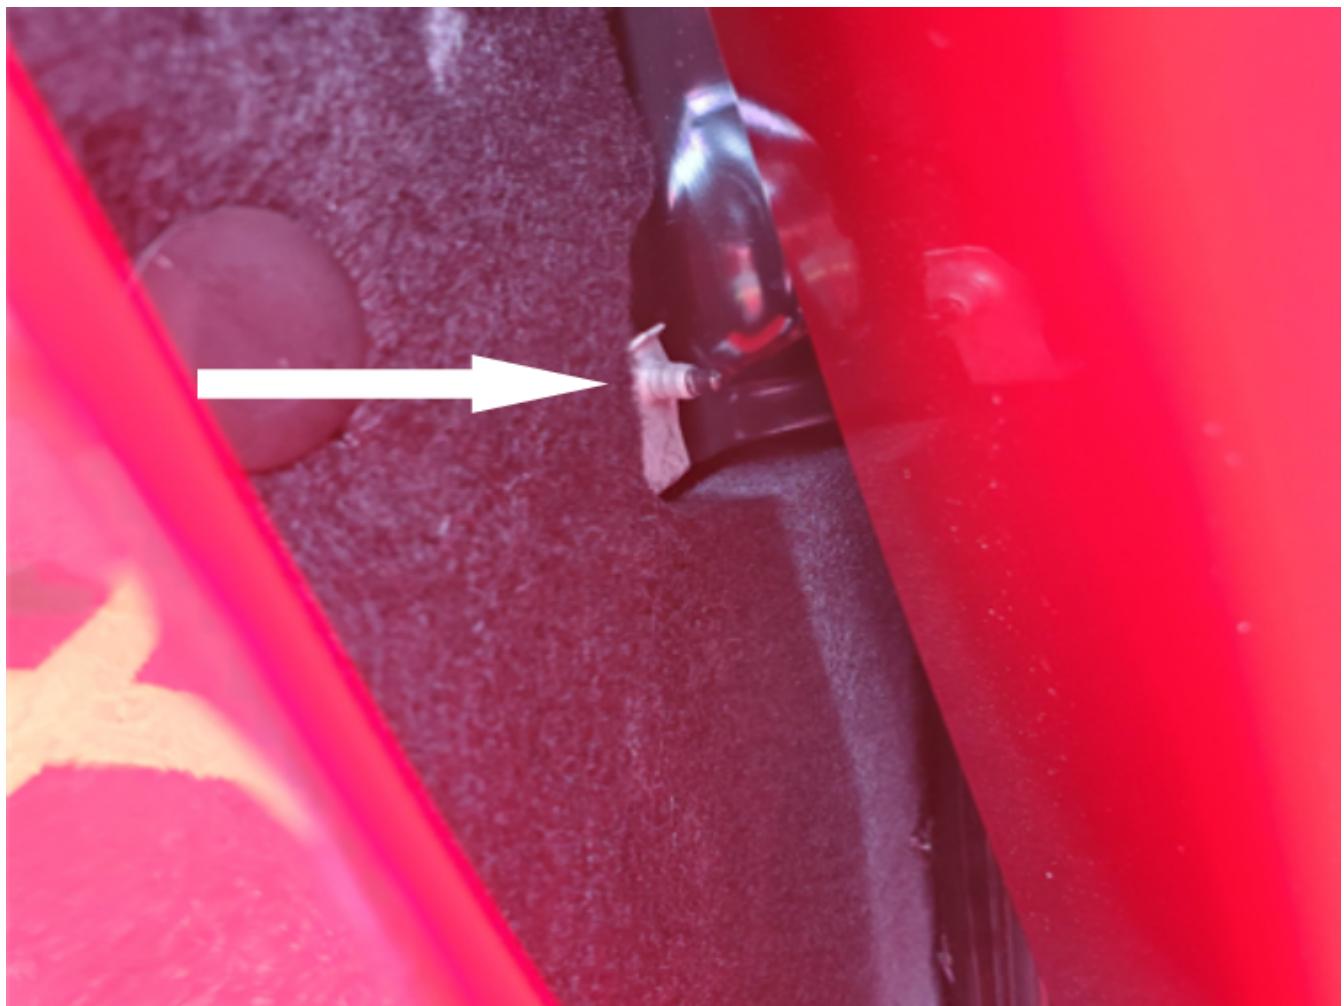
3. Count the number of threads showing.

- If less than 1 full thread is showing, no further action is required.

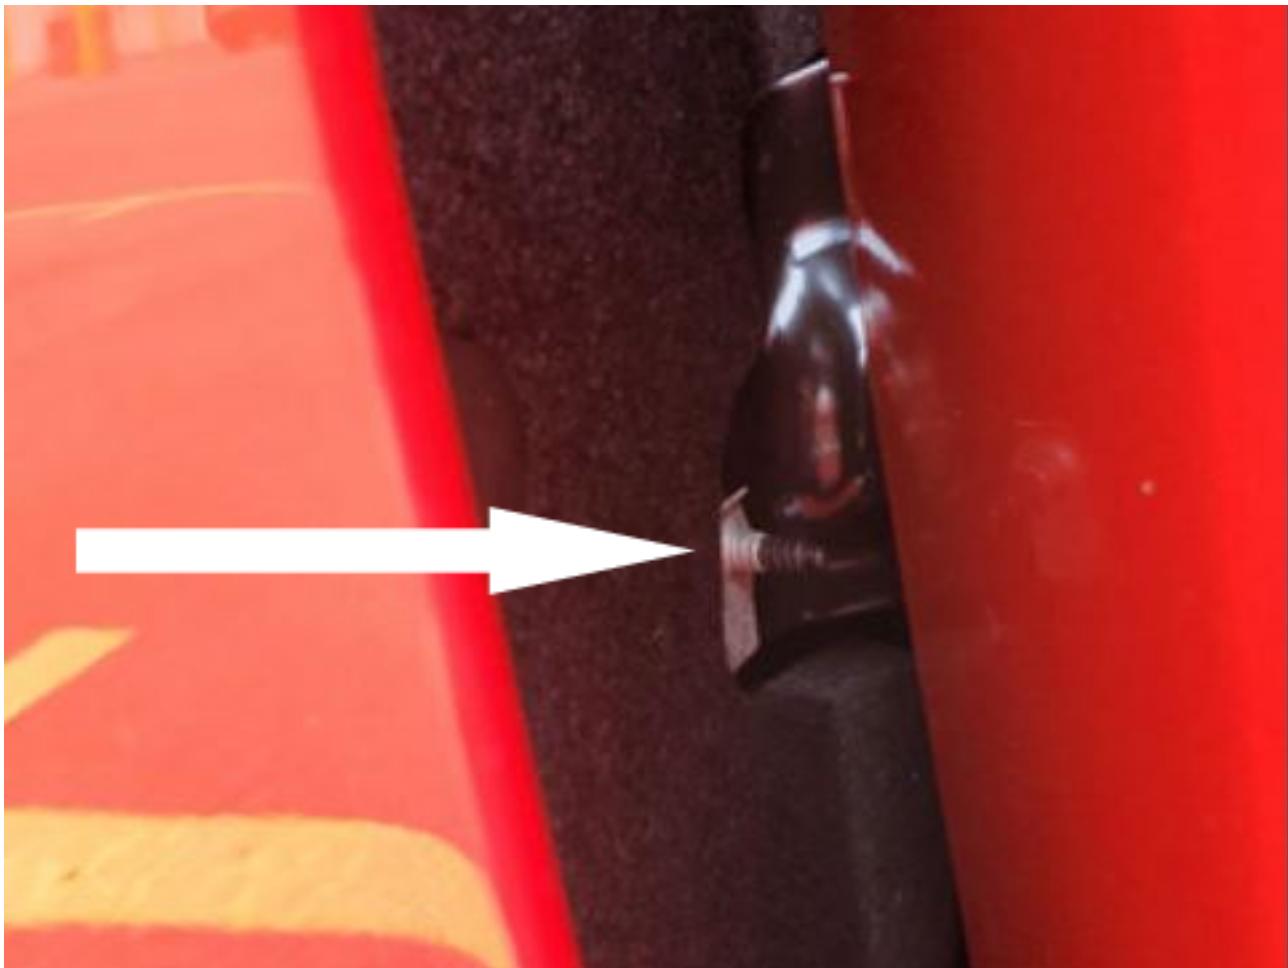
- If more than 2 threads are showing, proceed to step # 4.
- Partially remove the wheelhouse liner to access the rear fender mounting fasteners. Refer to *Front Wheelhouse Liner Replacement* in SI.
