# 2020 Corvette: Service Bulletin: #N202302840: Service Update - Door Paint Chipping

**Subject:** N202302840 — Door  
Paint Chipping  
**Models:** 2020 Chevrolet Corvette

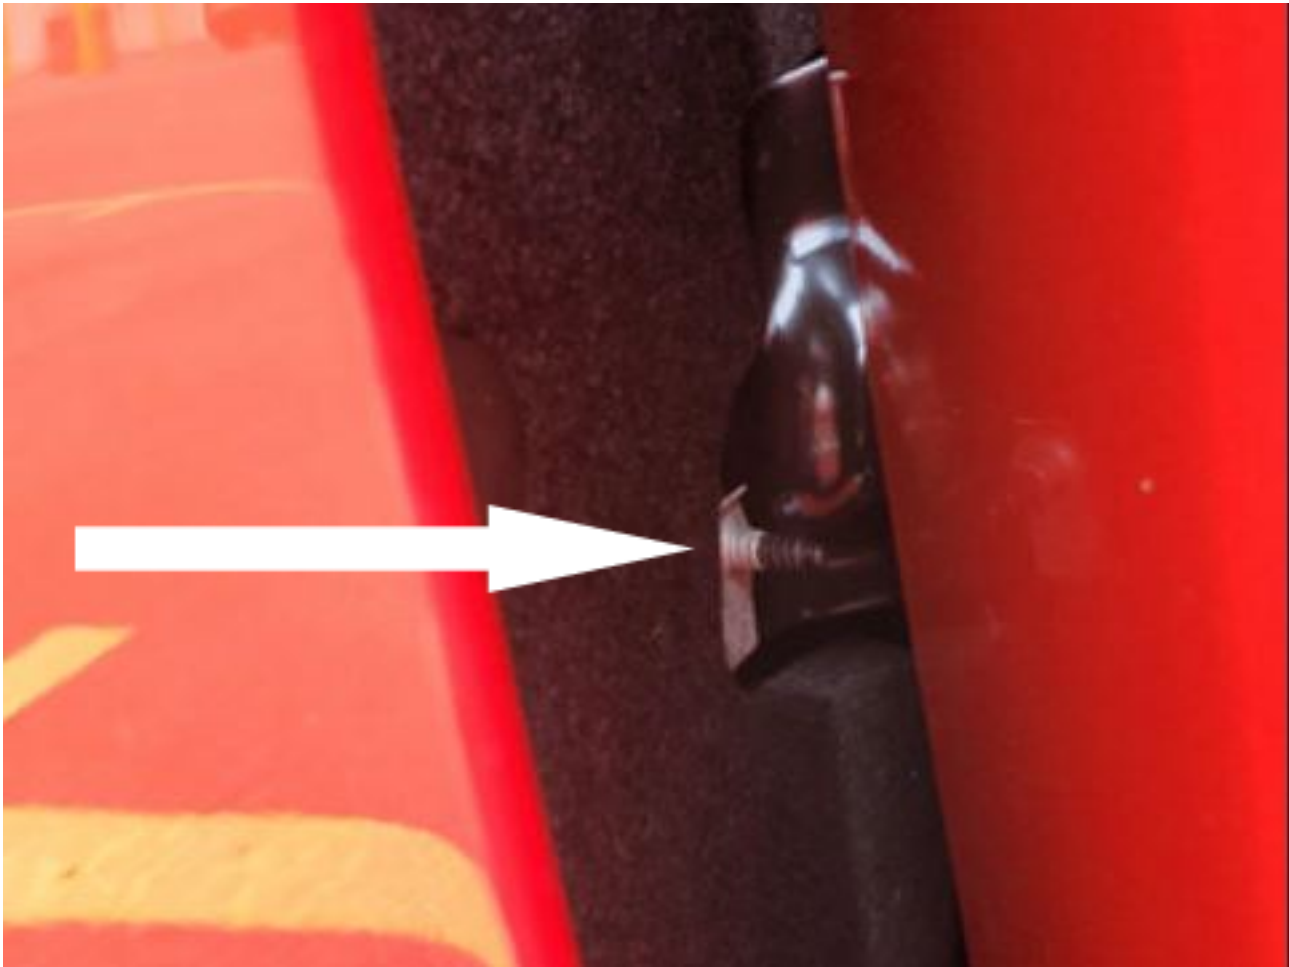
- If less than 1 full thread is showing, no further action is required.
