# 2020 Corvette: GM TechLink: Corvette Competition Seat Bolster Pad Support

**GM TechLink**  
**April 30, 2020**

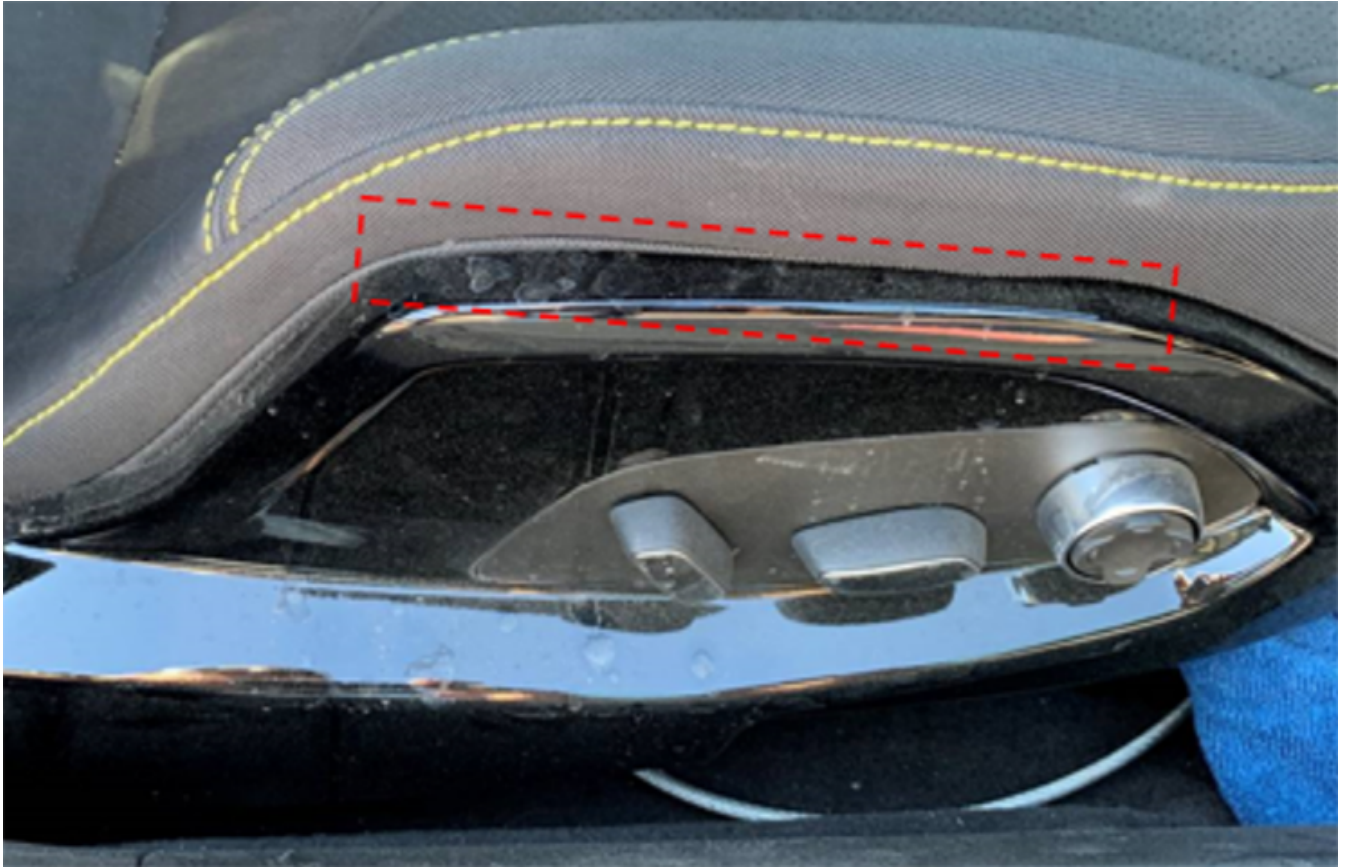
**Fig. 2**

The fit and appearance condition is due to an incorrect seat foam-to-side shield interface that causes the foam to be unsupported. (Fig. 2) As a result, the unsupported seat foam can create a poor appearance as the driver enters and exits the vehicle over time.

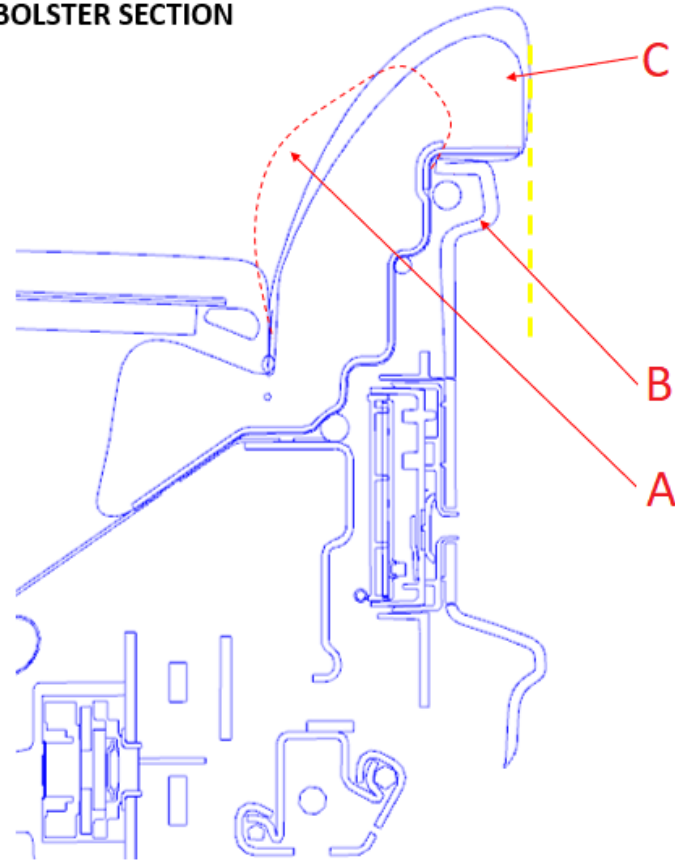
**Fig. 3**

If this condition is found, check that the foam and bottom felt of the foam pad (Fig. 3, A) are not caught on the edge of the side shield (Fig. 3, B), which may cause the poor trim appearance. The felt on the bottom of the foam pad should extend over the edge of the side shield, allowing the foam to be proud to the side shield. (Fig. 3, C)

When properly fitted, the bolster will be flush with the vertical surface of the side shield.
