# 2020 Corvette: GM TechLink: Corvette Competition Seat Bolster Pad Support

**GM TechLink**  
**April 30, 2020**

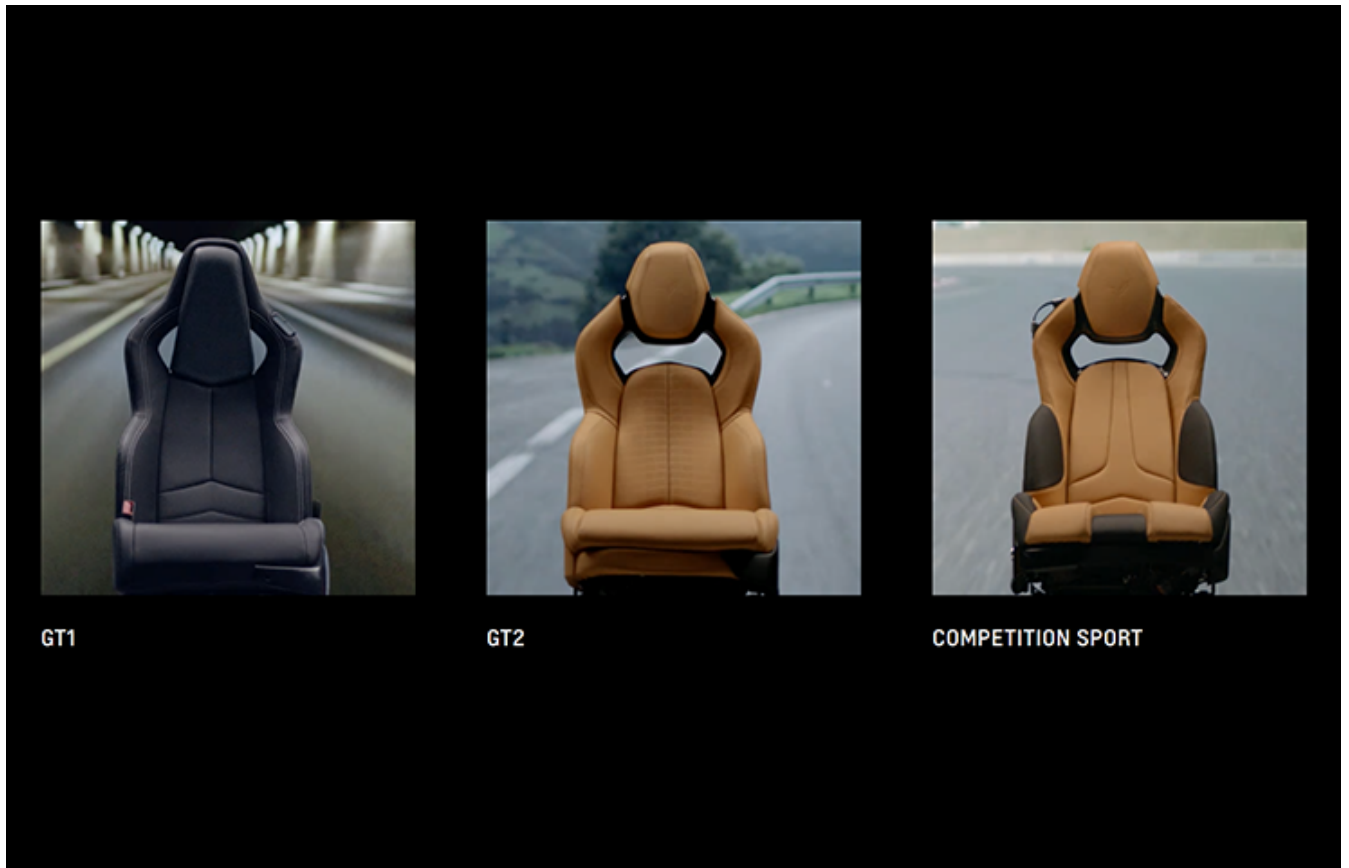
**Fig. 1**

The all-new 2020 Corvette Stingray features three available seats: GT1, GT2, and Competition Sport. (Fig. 1) On some models with the Competition Sport seats, the sides of the aggressive seat cushion bolsters may have a fit and appearance condition where the seat cushion pad folds under the cushion cover.

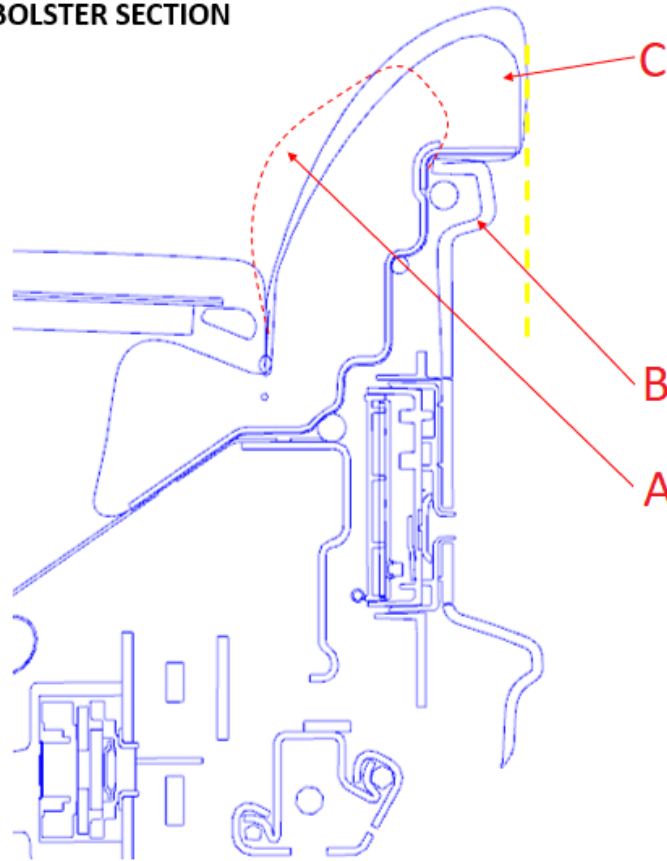
**Fig. 3**

If this condition is found, check that the foam and bottom felt of the foam pad (Fig. 3, A) are not caught on the edge of the side shield (Fig. 3, B), which may cause the poor trim appearance. The felt on the bottom of the foam pad should extend over the edge of the side shield, allowing the foam to be proud to the side shield. (Fig. 3, C)

When properly fitted, the bolster will be flush with the vertical surface of the side shield.
