2020 Corvette: GM TechLink: Corvette Competition Seat Bolster Pad Support

GM TechLink
April 30, 2020

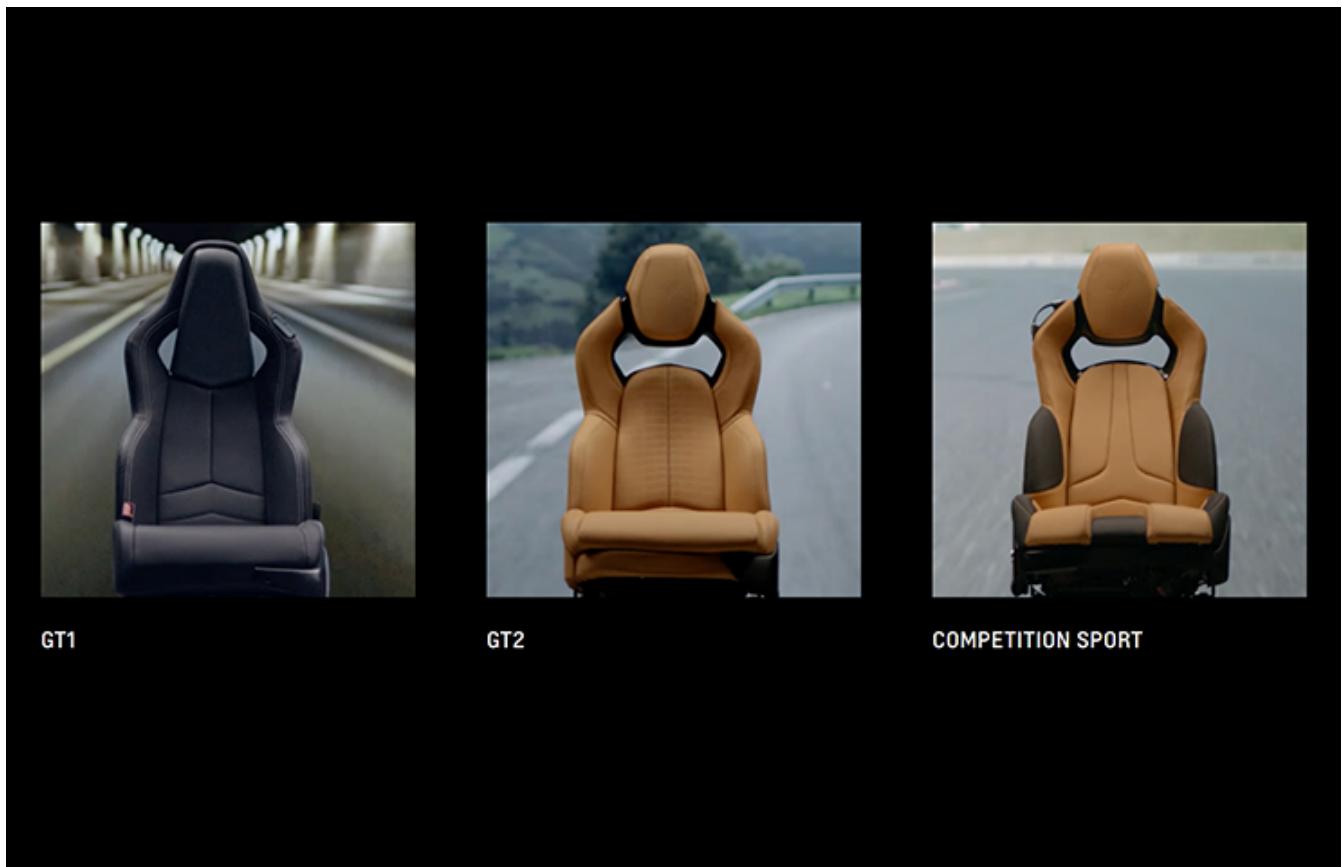
Fig. 1

The all-new 2020 Corvette Stingray features three available seats: GT1, GT2, and Competition Sport. (Fig. 1) On some models with the Competition Sport seats, the sides of the aggressive seat cushion bolsters may have a fit and appearance condition where the seat cushion pad folds under the cushion cover.

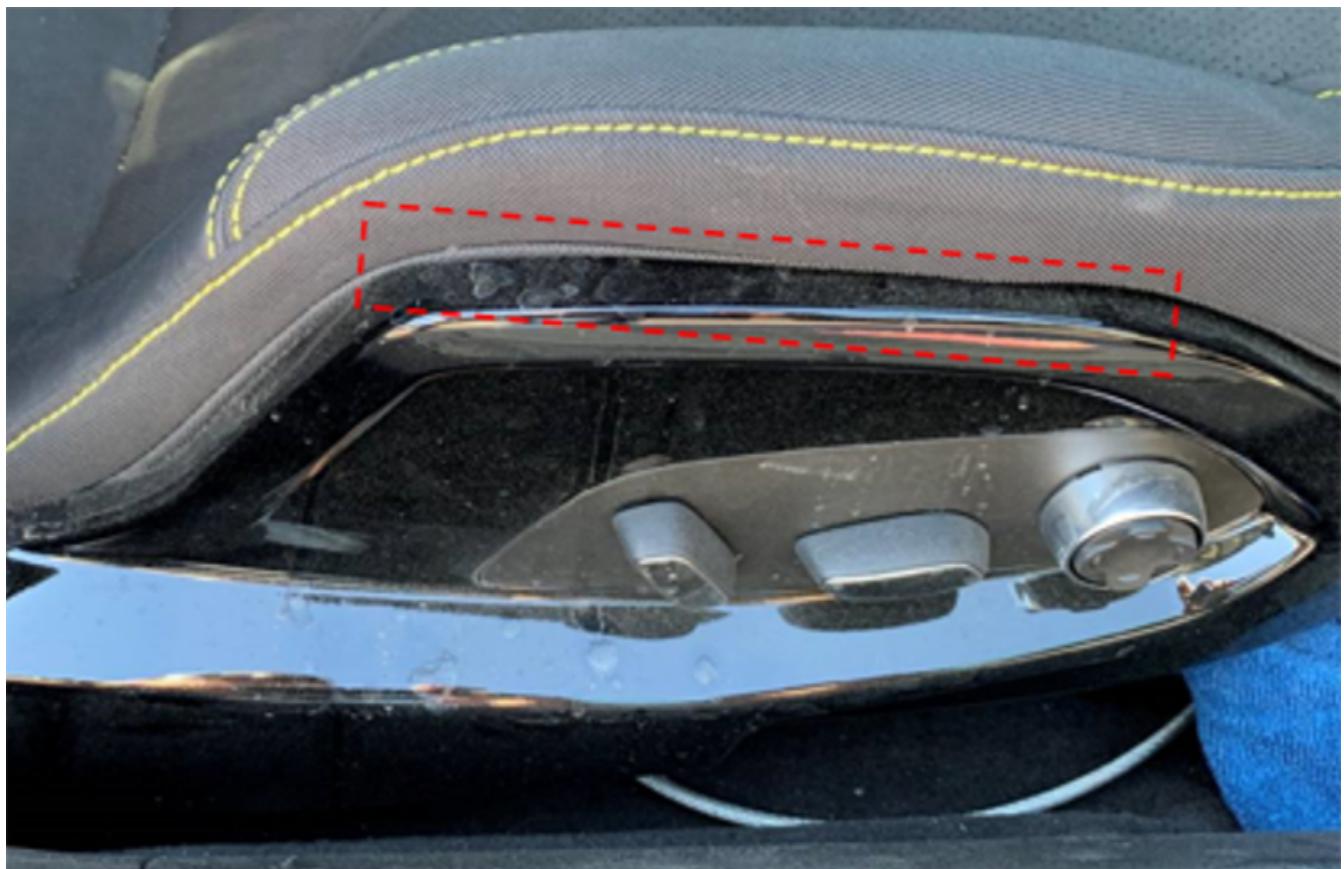
Fig. 2

The fit and appearance condition is due to an incorrect seat foam-to-side shield interface that causes the foam to be unsupported. (Fig. 2) As a result, the unsupported seat foam can create a poor appearance as the driver enters and exits the vehicle over time.

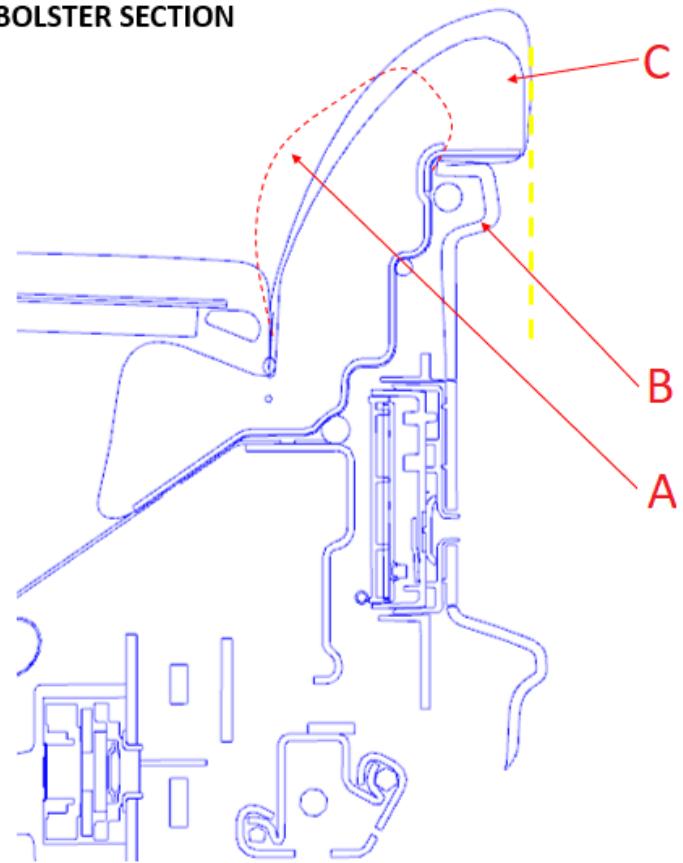
Fig. 3

If this condition is found, check that the foam and bottom felt of the foam pad (Fig. 3, A) are not caught on the edge of the side shield (Fig. 3, B), which may cause the poor trim appearance. The felt on the bottom of the foam pad should extend over the edge of the side shield, allowing the foam to be proud to the side shield. (Fig. 3, C)

When properly fitted, the bolster will be flush with the vertical surface of the side shield.
