2020 Corvette: GM TechLink: Corvette Competition Seat Bolster Pad Support

GM TechLink
April 30, 2020

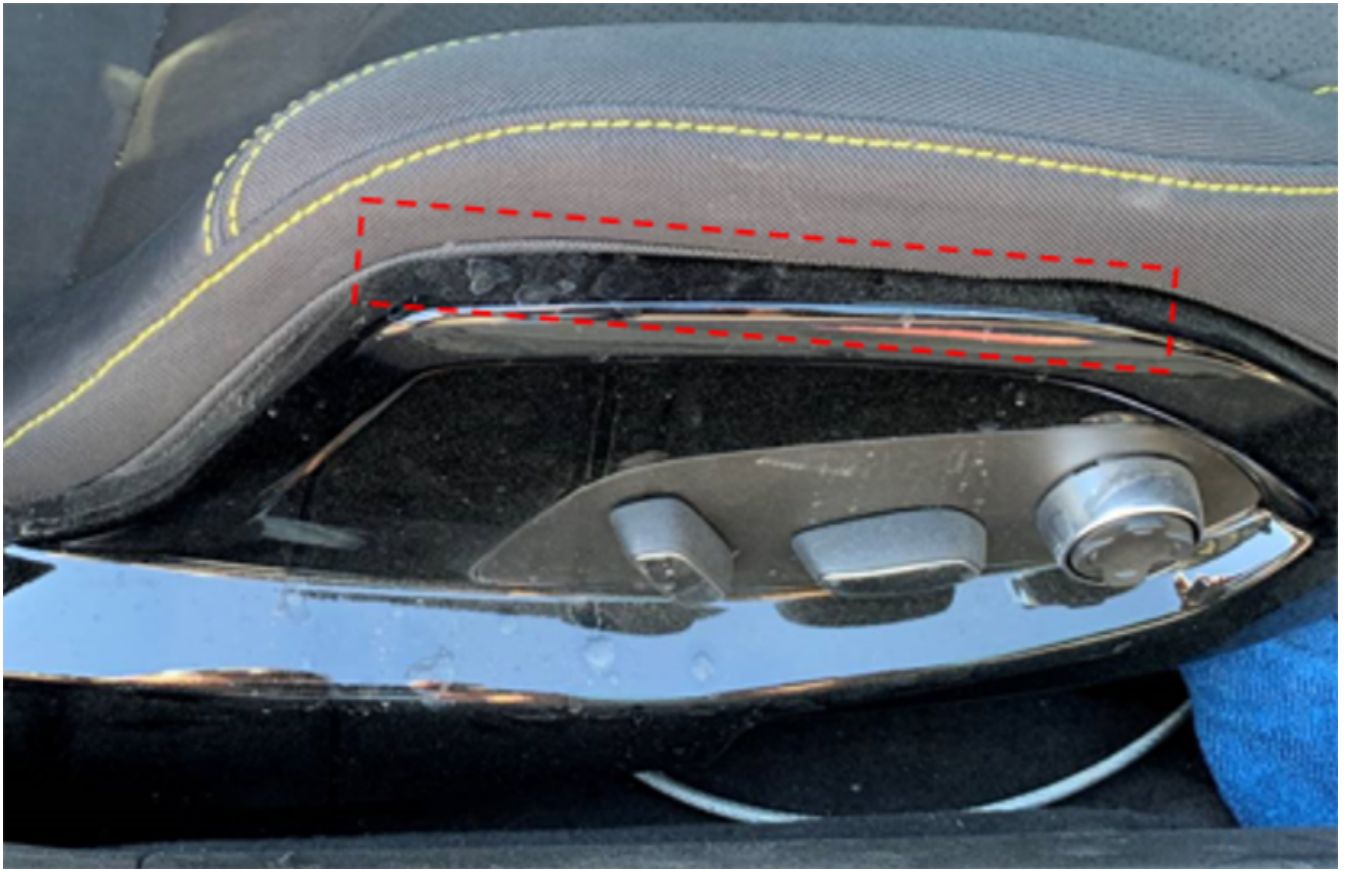
Fig. 2

The fit and appearance condition is due to an incorrect seat foam-to-side shield interface that causes the foam to be unsupported. (Fig. 2) As a result, the unsupported seat foam can create a poor appearance as the driver enters and exits the vehicle over time.
