## **2020 Corvette: Loose Carbon Patch in Air Cleaner Housing**

**GM TechLink**

**April 30, 2020**

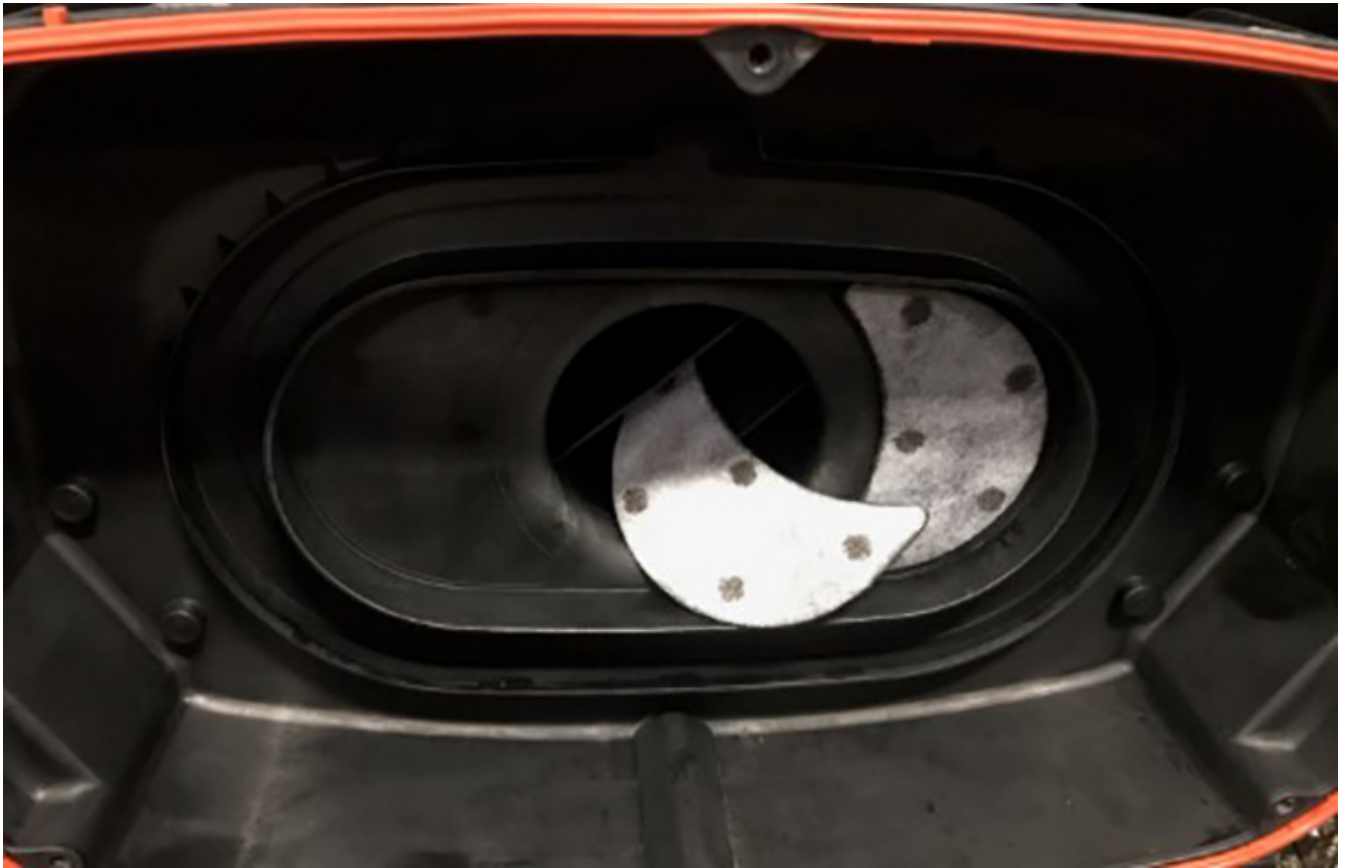
**Fig. 11**

A loose carbon patch in the air cleaner housing may be restricting air flow across the Mass Airflow (MAF) sensor on some 2020 Corvette models. (Fig. 11) DTCs P0101 (Mass Airflow Sensor Performance), P0171 (Fuel Trim System Lean) and P0174 (Fuel Trim System Lean Bank 2) may be set in the Engine Control Module (ECM).

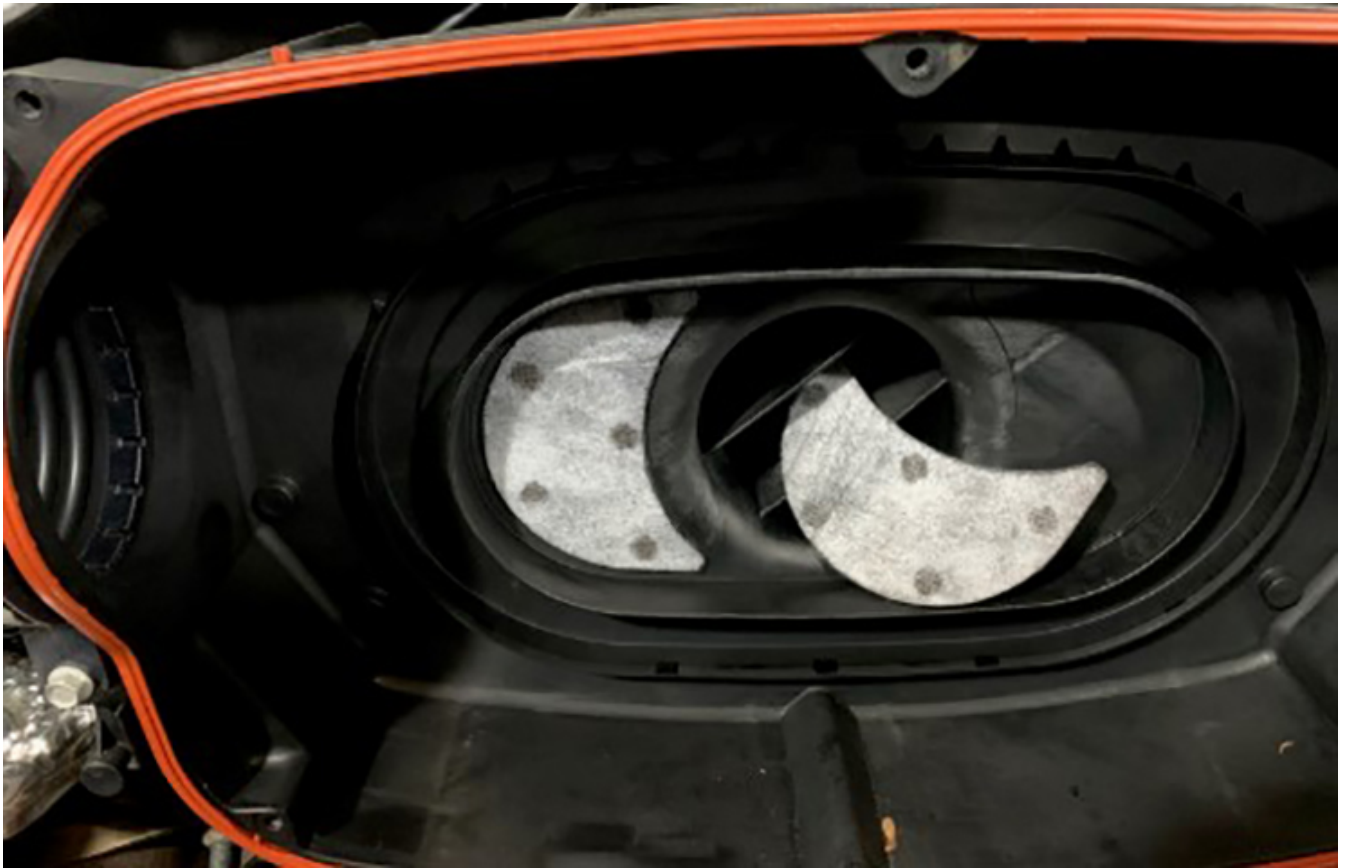
**Fig. 12**

If any of these DTCs are set, remove the air filter and inspect the carbon patches to determine if they are out of place. (Fig. 12)
