2014 - 2017 Corvette: Harsh Shift and Rough Idle Conditions

GM TechLink

October 9, 2016

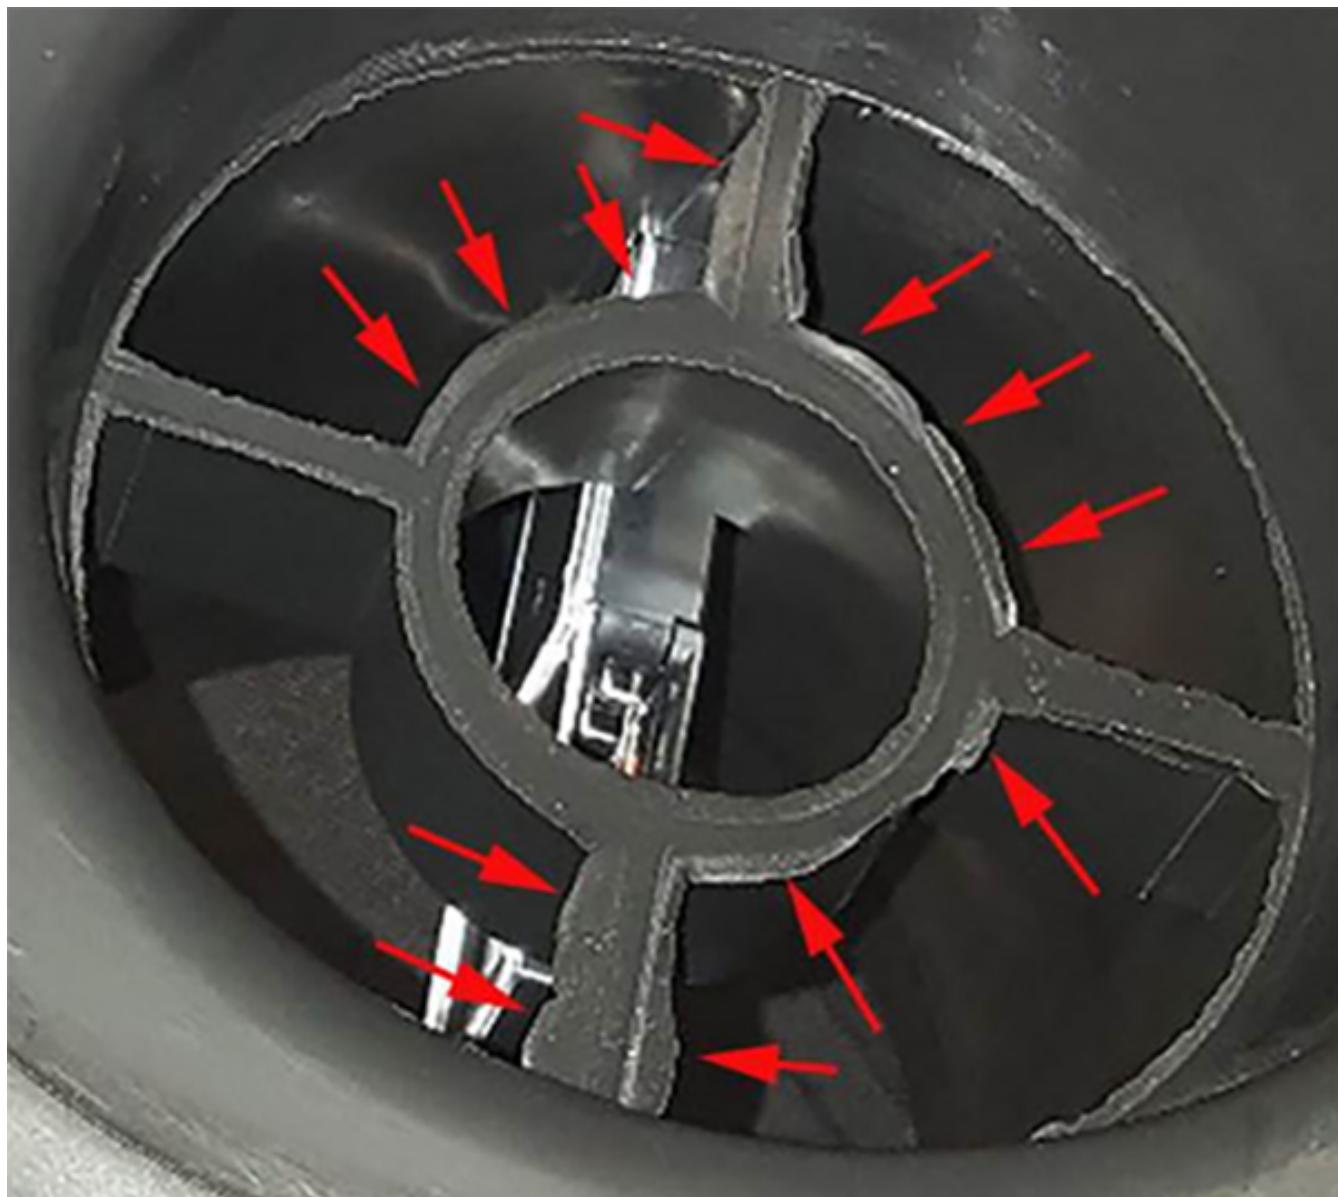
Fig. 11

The harsh shift may be felt on the 1/2 and 2/3 shift along with a sputter when applying the throttle between 0% and 30% and a rough idle. DTCs P0101 (MAF Sensor Performance), P0171 (Fuel Trim System Lean Bank 1), P0172 (Fuel Trim System Rich Bank 1), P0174 (Fuel Trim System Lean Bank 2) and P0175 (Fuel Trim System Rich Bank 2) may be set.

Inspect for cast flashing in the air filter housing near the Mass Air Flow (MAF) sensor for excessive flashing. (Fig. 11) If excessive flashing is found, replace the air filter housing lid. Be sure to check the flashing in the new lid as well.
