# 2014 - 2017 Corvette: GM TechLink: Harsh Shift and Rough Idle Conditions

GM TechLink  
October 9, 2016

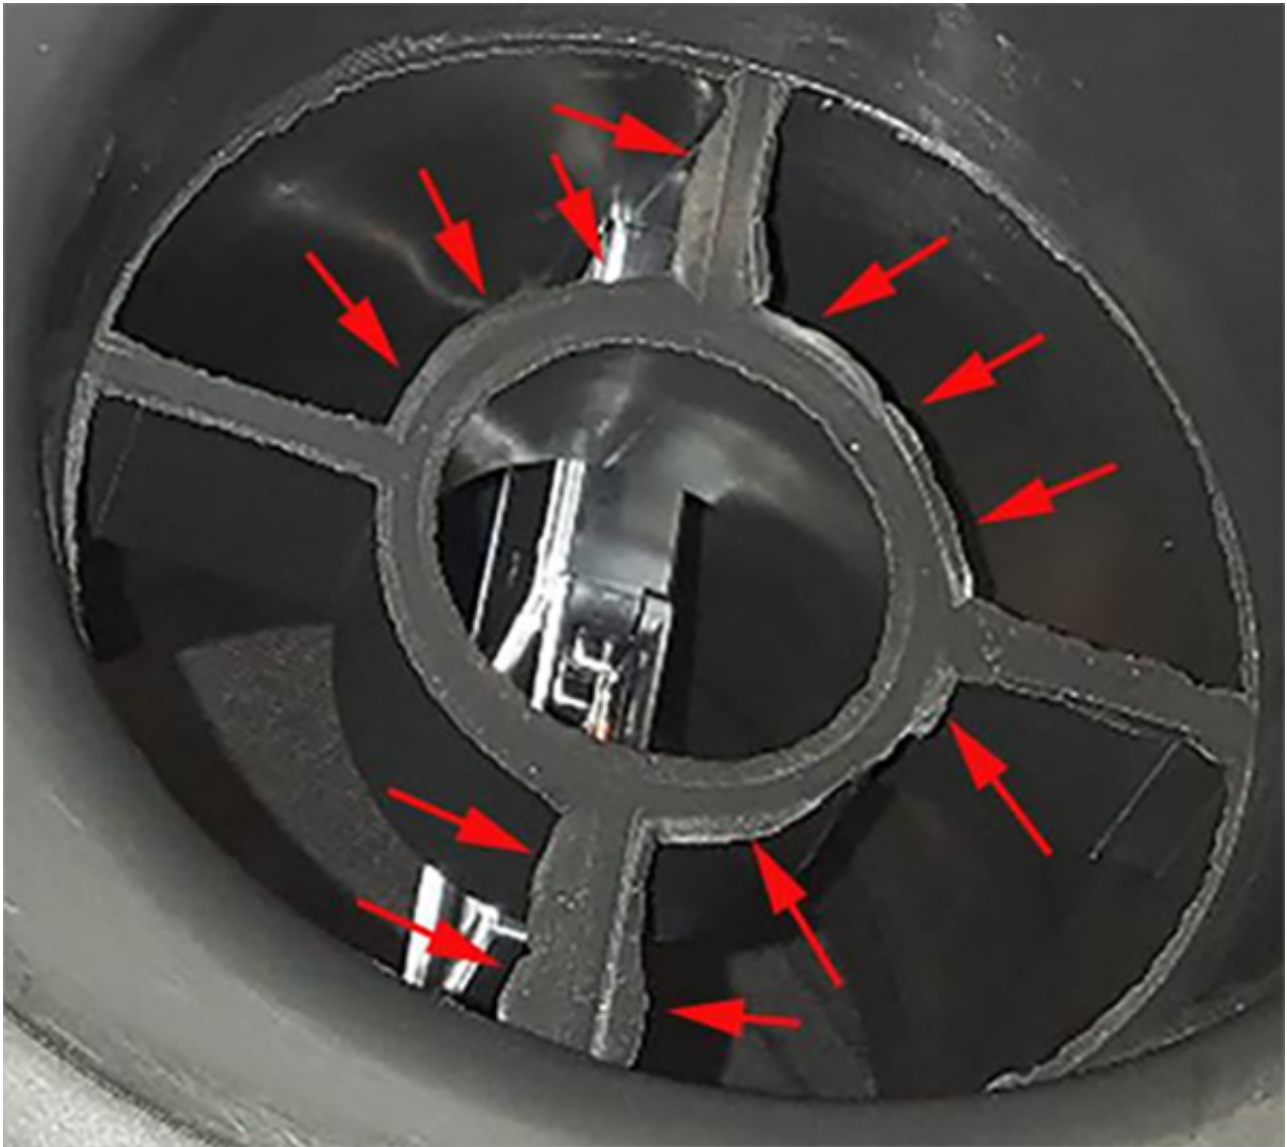
**Fig. 11**

The harsh shift may be felt on the 1/2 and 2/3 shift along with a sputter when applying the throttle between 0% and 30% and a rough idle. DTCs P0101 (MAF Sensor Performance), P0171 (Fuel Trim System Lean Bank 1), P0172 (Fuel Trim System Rich Bank 1), P0174 (Fuel Trim System Lean Bank 2) and P0175 (Fuel Trim System Rich Bank 2) may be set.

Inspect for cast flashing in the air filter housing near the Mass Air Flow (MAF) sensor for excessive flashing. (Fig. 11) If excessive flashing is found, replace the air filter housing lid. Be sure to check the flashing in the new lid as well.
