2020 Corvette: GM TechLink: Rushing Air Sound in PCV Tube

GM TechLink

May 21, 2020

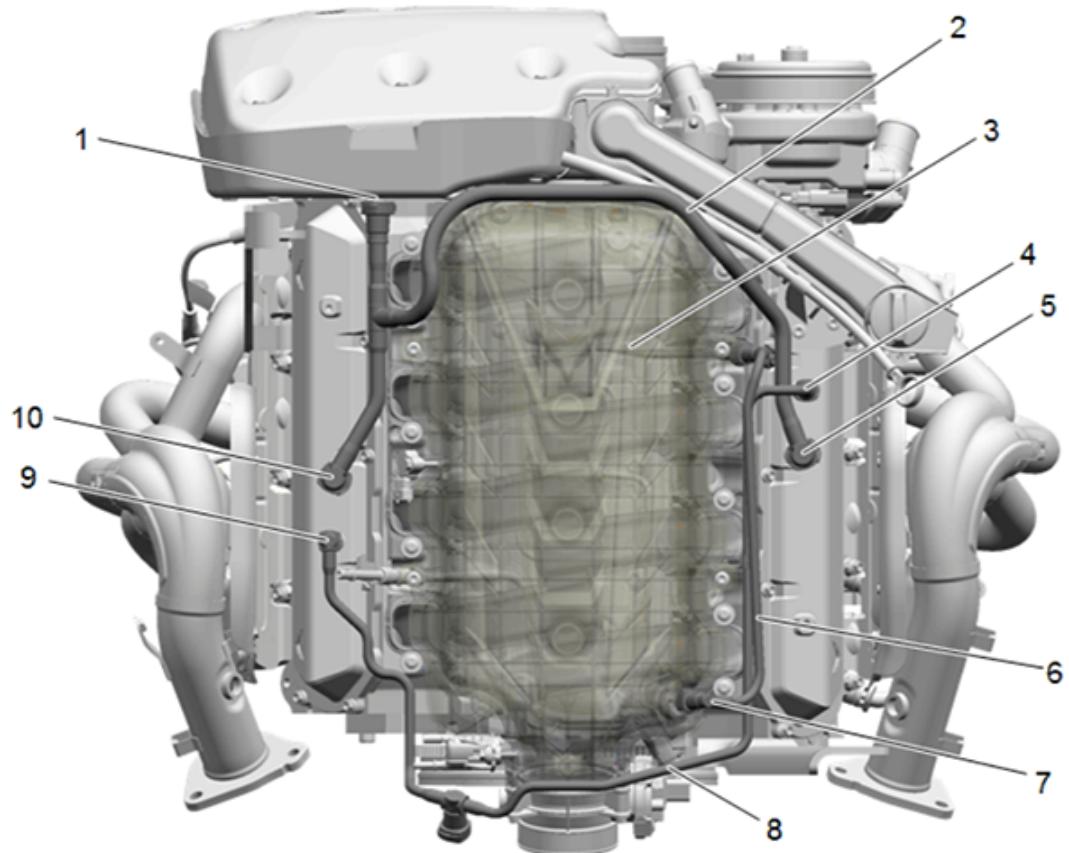
Fig. 3

In the LT2 engine, filtered fresh air is routed from upstream of the throttle plate through a formed nylon fresh air tube (8) to a PCV fitting (9) in the left-side rocker arm cover and a PCV fitting (4) in the right-side rocker arm cover. The design of the rocker arm covers shields rocker arm oil spray, reducing the potential for oil being drawn back into the fresh air PCV tube during any backflow of the ventilation system. Separated foul vapor from the engine oil tank (1) is routed to a PCV fitting (10) in the left-side rocker arm cover and a PCV fitting (5) in the right-side rocker arm cover via a formed nylon recirculation tube (2). Foul crankcase vapor is routed through a formed nylon foul air tube (6) from a PCV connection (3) on the engine oil separator in the engine valley to right side rear of the intake manifold (7). (Fig. 3)

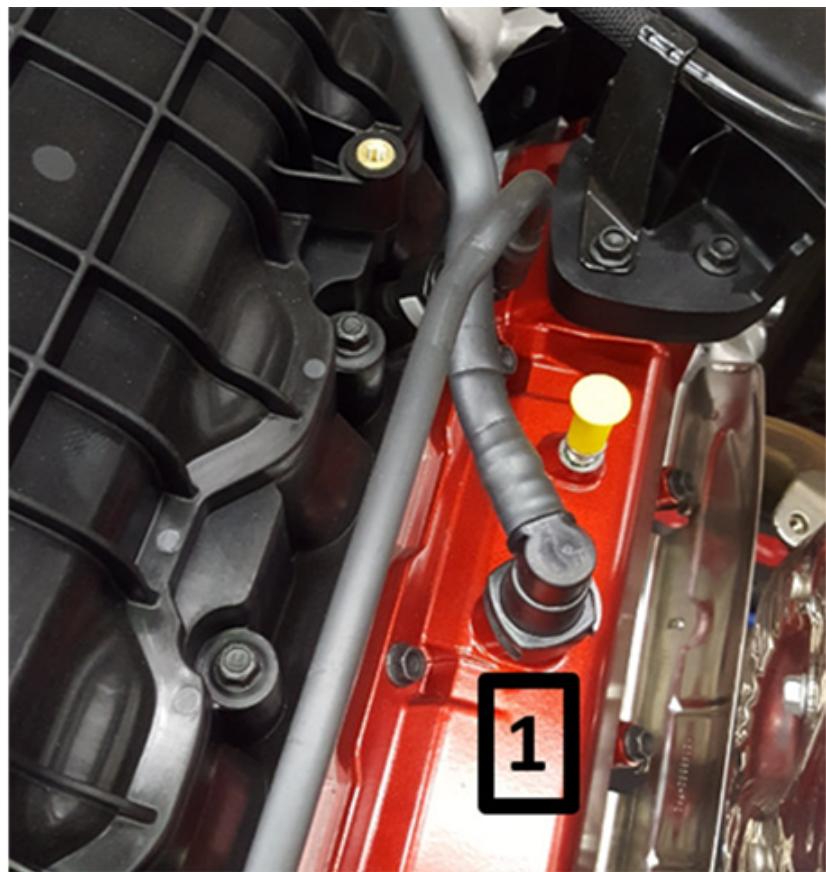
Fig. 4

When diagnosing the hissing sound, first verify the correct PCV tube routing. The following photo shows a PCV tube that is incorrectly routed. (Fig. 4)

The sound may change when moving the PCV tube, which is normal. However, if the PCV tube is routed incorrectly, the sound may be magnified.

If a leak is suspected, perform a smoke test to check the induction system. If tests show that the PCV tube is not leaking, it should not be replaced due to the rushing air or hissing sound only.

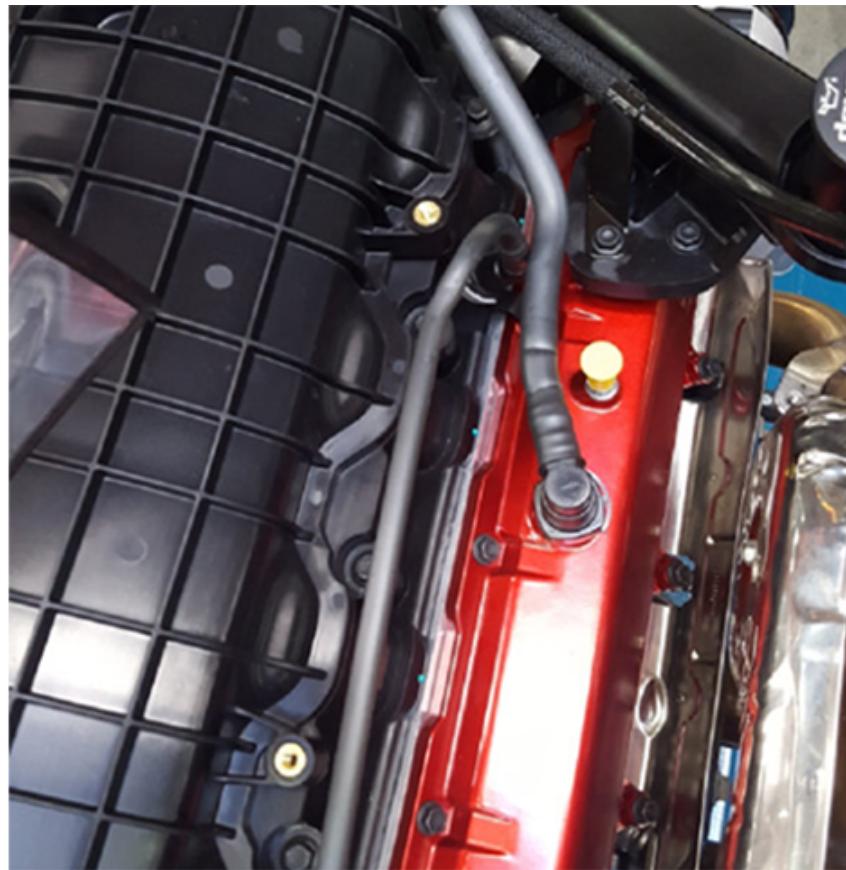
Fig. 5

The PCV tube is routed correct in the following photo. (Fig. 5)
