# 2020 Corvette: GM TechLink: Rushing Air Sound in PCV Tube

GM TechLink

May 21, 2020

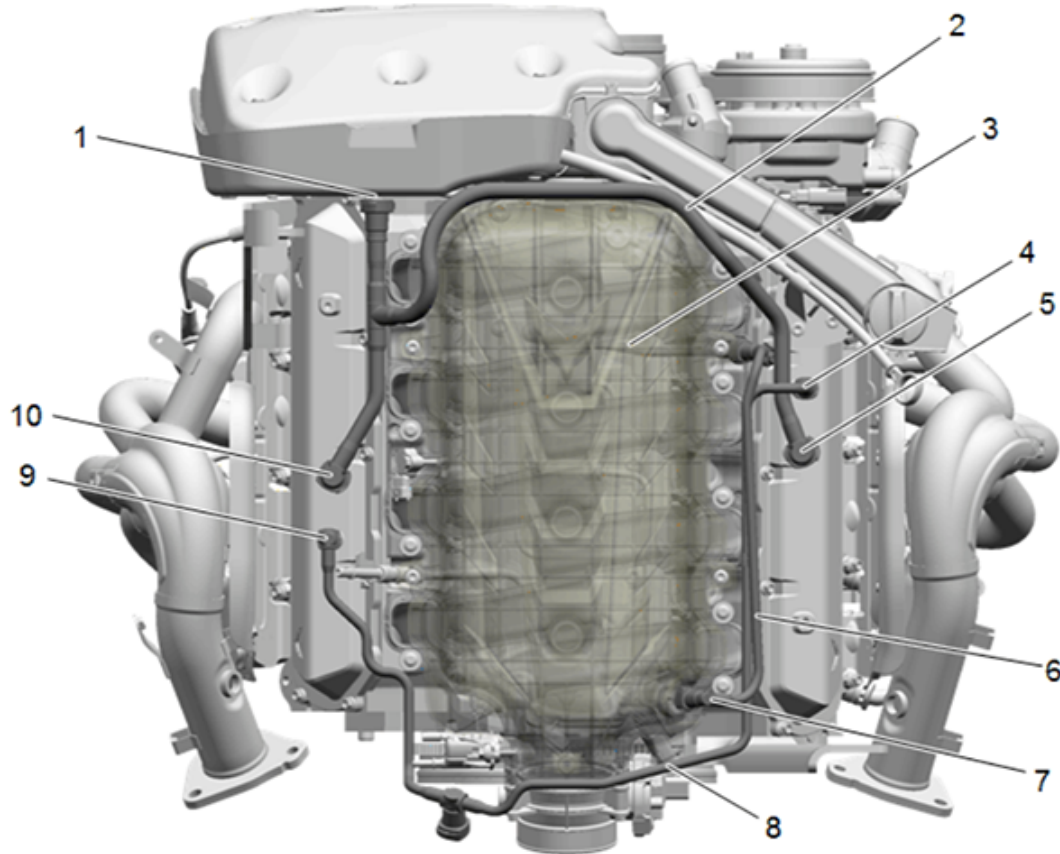
**Fig. 3**

In the LT2 engine, filtered fresh air is routed from upstream of the throttle plate through a formed nylon fresh air tube (8) to a PCV fitting (9) in the left-side rocker arm cover and a PCV fitting (4) in the right-side rocker arm cover. The design of the rocker arm covers shields rocker arm oil spray, reducing the potential for oil being drawn back into the fresh air PCV tube during any backflow of the ventilation system. Separated foul vapor from the engine oil tank (1) is routed to a PCV fitting (10) in the left-side rocker arm cover and a PCV fitting (5) in the right-side rocker arm cover via a formed nylon recirculation tube (2). Foul crankcase vapor is routed through a formed nylon foul air tube (6) from a PCV connection (3) on the engine oil separator in the engine valley to right side rear of the intake manifold (7). (Fig. 3)

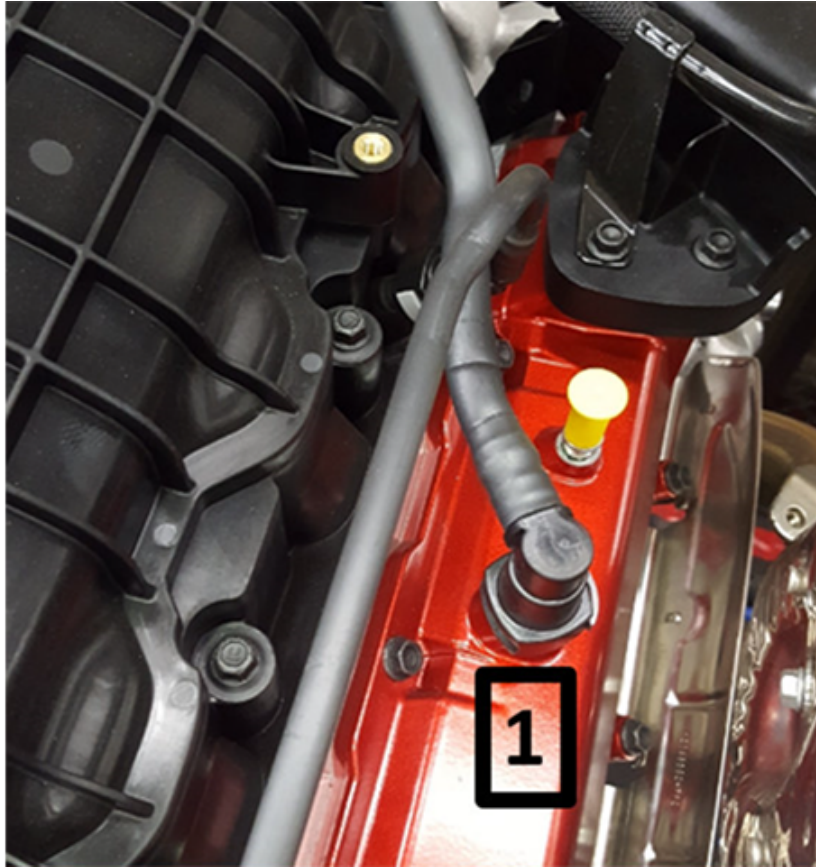
**Fig. 4**

When diagnosing the hissing sound, first verify the correct PCV tube routing. The following photo shows a PCV tube that is incorrectly routed. (Fig. 4)

The sound may change when moving the PCV tube, which is normal. However, if the PCV tube is routed incorrectly, the sound may be magnified.

If a leak is suspected, perform a smoke test to check the induction system. If tests show that the PCV tube is not leaking, it should not be replaced due to the rushing air or hissing sound only.

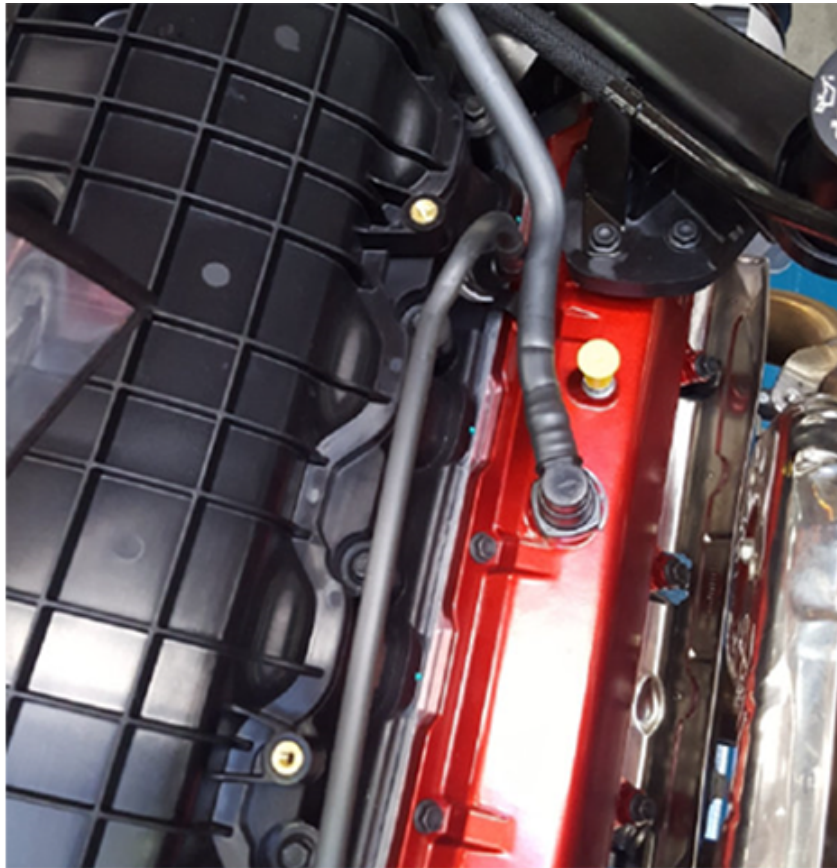
**Fig. 5**

The PCV tube is routed correct in the following photo. (Fig. 5)
