2020 Corvette: Rushing Air Sound in PCV Tube

GM TechLink

May 21, 2020

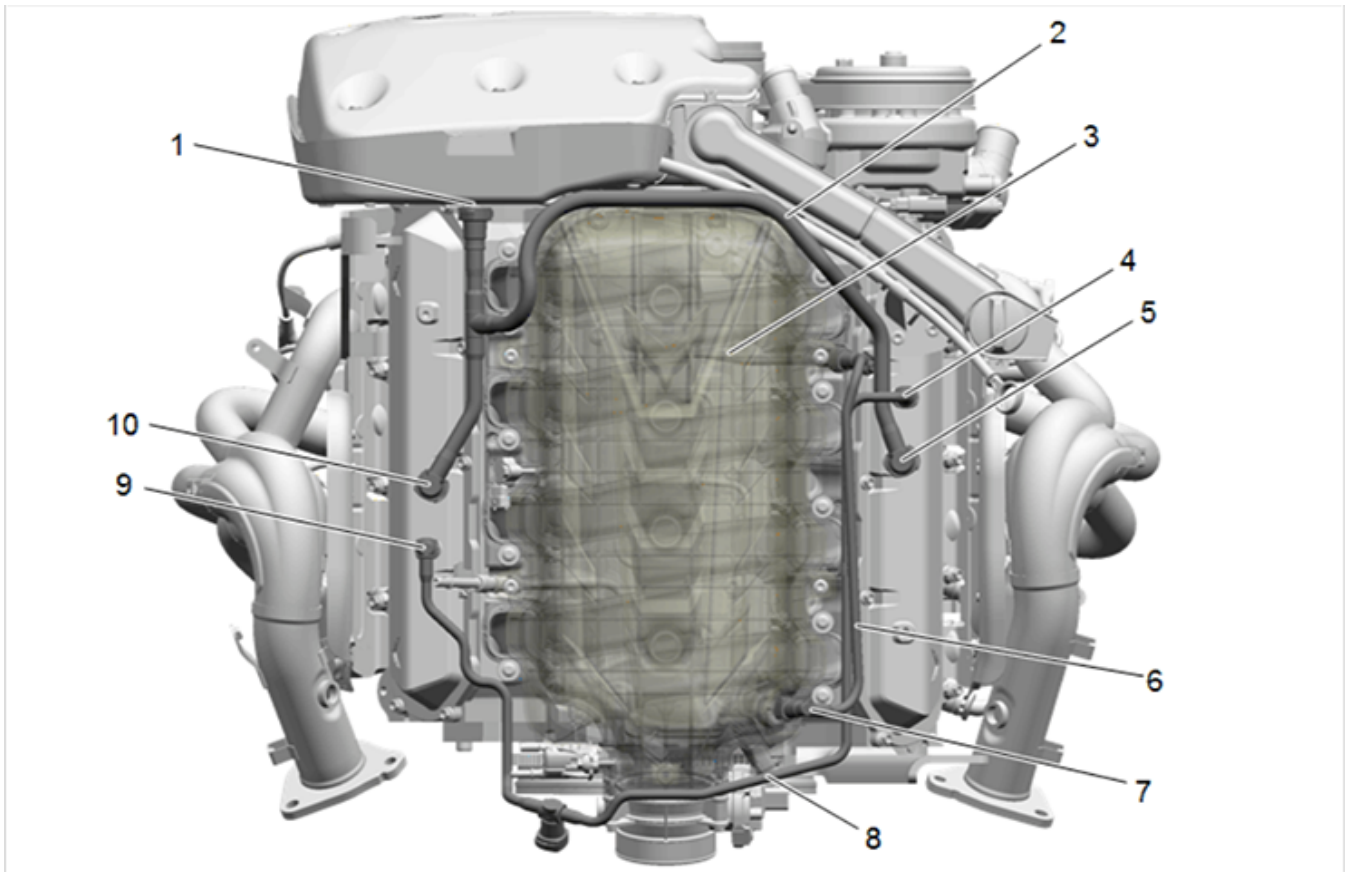
Fig. 3

In the LT2 engine, filtered fresh air is routed from upstream of the throttle plate through a formed nylon fresh air tube (8) to a PCV fitting (9) in the left-side rocker arm cover and a PCV fitting (4) in the right-side rocker arm cover. The design of the rocker arm covers shields rocker arm oil spray, reducing the potential for oil being drawn back into the fresh air PCV tube during any backflow of the ventilation system. Separated foul vapor from the engine oil tank (1) is routed to a PCV fitting (10) in the left-side rocker arm cover and a PCV fitting (5) in the right-side rocker arm cover via a formed nylon recirculation tube (2). Foul crankcase vapor is routed through a formed nylon foul air tube (6) from a PCV connection (3) on the engine oil separator in the engine valley to right side rear of the intake manifold (7). (Fig. 3)

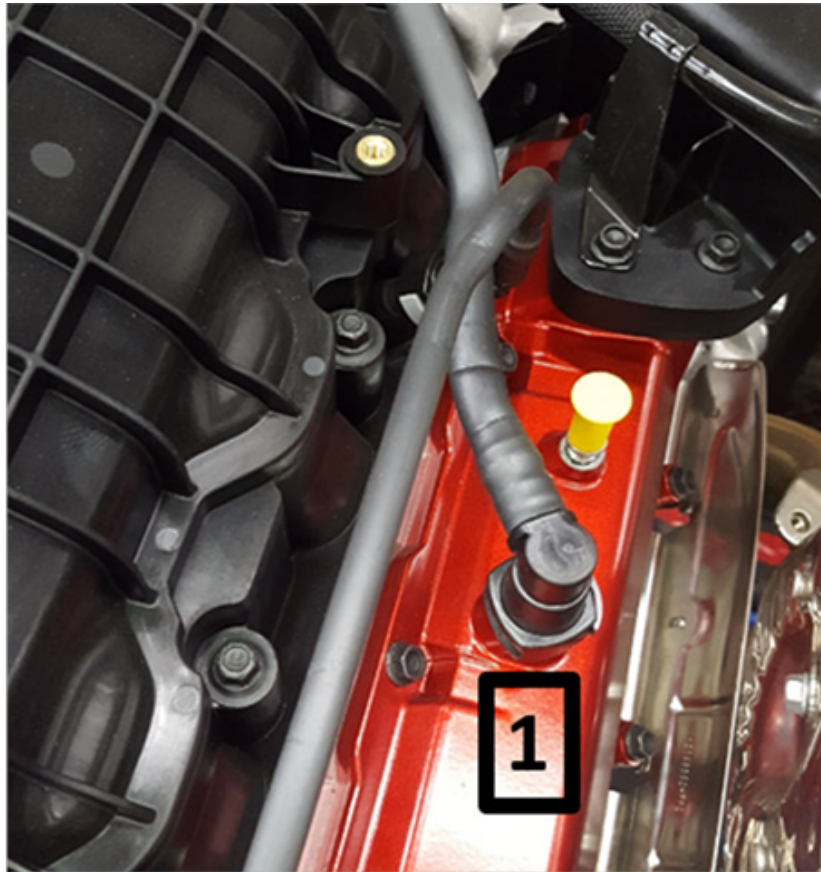
Fig. 4

When diagnosing the hissing sound, first verify the correct PCV tube routing. The following photo shows a PCV tube that is incorrectly routed. (Fig. 4)

The sound may change when moving the PCV tube, which is normal. However, if the PCV tube is routed incorrectly, the sound may be magnified.

If a leak is suspected, perform a smoke test to check the induction system. If tests show that the PCV tube is not leaking, it should not be replaced due to the rushing air or hissing sound only.

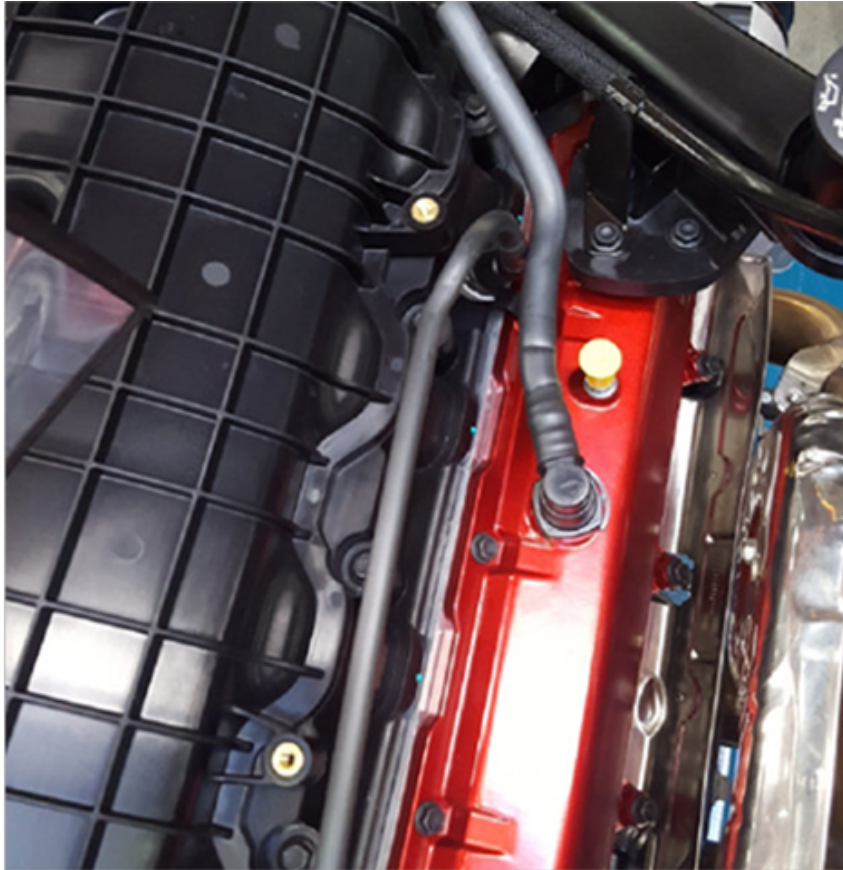
Fig. 5

The PCV tube is routed correct in the following photo. (Fig. 5)
