2020 Corvette: GM TechLink: Rushing Air Sound in PCV Tube

2020 Corvette: Rushing Air Sound in PCV Tube

GM TechLink

May 21, 2020

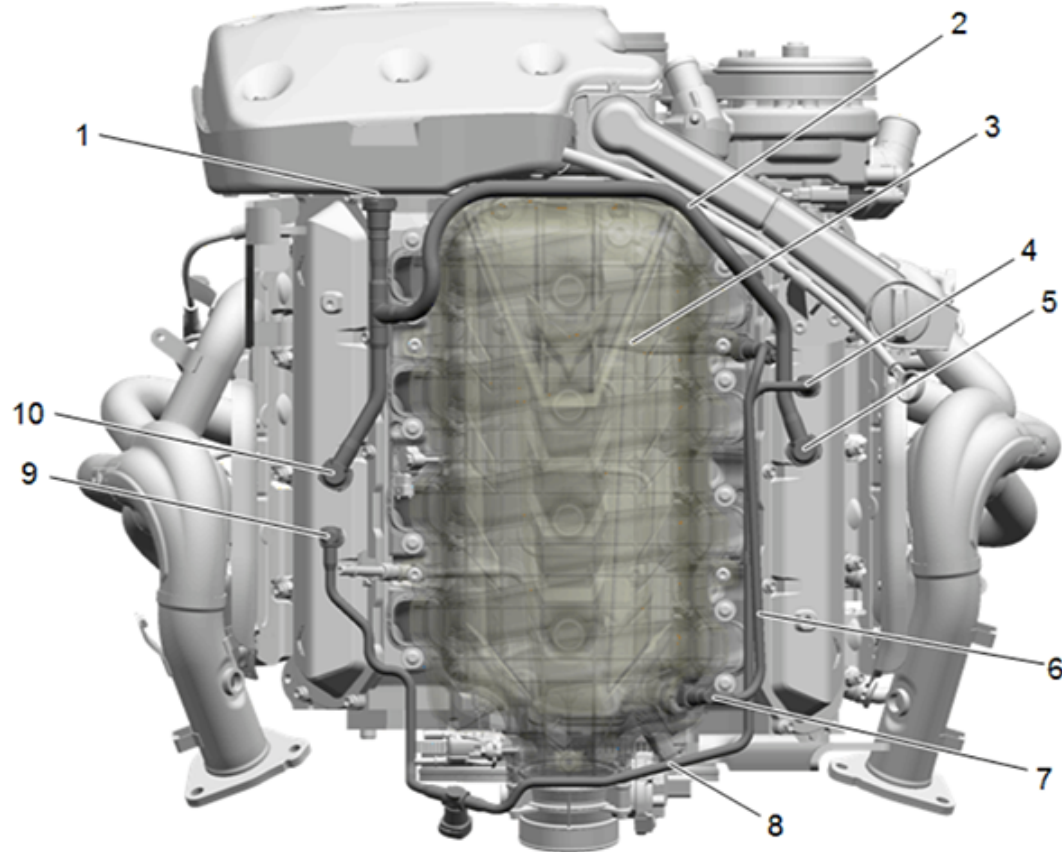
Fig. 3

In the LT2 engine, filtered fresh air is routed from upstream of the throttle plate through a formed nylon fresh air tube (8) to a PCV fitting (9) in the left-side rocker arm cover and a PCV fitting (4) in the right-side rocker arm cover. The design of the rocker arm covers shields rocker arm oil spray, reducing the potential for oil being drawn back into the fresh air PCV tube during any backflow of the ventilation system. Separated foul vapor from the engine oil tank (1) is routed to a PCV fitting (10) in the left-side rocker arm cover and a PCV fitting (5) in the right-side rocker arm cover via a formed nylon recirculation tube (2). Foul crankcase vapor is routed through a formed nylon foul air tube (6) from a PCV connection (3) on the engine oil separator in the engine valley to right side rear of the intake manifold (7). (Fig. 3)

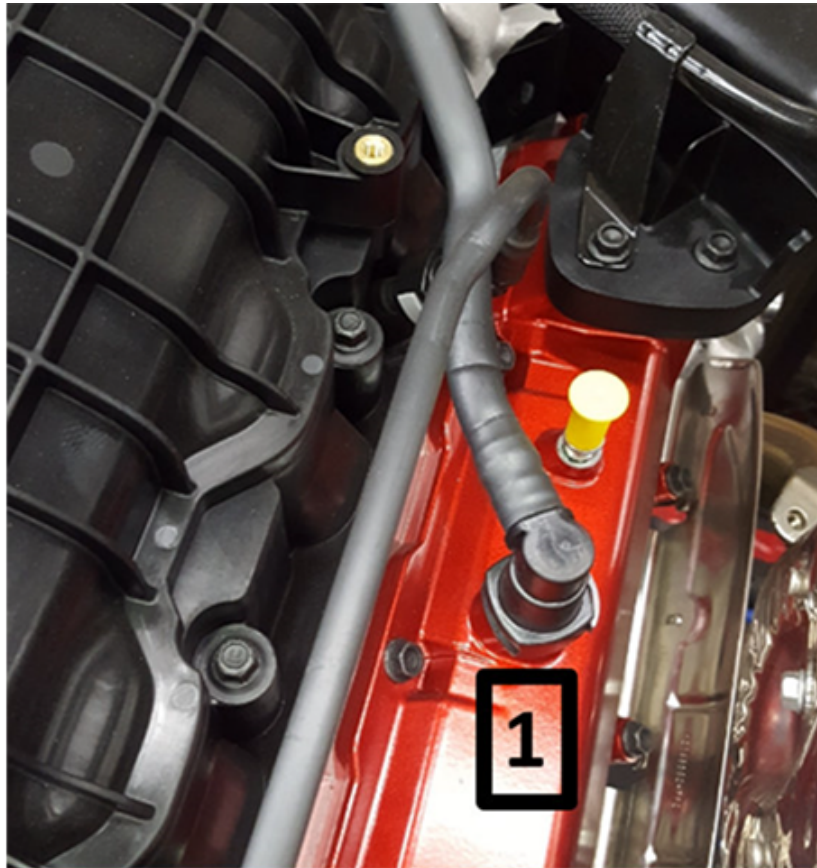
Fig. 4

When diagnosing the hissing sound, first verify the correct PCV tube routing. The following photo shows a PCV tube that is incorrectly routed. (Fig. 4)

The sound may change when moving the PCV tube, which is normal. However, if the PCV tube is routed incorrectly, the sound may be magnified.

If a leak is suspected, perform a smoke test to check the induction system. If tests show that the PCV tube is not leaking, it should not be replaced due to the rushing air or hissing sound only.

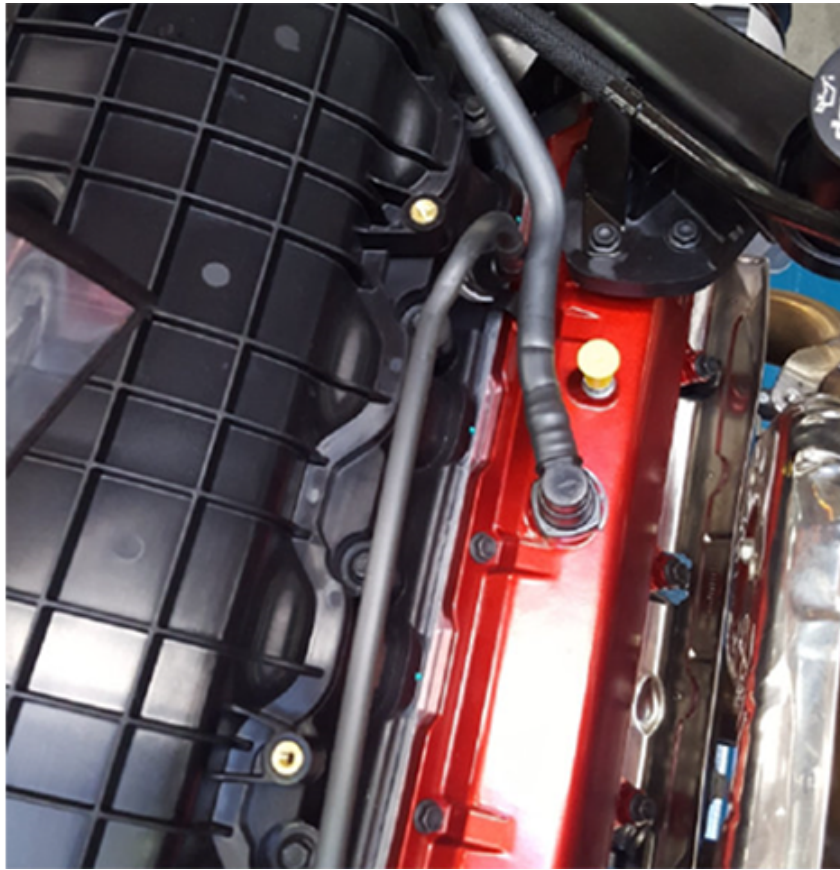
Fig. 5

The PCV tube is routed correct in the following photo. (Fig. 5)
