# 2018 - 2019 Corvette: GM TechLink: Intermittent Parasitic Battery Draw Below 40° F/4° C

## Intermittent Parasitic Battery Draw Below 40° F/4° C

June 16, 2020  
GM TechLink

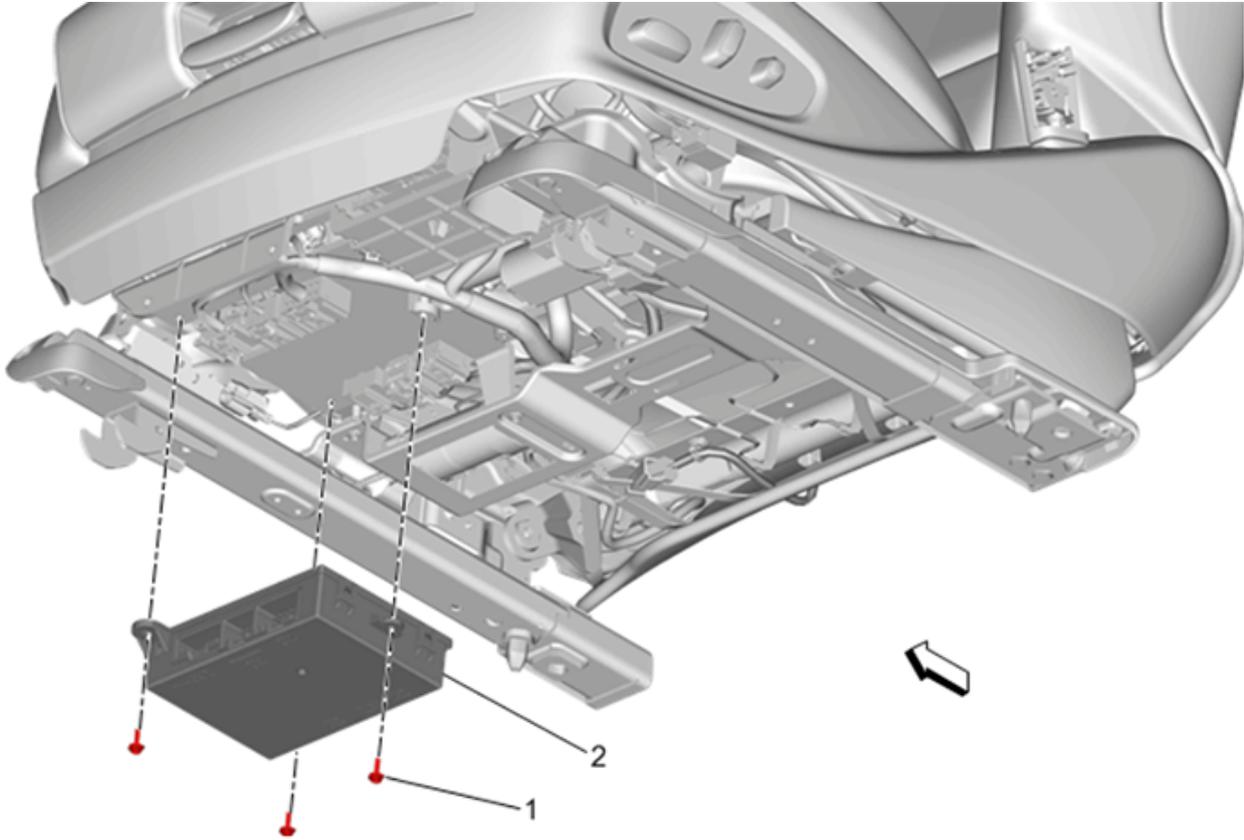
**Fig. 9**

These conditions may be due to a low battery state of charge that is being caused by one or more modules waking up the Low Speed GM LAN Bus. When the ambient air temperature is below 40° F/4° C, the Seat Memory Control Module (SMCM) could inadvertently wake up the Low Speed GM

LAN Bus. All SMCM's on a vehicle, including the Driver K40 (Fig. 9), Passenger K40P, Left Rear K40LR and/or Right Rear K40RR module, may apply.

Follow the Battery Electrical Drain/Parasitic Load Test procedure in the appropriate Service Information. If an excessive battery draw is duplicated, as part of the Circuit/System Testing procedure, remove the fuse(s) that powers the SMCM. The SMCM may be powered by more than one fuse. Wait several minutes to see if the vehicle will return to an acceptable battery draw level. If so, replace the appropriate SMCM.
