2018 - 2019 Corvette: GM TechLink: Intermittent Parasitic Battery Draw Below 40° F/4° C

June 16, 2020
GM TechLink

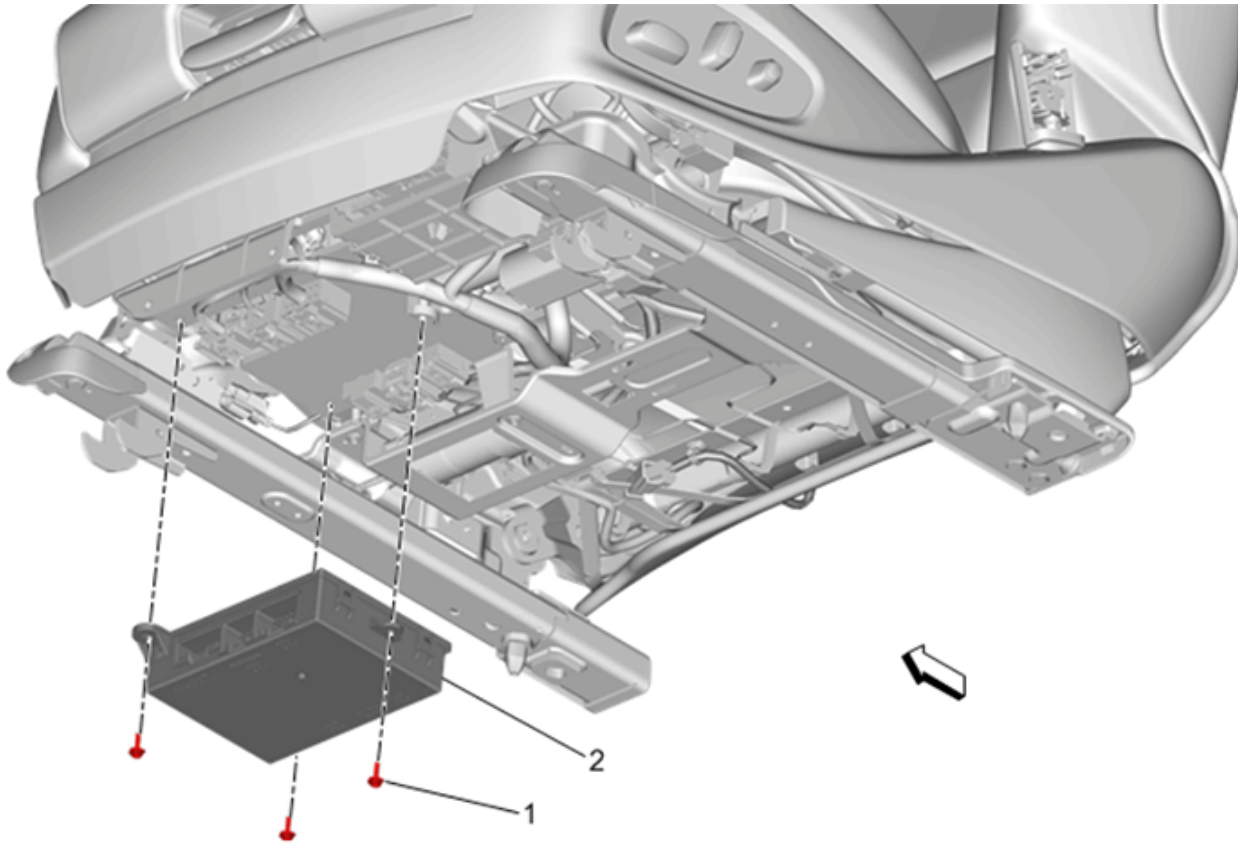
Fig. 9

These conditions may be due to a low battery state of charge that is being caused by one or more modules waking up the Low Speed GM LAN Bus. When the ambient air temperature is below 40° F/4° C, the Seat Memory Control Module (SMCM) could inadvertently wake up the Low Speed GM

LAN Bus. All SMCM's on a vehicle, including the Driver K40 (Fig. 9), Passenger K40P, Left Rear K40LR and/or Right Rear K40RR module, may apply.

Follow the Battery Electrical Drain/Parasitic Load Test procedure in the appropriate Service Information. If an excessive battery draw is duplicated, as part of the Circuit/System Testing procedure, remove the fuse(s) that powers the SMCM. The SMCM may be powered by more than one fuse. Wait several minutes to see if the vehicle will return to an acceptable battery draw level. If so, replace the appropriate SMCM.
