2018 - 2019 Corvette: GM TechLink: Intermittent Parasitic Battery Draw Below 40° F/4° C

Intermittent Parasitic Battery Draw Below 40° F/4° C

June 16, 2020

GM TechLink

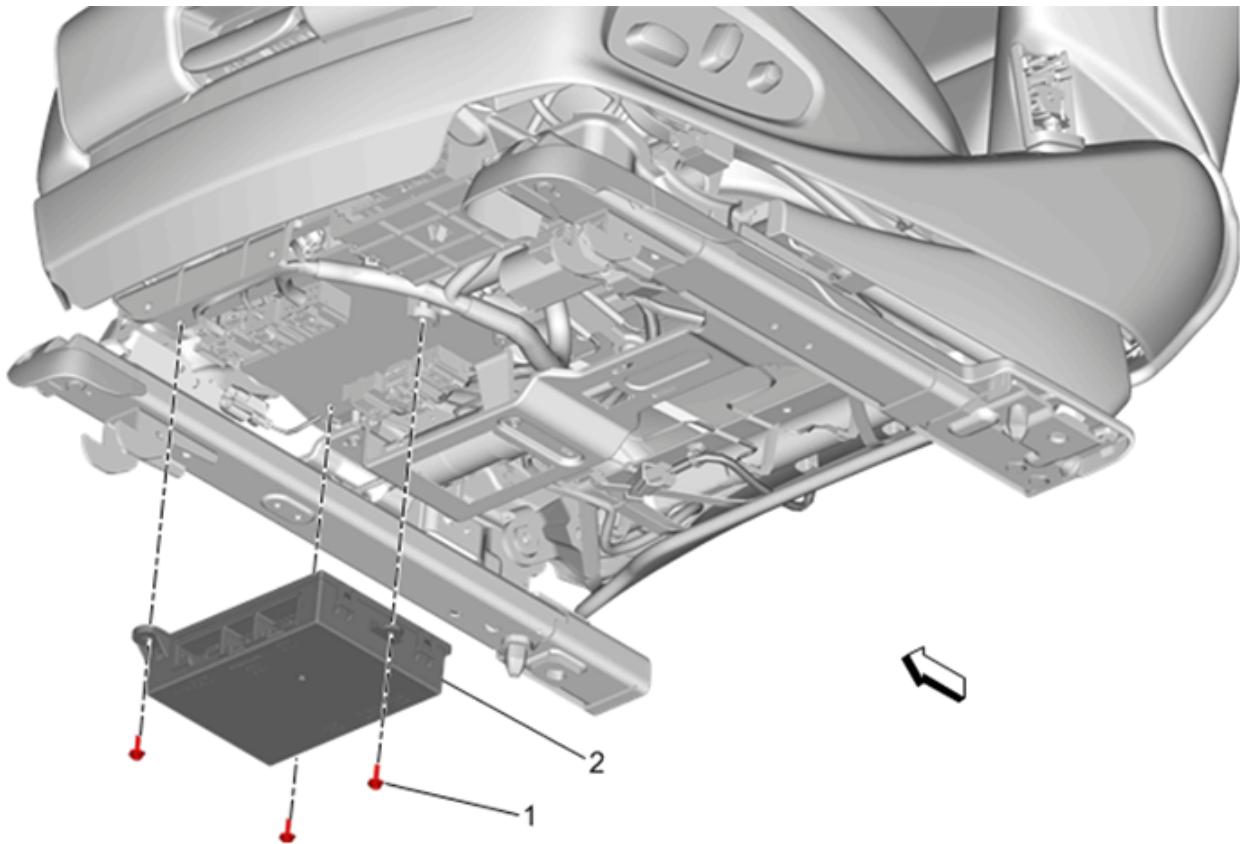
Fig. 9

These conditions may be due to a low battery state of charge that is being caused by one or more modules waking up the Low Speed GM LAN Bus. When the ambient air temperature is below 40° F/4° C, the Seat Memory Control Module (SMCM) could inadvertently wake up the Low Speed GM

LAN Bus. All SMCM's on a vehicle, including the Driver K40 (Fig. 9), Passenger K40P, Left Rear K40LR and/or Right Rear K40RR module, may apply.

Follow the Battery Electrical Drain/Parasitic Load Test procedure in the appropriate Service Information. If an excessive battery draw is duplicated, as part of the Circuit/System Testing procedure, remove the fuse(s) that powers the SMCM. The SMCM may be powered by more than one fuse. Wait several minutes to see if the vehicle will return to an acceptable battery draw level. If so, replace the appropriate SMCM.
