2020 Corvette: GM TechLink: Front Fender and Fascia Realignment

2020 Corvette: Front Fender and Fascia Realignment

June 16, 2020
GM TechLink

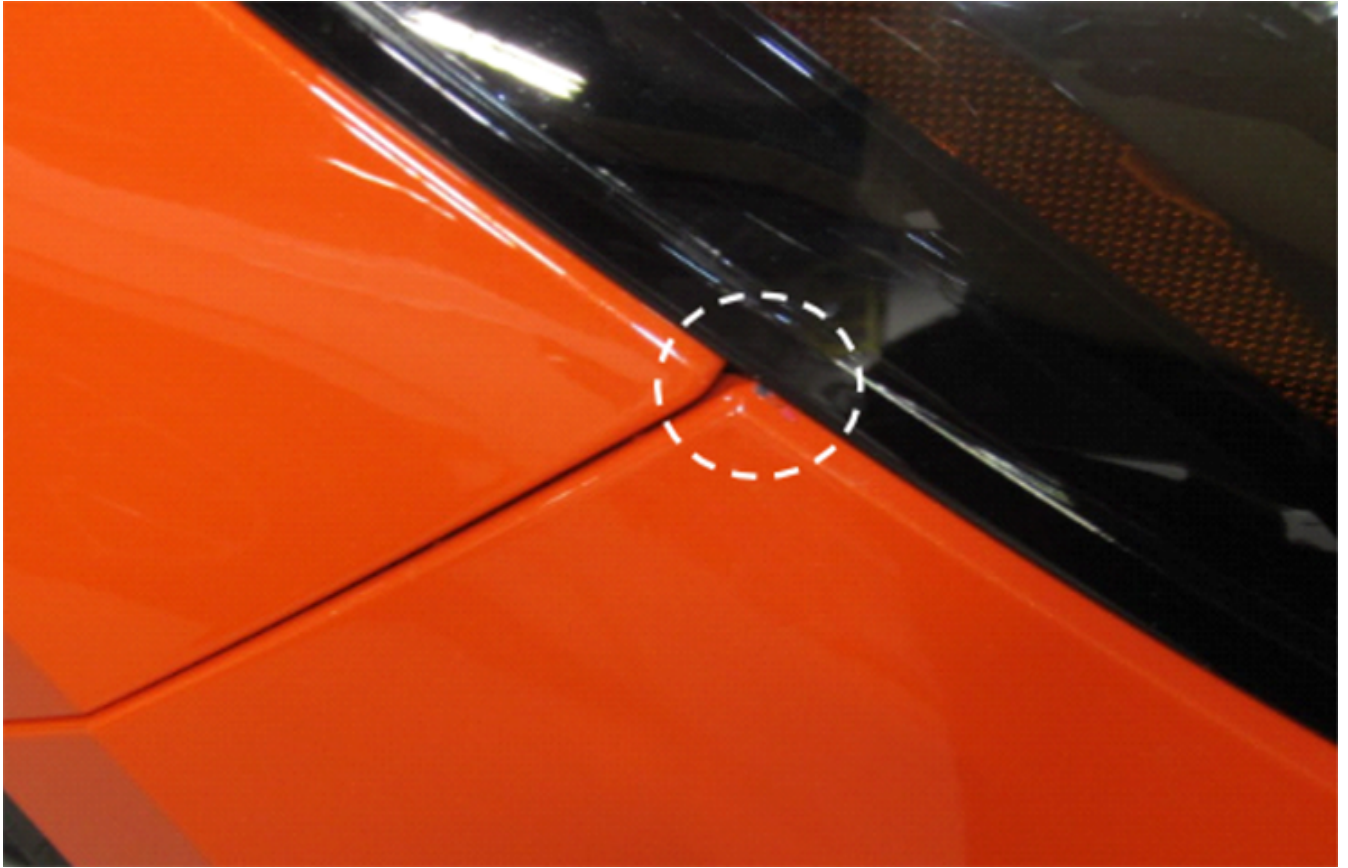
Fig. 10

Some 2020 Corvettes may have a small paint chip in the front fascia below the headlamp on one or both sides of the vehicle. (Fig. 10) The paint chip may be caused by a mis-positioned fender-to-fascia gap joint.

The fender and fascia joint fit should be realigned. (Fig. 11, #1) The realignment will reposition the fender and fascia downward and inboard so that the fascia is flush with the fender. After realignment, the paint chip will no longer be visible. (Fig. 11, #2)

Follow the realignment procedure in Bulletin #20-NA-124. The front tire and wheel assembly, front wheelhouse liner and front wheel opening molding must be removed on the affected side of the vehicle.
