2020 Corvette: Front Fender and Fascia Realignment

June 16, 2020
GM TechLink

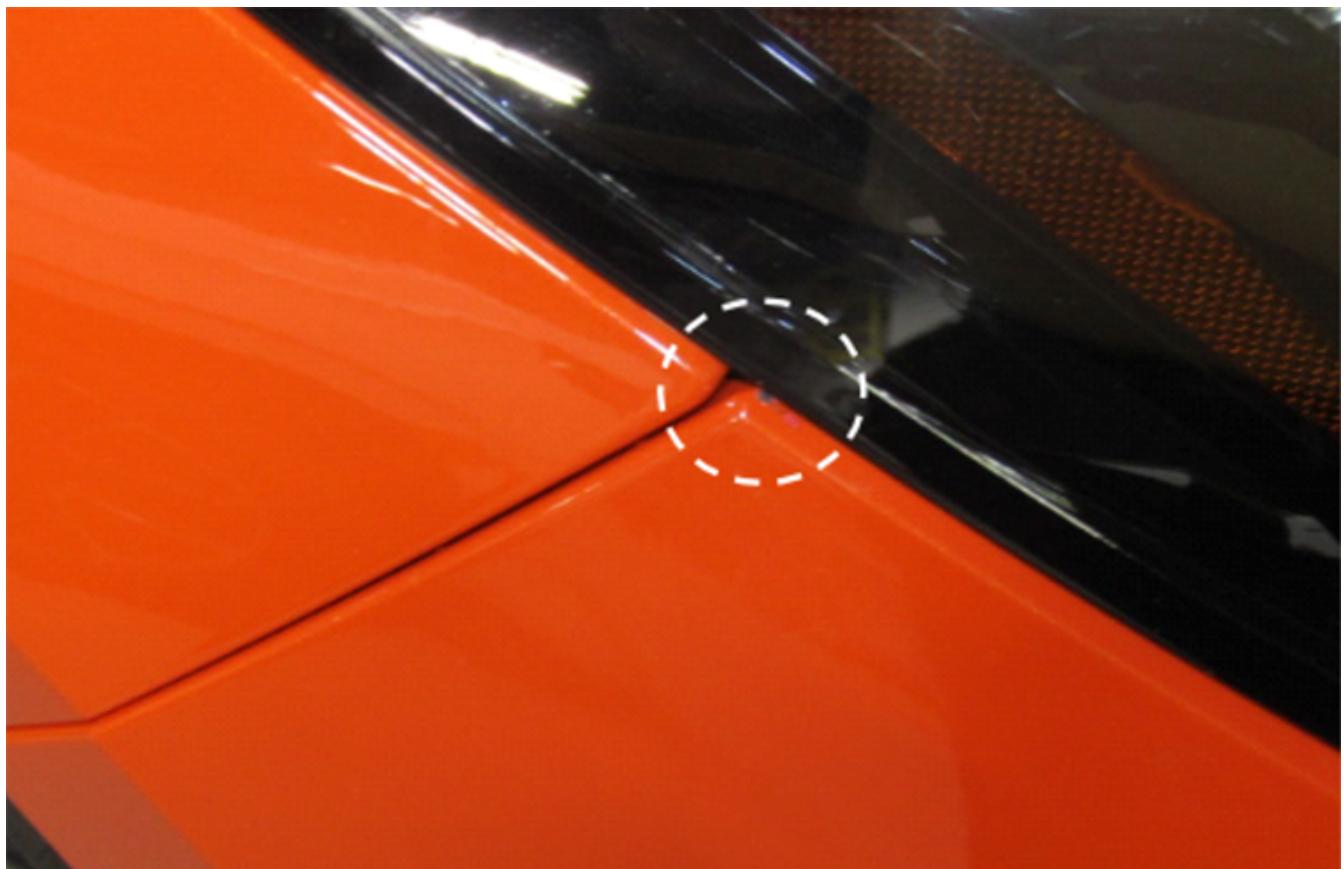
Fig. 10

Some 2020 Corvettes may have a small paint chip in the front fascia below the headlamp on one or both sides of the vehicle. (Fig. 10) The paint chip may be caused by a mis-positioned fender-to-fascia gap joint.

The fender and fascia joint fit should be realigned. (Fig. 11, #1) The realignment will reposition the fender and fascia downward and inboard so that the fascia is flush with the fender. After realignment, the paint chip will no longer be visible. (Fig. 11, #2)

Follow the realignment procedure in Bulletin #20-NA-124. The front tire and wheel assembly, front wheelhouse liner and front wheel opening molding must be removed on the affected side of the vehicle.

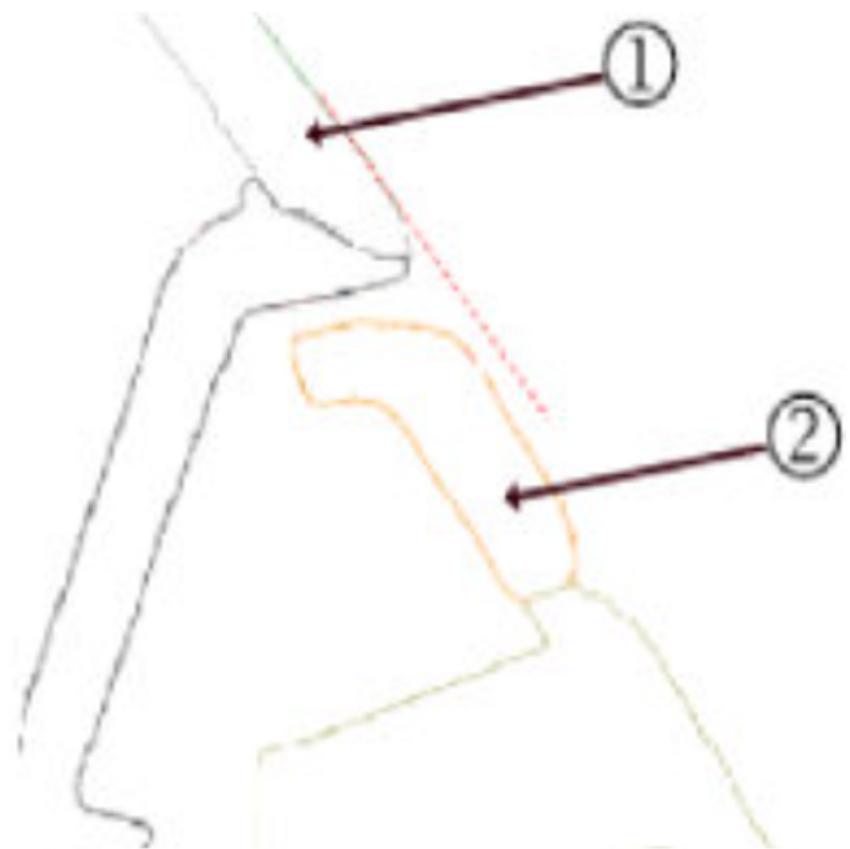
Fig. 12

After adjusting the fender inboard, the headlamp lens (Fig. 12, #1) will be proud of the fender (Fig. 12, #2) and the fascia tip will install below the headlamp lens. (Fig. 13)
