# 2020 Corvette: GM TechLink: Front Fender and Fascia Realignment

June 16, 2020  
GM TechLink

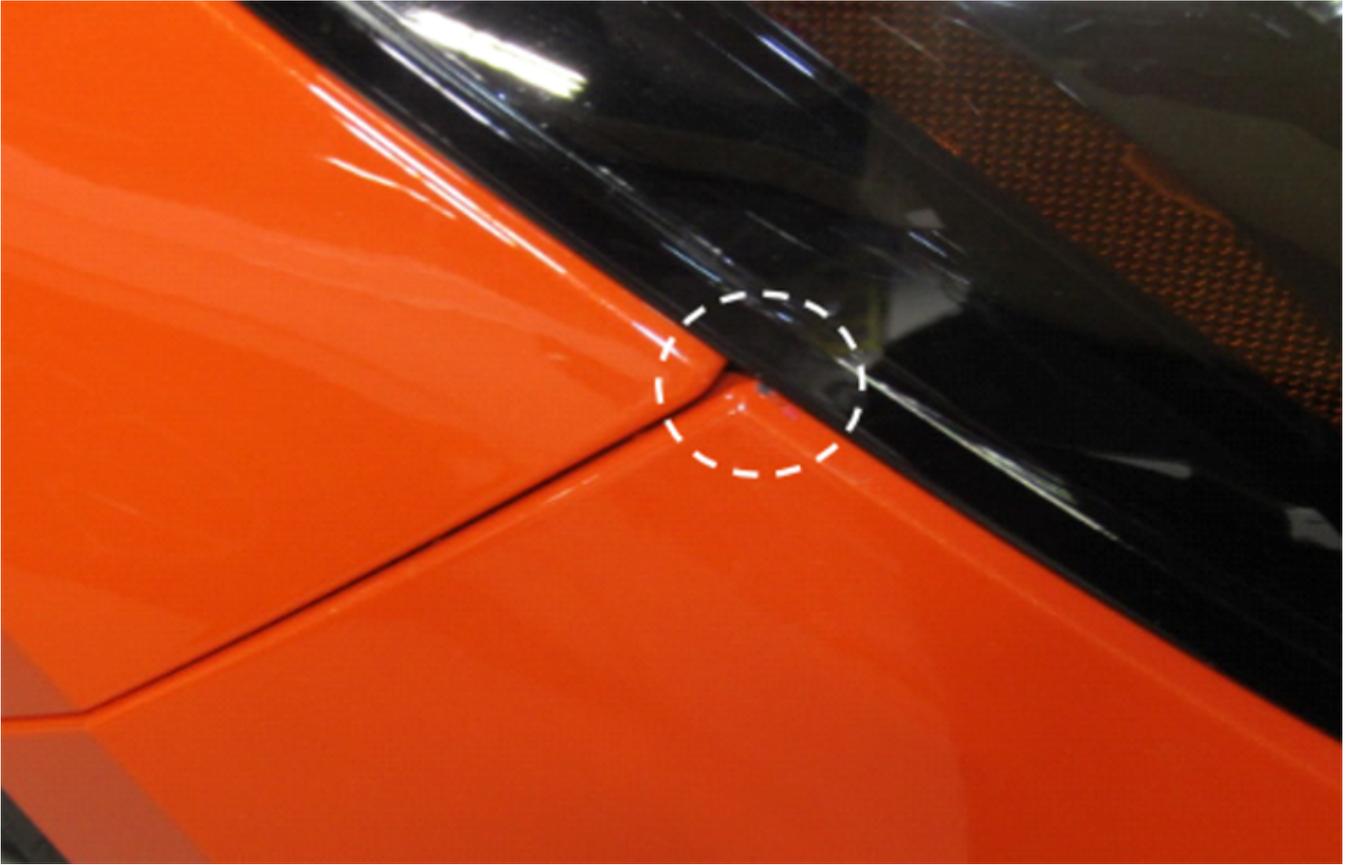
**Fig. 10**

Some 2020 Corvettes may have a small paint chip in the front fascia below the headlamp on one or both sides of the vehicle. (Fig. 10) The paint chip may be caused by a mis-positioned fender-to-fascia gap joint.

The fender and fascia joint fit should be realigned. (Fig. 11, #1) The realignment will reposition the fender and fascia downward and inboard so that the fascia is flush with the fender. After realignment, the paint chip will no longer be visible. (Fig. 11, #2)

Follow the realignment procedure in Bulletin #20-NA-124. The front tire and wheel assembly, front wheelhouse liner and front wheel opening molding must be removed on the affected side of the vehicle.

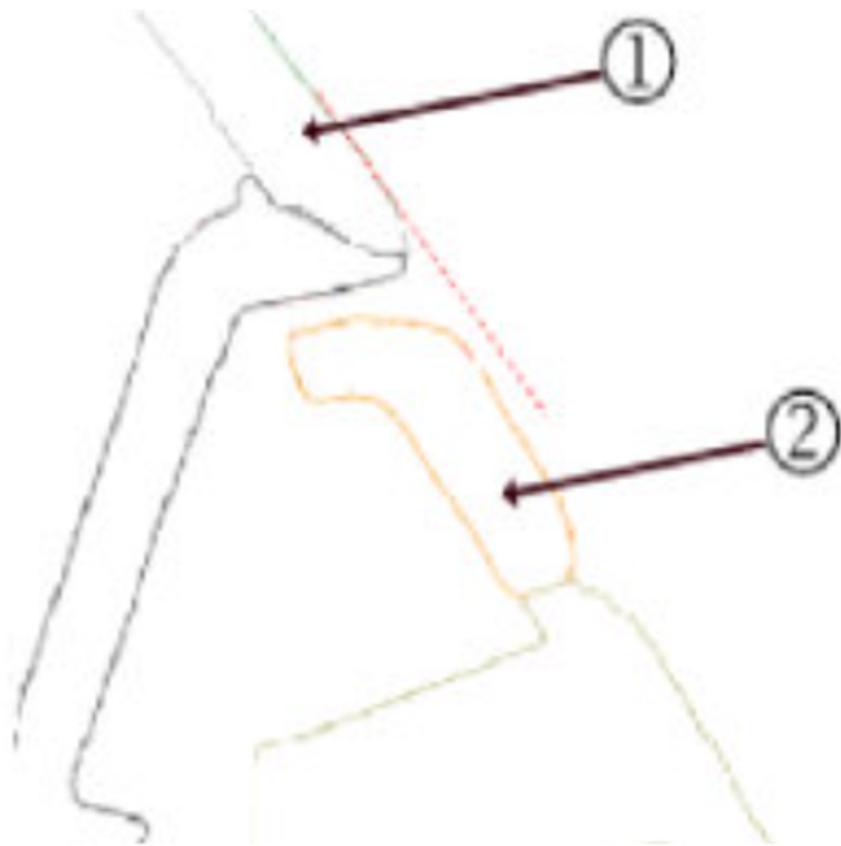
Fig. 12

After adjusting the fender inboard, the headlamp lens (Fig. 12, #1) will be proud of the fender (Fig. 12, #2) and the fascia tip will install below the headlamp lens. (Fig. 13)
