2020 Corvette: Front Fender and Fascia Realignment

June 16, 2020
GM TechLink

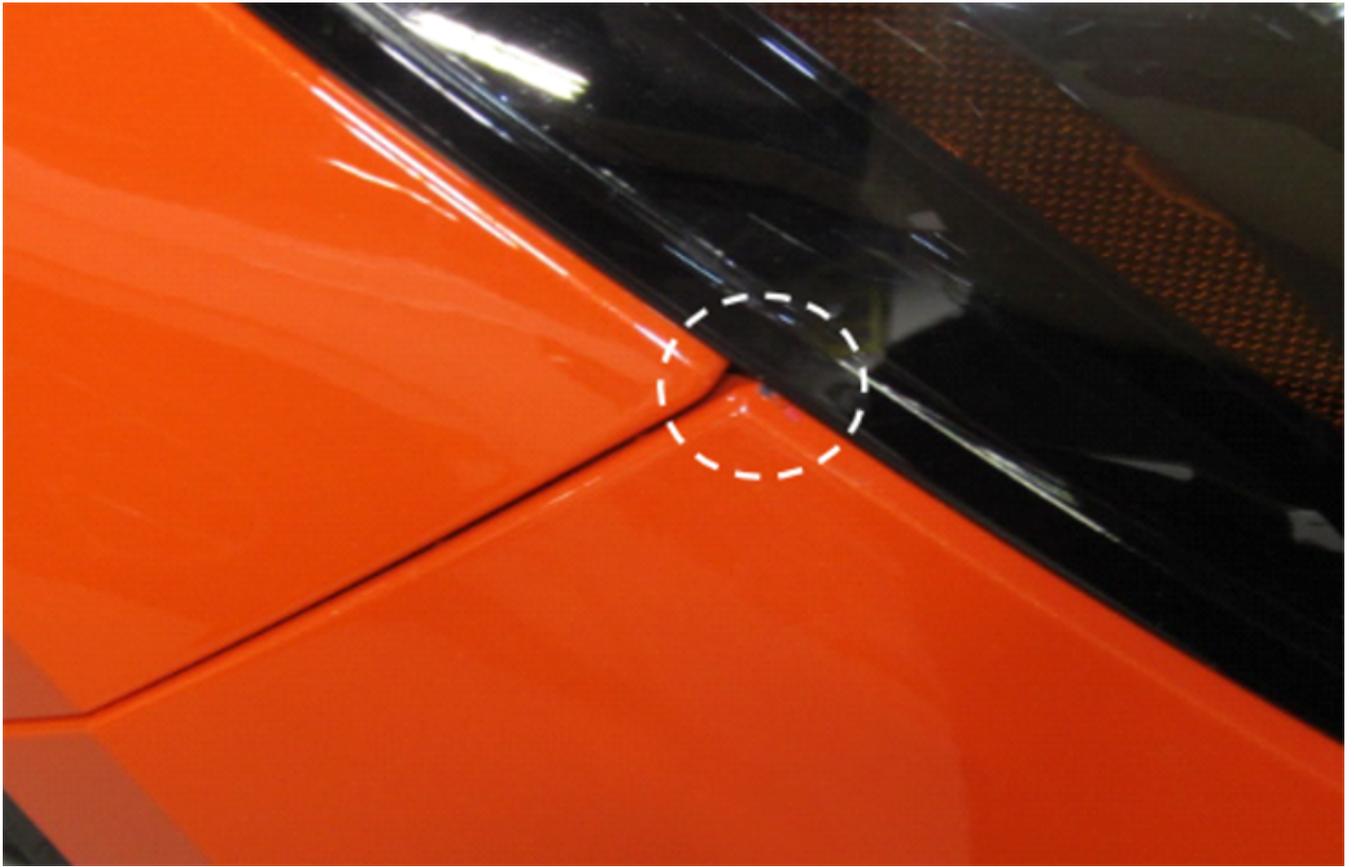
Fig. 10

Some 2020 Corvettes may have a small paint chip in the front fascia below the headlamp on one or both sides of the vehicle. (Fig. 10) The paint chip may be caused by a mis-positioned fender-to-fascia gap joint.
