2020 Corvette: Recall Notice: #N202309350: Non-Compliance - Interior Trunk Release Button Inoperative Ten Minutes After Power Off

Subject: N202309350 — Interior
Trunk Release Button
Inoperative Ten Minutes
After Power Off

Models: 2020 Chevrolet Corvette

Release Date: August 2020

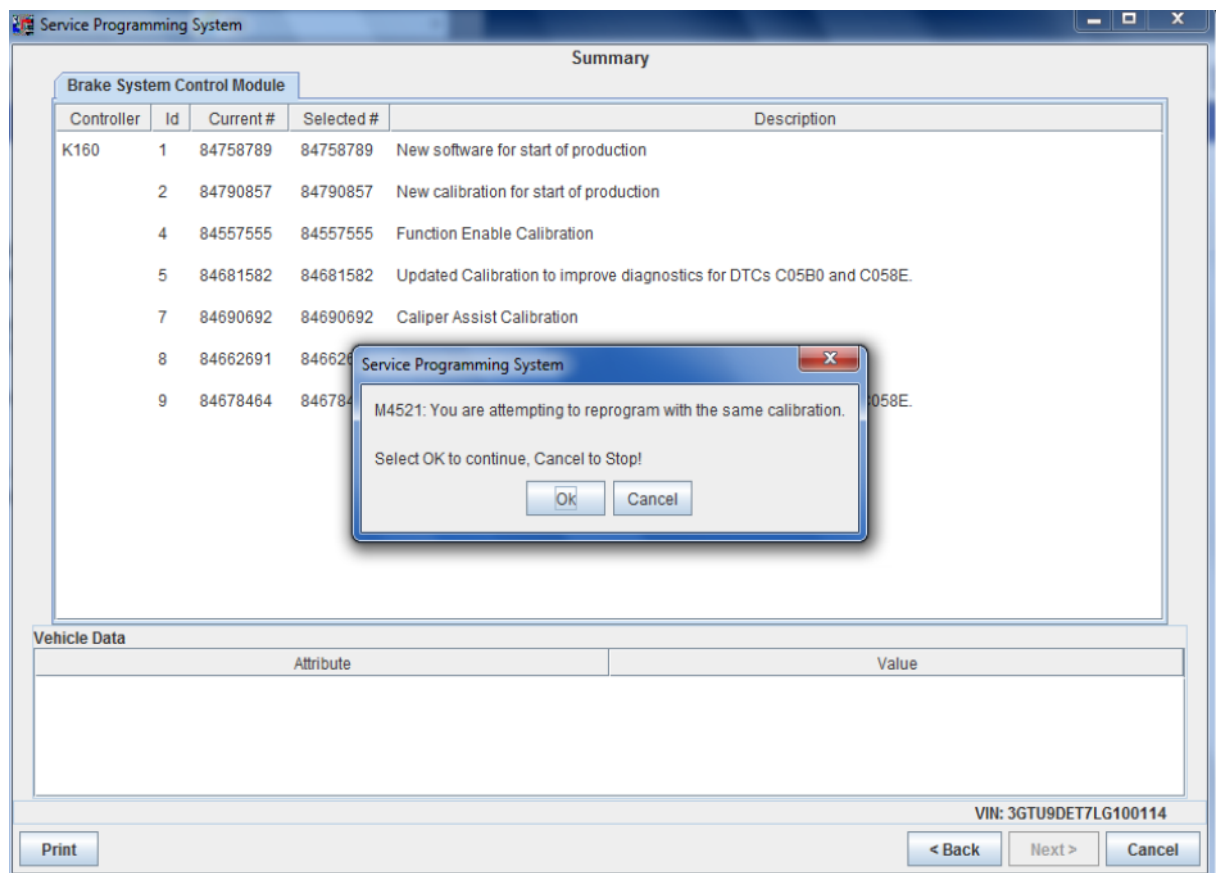
Important: TIS2WEB screen shown. Techline Connect screen is similar and will be included in the near future.

Important: If the Same Calibration/Software Warning is noted on the SPS Summary screen, record the warranty claim code (WCC) and select OK and follow screen instructions. After a successful programming event, the WCC is located in the Service Programming System dialogue box of the SPS Summary screen. No further action is required. Refer to the Warranty section of the bulletin.

1. Reprogram the body control module. Refer to *K9 Body Control Module: Programming and Setup* in SI.

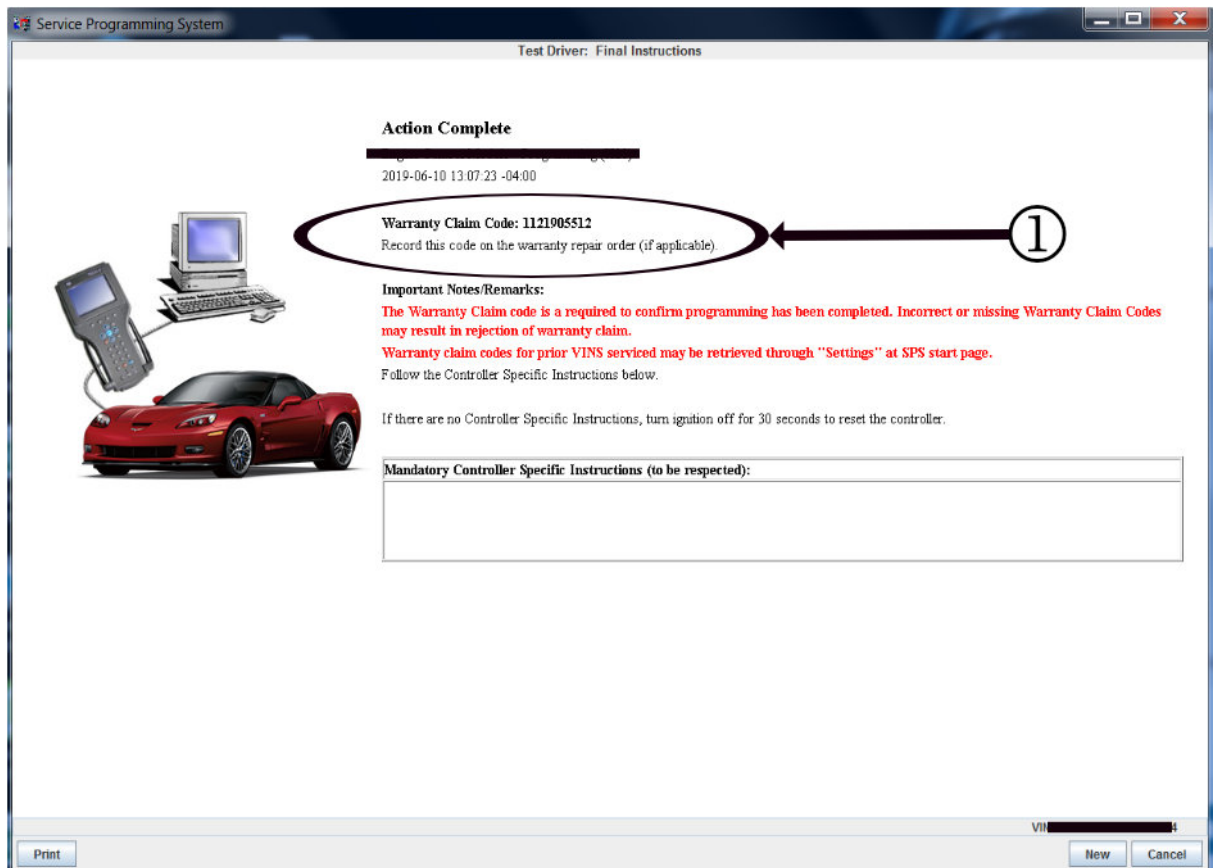
Important: TIS2WEB screen shown. Techline Connect screen is similar and will be included in the near future.

Important: To avoid warranty transaction rejections, you *MUST*

record the warranty claim code provided on the SPS Warranty Claim Code (WCC) screen on the job card. Refer to callout 1 for the location of the WCC on the SPS screen.

1. Record SPS Warranty Claim Code on job card for warranty transaction submission.
