# 2020 Corvette: Recall Notice: #N202309350: Non-Compliance - Interior Trunk Release Button Inoperative Ten Minutes After Power Off

## #N202309350: Non-Compliance - Interior Trunk Release Button Inoperative Ten Minutes After Power Off - (Aug 6, 2020)

**Subject:** N202309350 — Interior Trunk Release Button Inoperative Ten Minutes After Power Off  
**Models:** 2020 Chevrolet Corvette

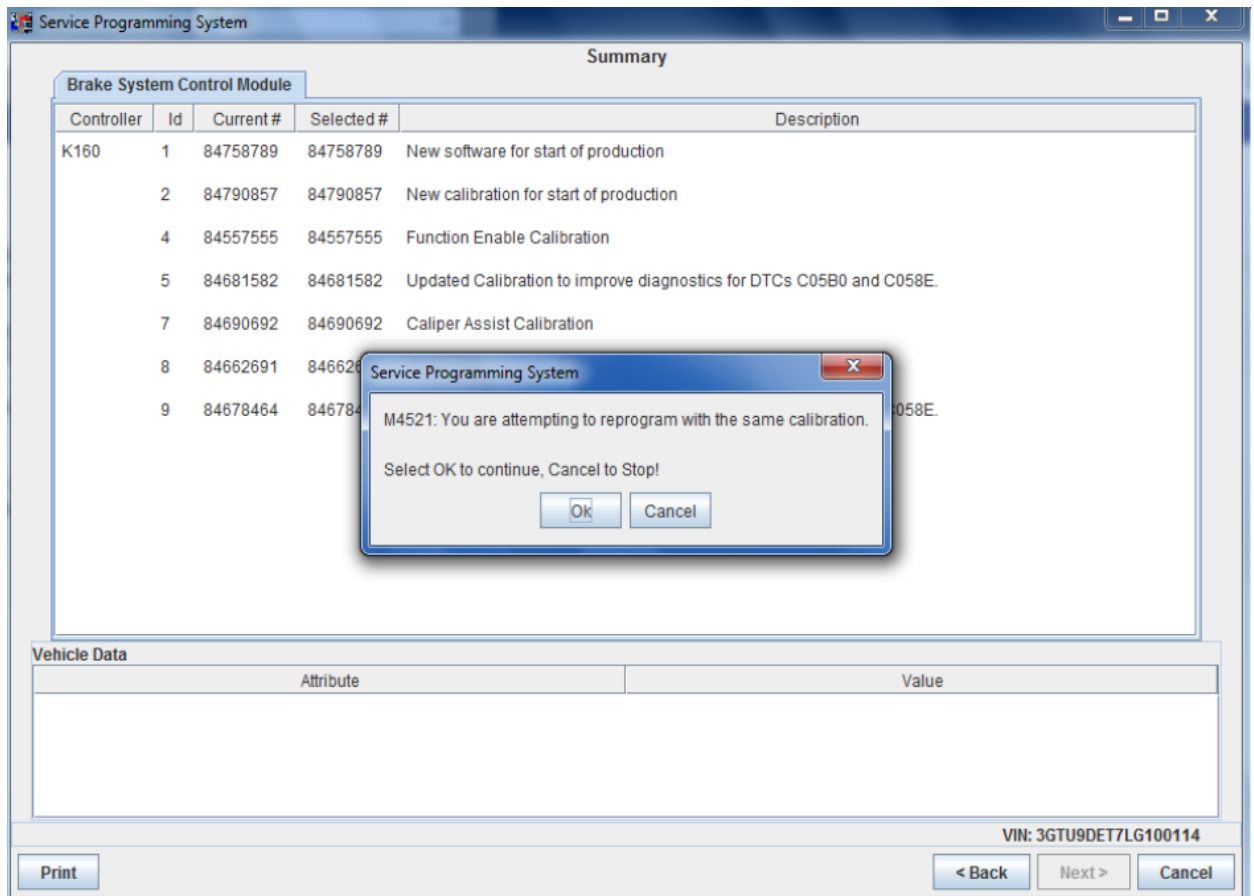
**Important:** TIS2WEB screen shown. Techline Connect screen is similar and will be included in the near future.

**Important:** If the Same Calibration/Software Warning is noted on the SPS Summary screen, record the warranty claim code (WCC) and select OK and follow screen instructions. After a successful programming event, the WCC is located in the Service Programming System dialogue box of the SPS Summary screen. No further action is required. Refer to the Warranty section of the bulletin.

1. Reprogram the body control module. Refer to *K9 Body Control Module: Programming and Setup* in SI.

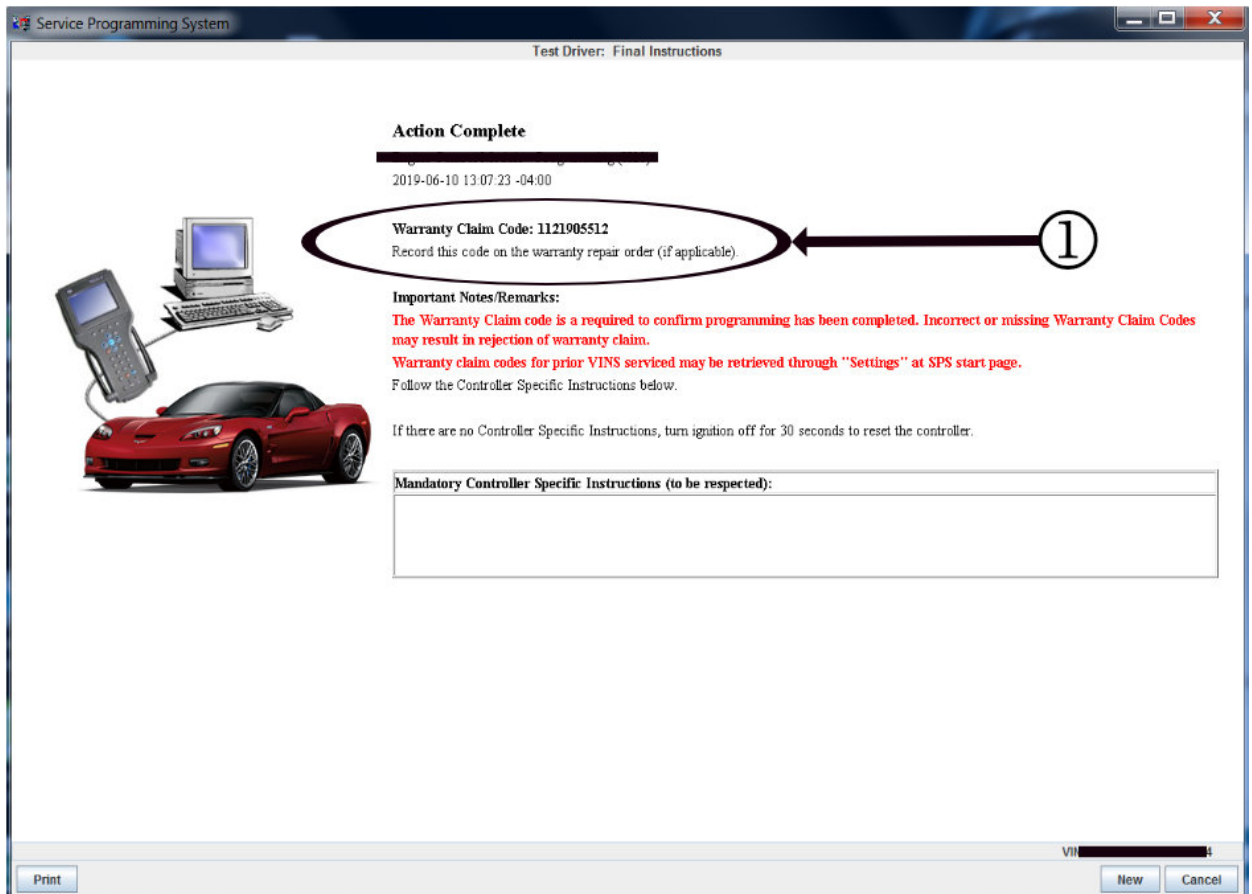
**Important:** TIS2WEB screen shown. Techline Connect screen is similar and will be included in the near future.

**Important:** To avoid warranty transaction rejections, you *MUST* record the warranty claim code provided on the SPS Warranty Claim Code (WCC) screen on the job card. Refer to callout 1 for the location of the WCC on the SPS screen.

1. Record SPS Warranty Claim Code on job card for warranty transaction submission.
