2020 Corvette: Recall Notice: #N202309350: Non-Compliance - Interior Trunk Release Button Inoperative Ten Minutes After Power Off

Subject: N202309350 — Interior
Trunk Release Button
Inoperative Ten Minutes
After Power Off

Models: 2020 Chevrolet Corvette

Release Date: August 2020 **Revision:** 00

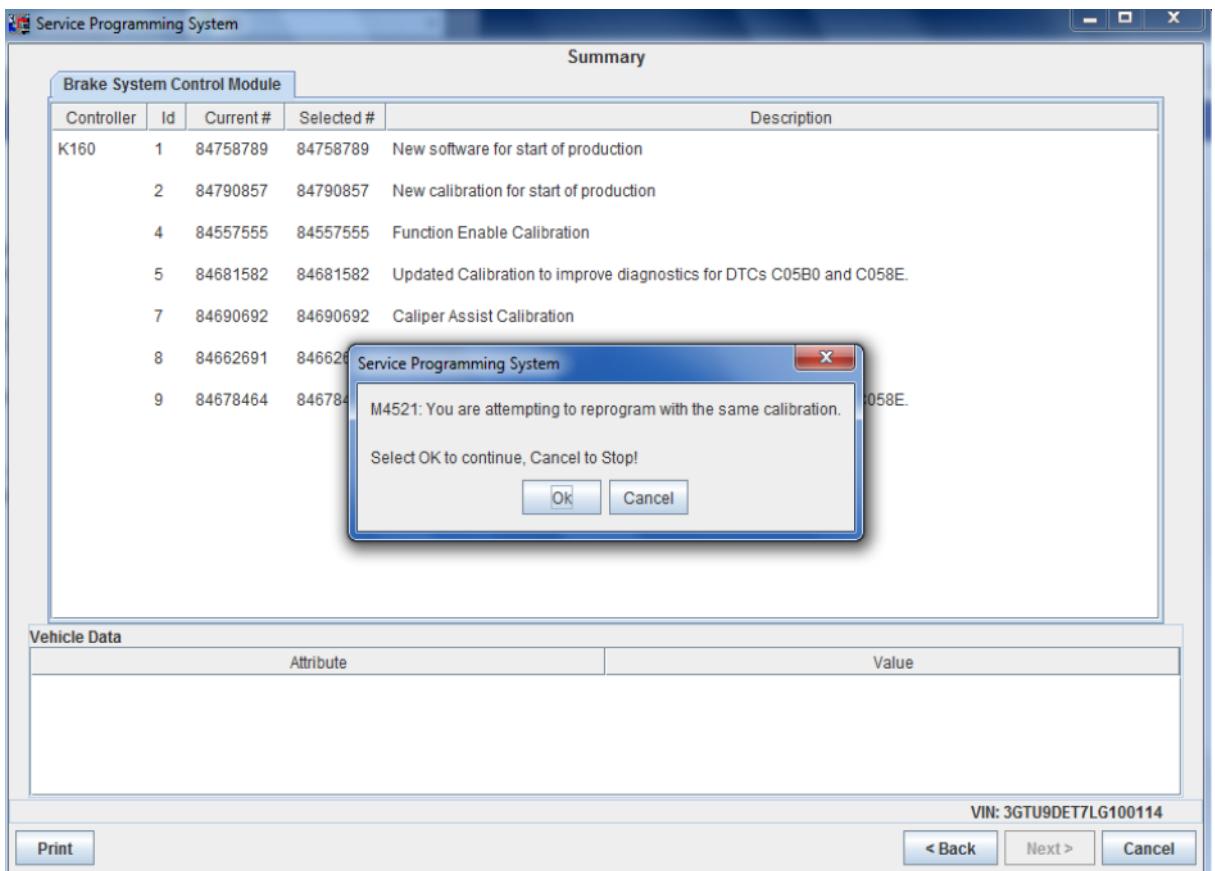
Important: TIS2WEB screen shown. Techline Connect screen is similar and will be included in the near future.

Important: If the Same Calibration/Software Warning is noted on the SPS Summary screen, record the warranty claim code (WCC) and select OK and follow screen instructions. After a successful programming event, the WCC is located in the Service Programming System dialogue box of the SPS Summary screen. No further action is required. Refer to the Warranty section of the bulletin.

1. Reprogram the body control module. Refer to *K9 Body Control Module: Programming and Setup* in SI.

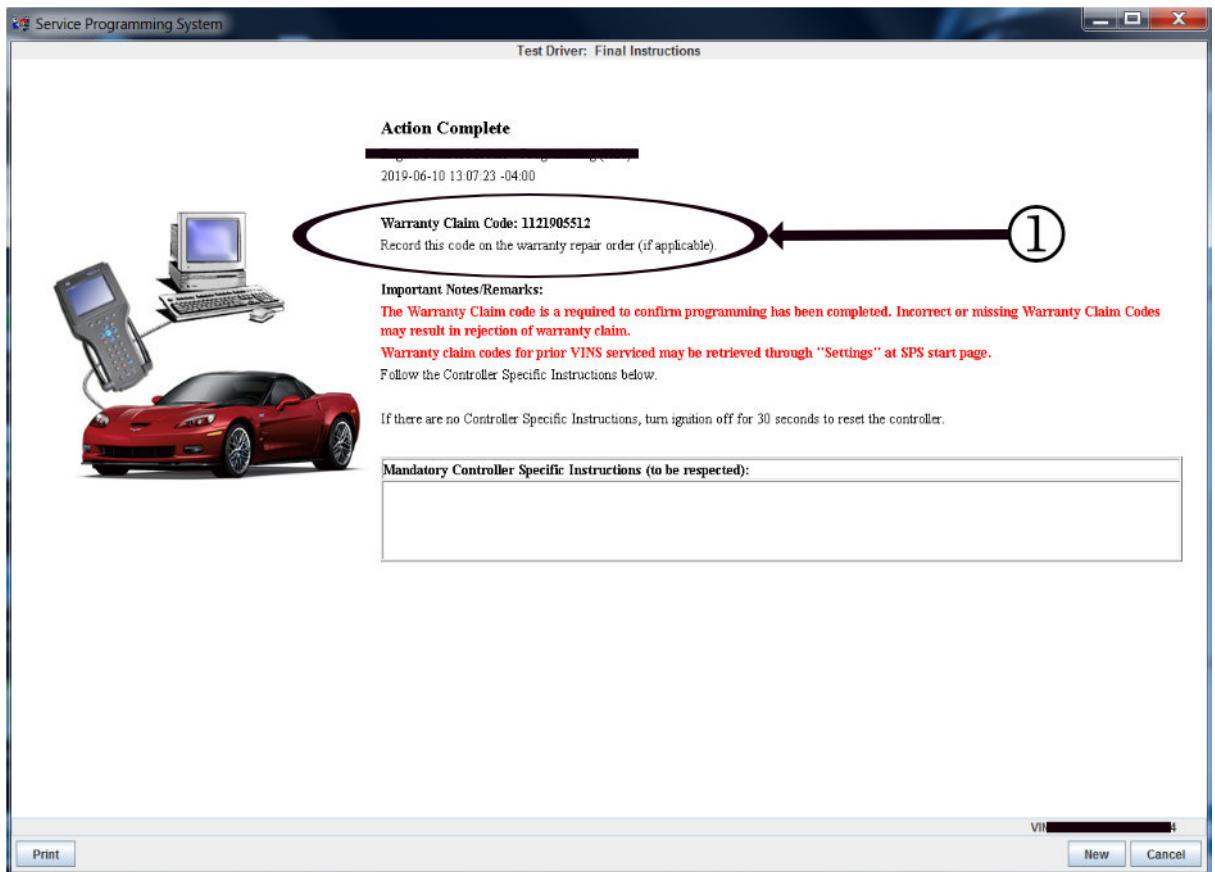
Important: TIS2WEB screen shown. Techline Connect screen is similar and will be included in the near future.

Important: To avoid warranty transaction rejections, you *MUST*

record the warranty claim code provided on the SPS Warranty Claim Code (WCC) screen on the job card. Refer to callout 1 for the location of the WCC on the SPS screen.

1. Record SPS Warranty Claim Code on job card for warranty transaction submission.
