# 2014 - 2019 Corvette: GM TechLink: Warble Sound from Rear of Vehicle

## Warble Sound from Rear of Vehicle

GM TechLink

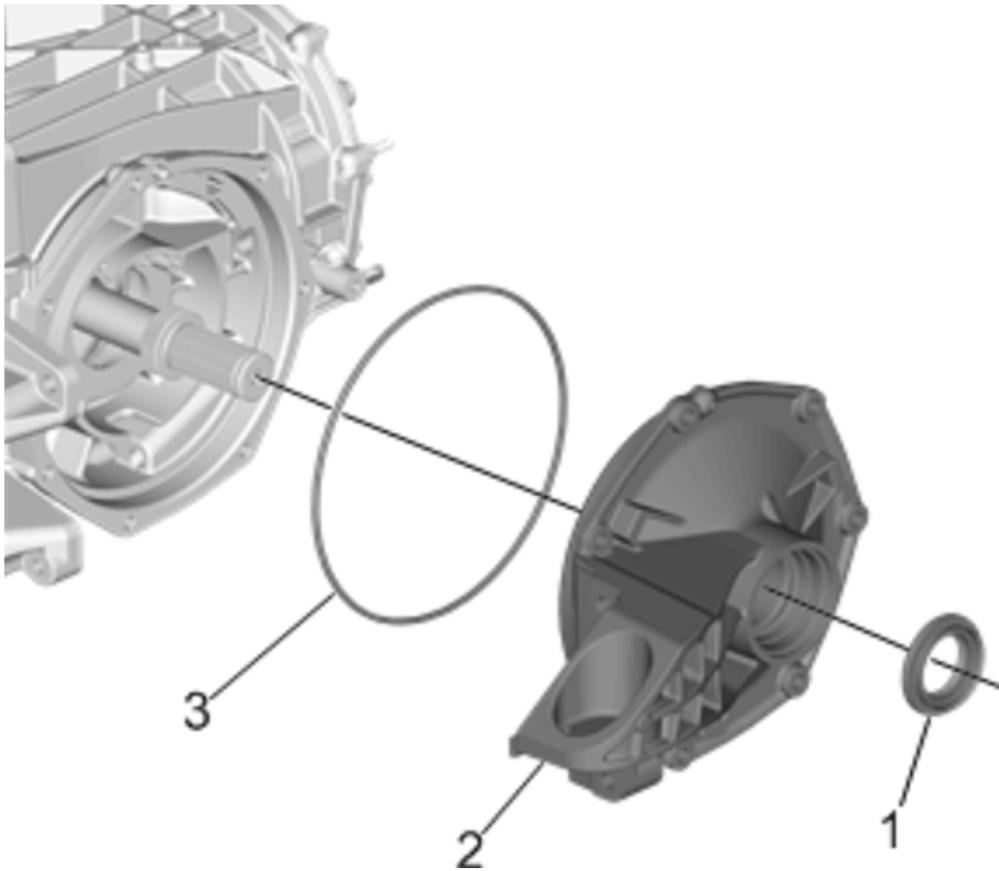
**Fig. 24**

The warble sound may be due to the bushing in the left-side differential cover having too much clearance. If the condition is found, replace the left-side differential cover and shaft seal. (Fig. 24)

Use the DT-45000 Seal Remover to remove the differential rear axle shaft seal and the DT-48076 Rock Guard Installer to install the seal.
