# 2014 - 2019 Corvette: GM TechLink: Warble Sound from Rear of Vehicle

## Warble Sound from Rear of Vehicle

July 30, 2020

GM TechLink

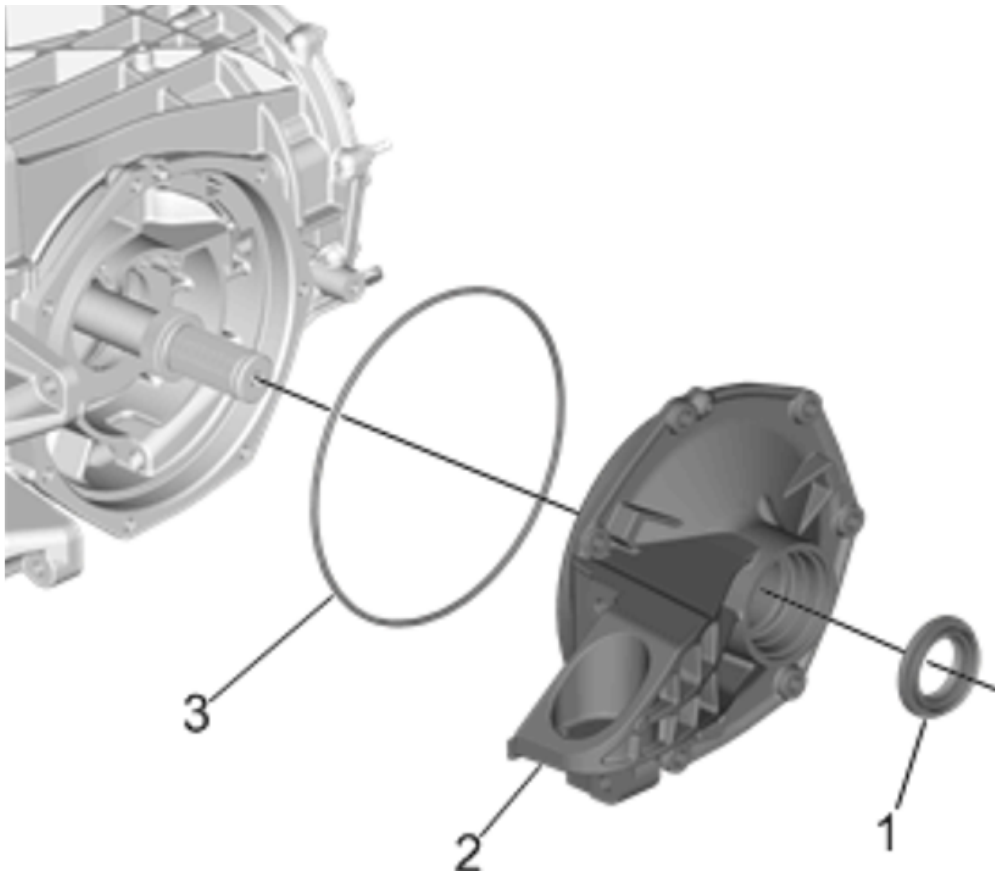
**Fig. 24**

The warble sound may be due to the bushing in the left-side differential cover having too much clearance. If the condition is found, replace the left-side differential cover and shaft seal. (Fig. 24)

Use the DT-45000 Seal Remover to remove the differential rear axle shaft seal and the DT-48076 Rock Guard Installer to install the seal.
