2014 - 2019 Corvette: GM TechLink: Warble Sound from Rear of Vehicle

Warble Sound from Rear of Vehicle

July 30, 2020
GM TechLink

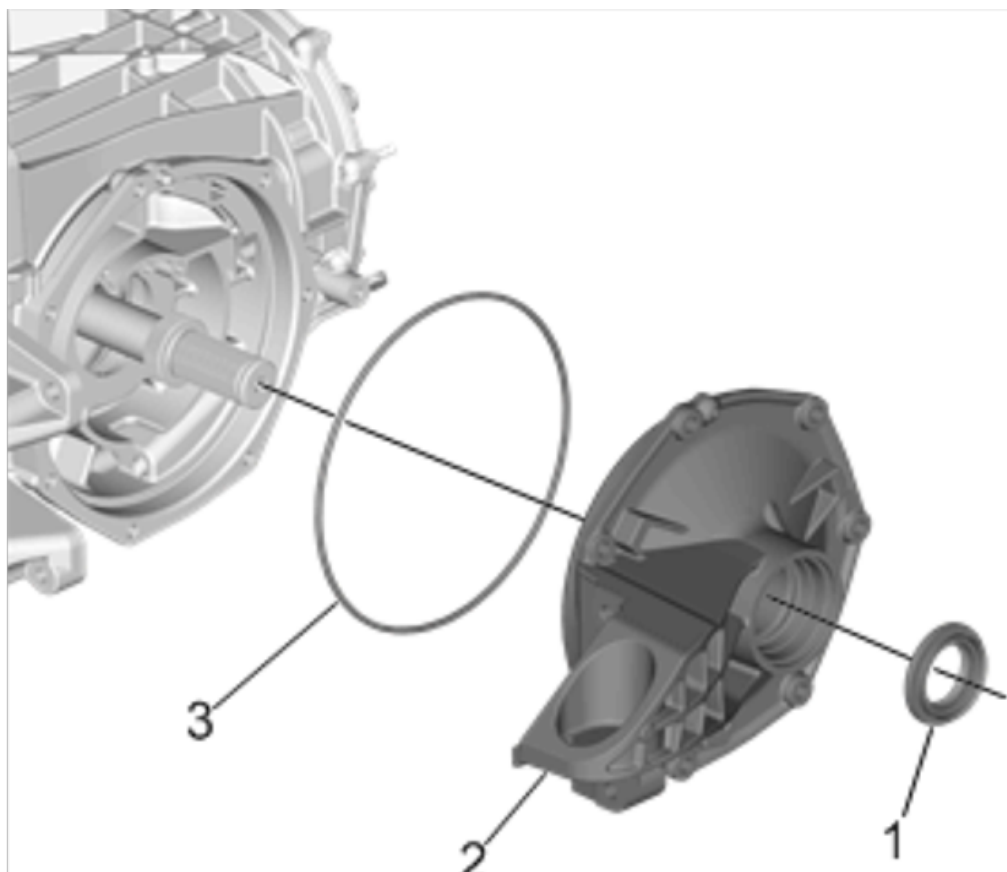
Fig. 24

Some 2014 - 2019 Corvette models equipped with the 6.2L V8 engine (RPO LT1) and 8L90 automatic transmission (RPO M5U) may have a warble-type sound coming from the rear of the vehicle with engine speed around 1,500 rpm. The sound may be more noticeable when driving up a slight grade with little throttle input.

The warble sound may be due to the bushing in the left-side differential cover having too much clearance. If the condition is found, replace the left-side differential cover and shaft seal. (Fig. 24)

Use the DT-45000 Seal Remover to remove the differential rear axle shaft seal and the DT-48076 Rock Guard Installer to install the seal.

Refer to Bulletin #20-NA-041 for additional information and part numbers.
