2014 - 2019 Corvette: GM TechLink: Warble Sound from Rear of Vehicle

Warble Sound from Rear of Vehicle

July 30, 2020
GM TechLink

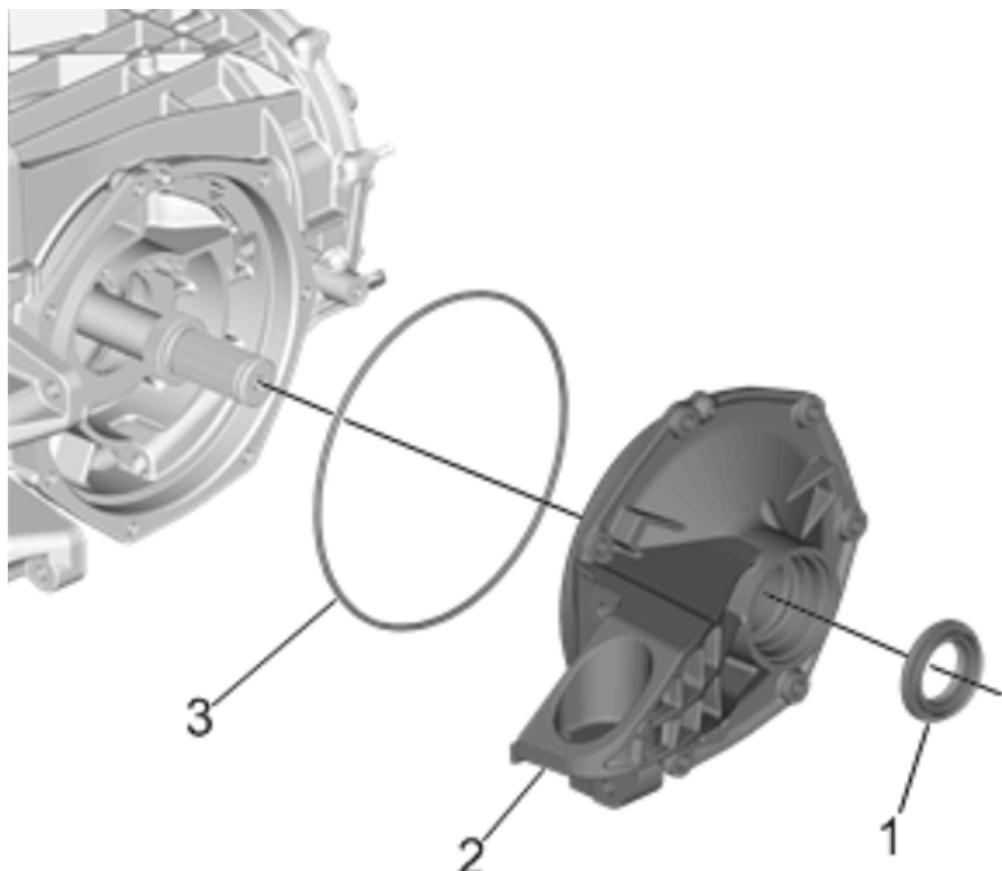
Fig. 24

The warble sound may be due to the bushing in the left-side differential cover having too much clearance. If the condition is found, replace the left-side differential cover and shaft seal. (Fig. 24)

Use the DT-45000 Seal Remover to remove the differential rear axle shaft seal and the DT-48076 Rock Guard Installer to install the seal.
